## **Building Condition Survey Report**

(NSDC018) Whitchurch Civic Centre & (6000) Whitchurch Library  
High Street, Whitchurch, Shropshire, SY13 1AX

**Date of Survey: January/February 2026**

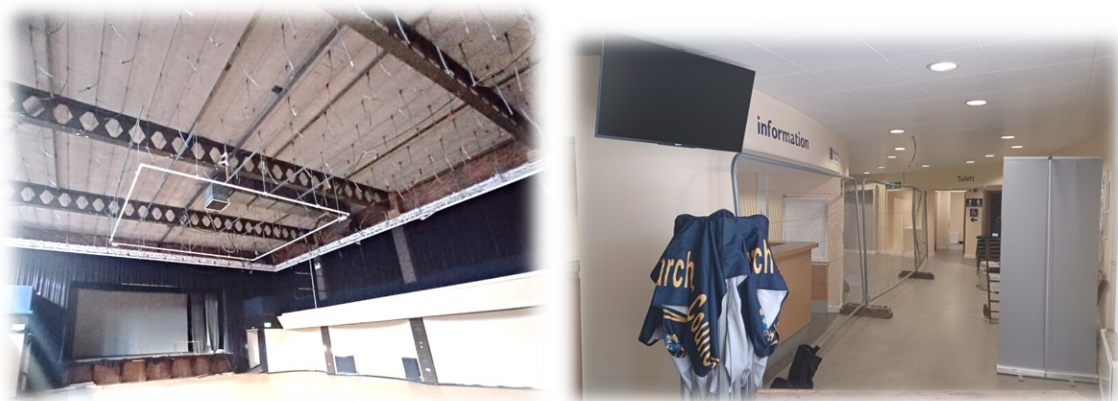
the limited bearing width of existing steel structures plus ongoing inspection regimes. Replacement of the structural deck may be preferable.

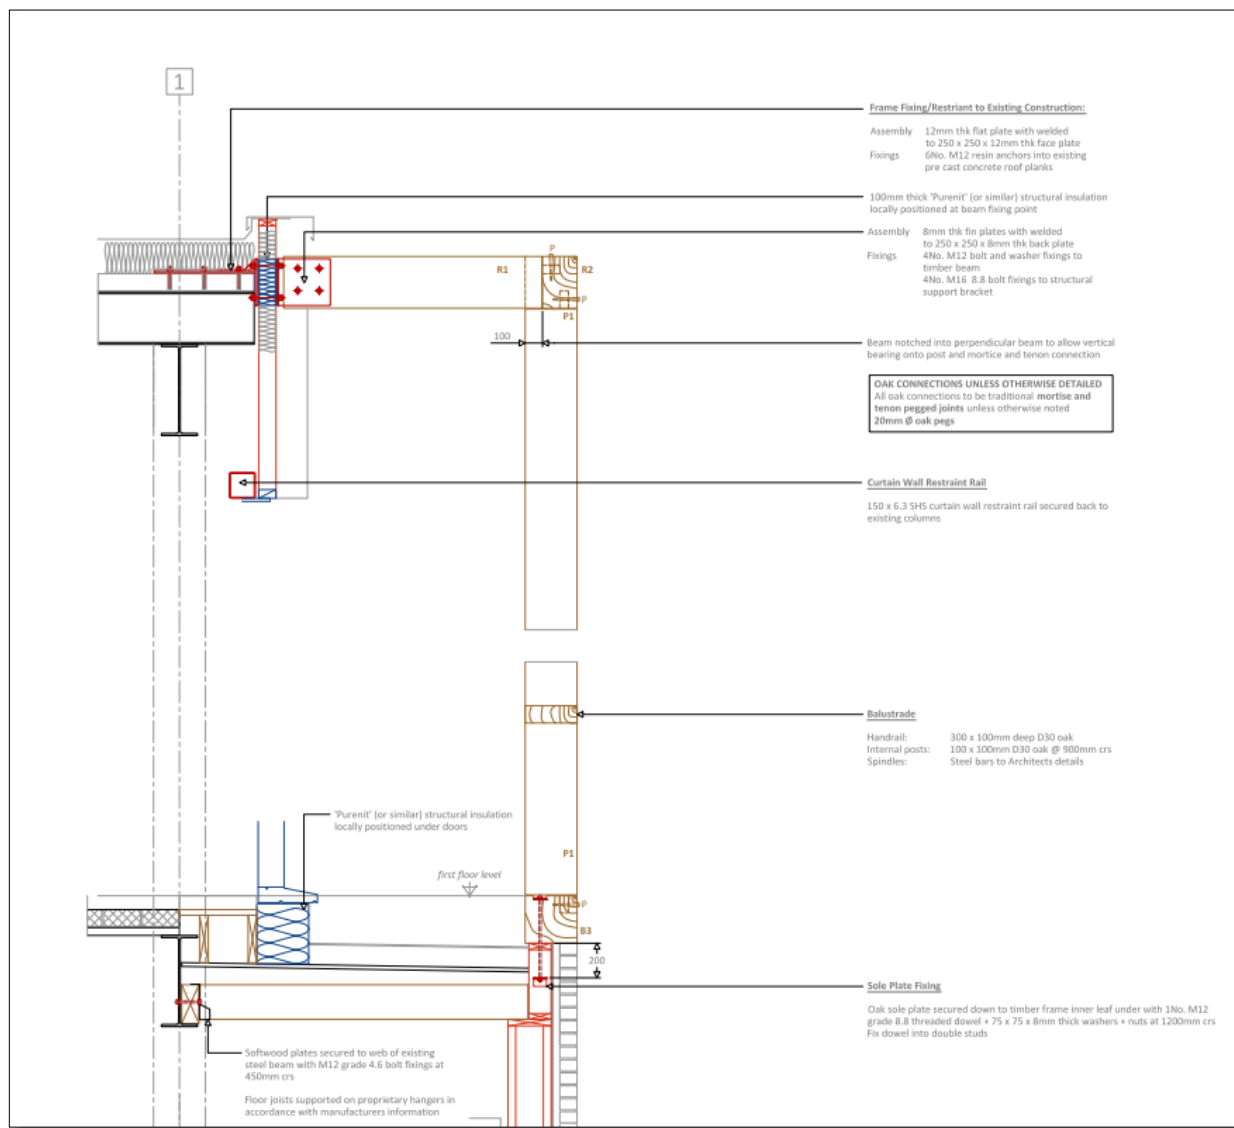
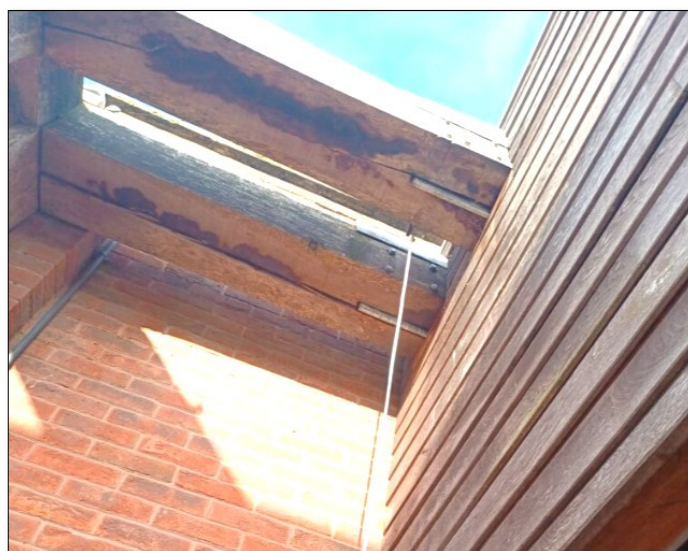
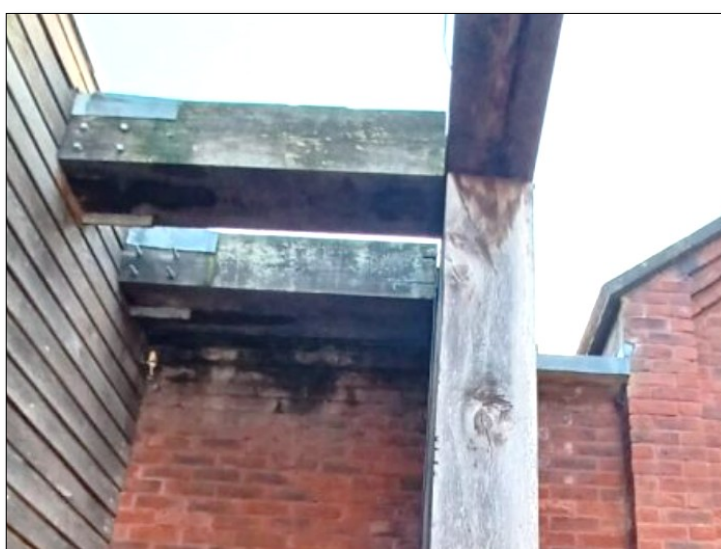
Figure 2 - External canopy/decking detail.

The front west façade has a large solid timber frame structure forming a pagoda and balustrade. It was observed the balustrade structure of untreated (though may have been tanalised) timber has shrunk and several shakes (splits). The timber joints have shrunk and showing connections and caution should be exercised and prevention of allowing a large quantity of people accessing this area i.e. leaning on the balustrade, as this may cause partial collapse – though the property is currently vacant and unoccupied in this area. The larger overhead timber structure shows signs of weathering and mortice/tenon joint shrinkage though currently is not thought to be an imminent danger. To prevent further deterioration and health and safety obligations in protecting staff/visitors/public, further assessment and design is required in the replacement of timbers and or treatment to extend its life span, with connections requiring strengthening with additional steel plate fixings.

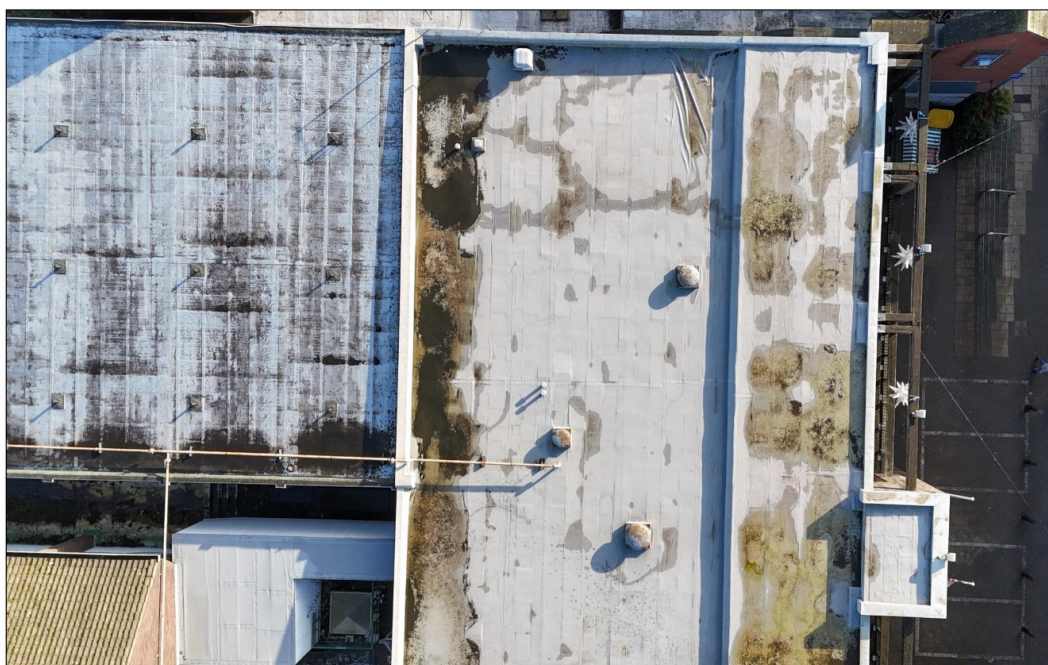
The roof structure appears to be modern and likely provided as an alternative means of escape serving the Merrie Lounge, with timber purlins and metal sheet structural deck. The roof covering appears to be a single ply rubber membrane. Blisters to the membrane surface were noted in the aerial images, however, no leaks were observed internally.

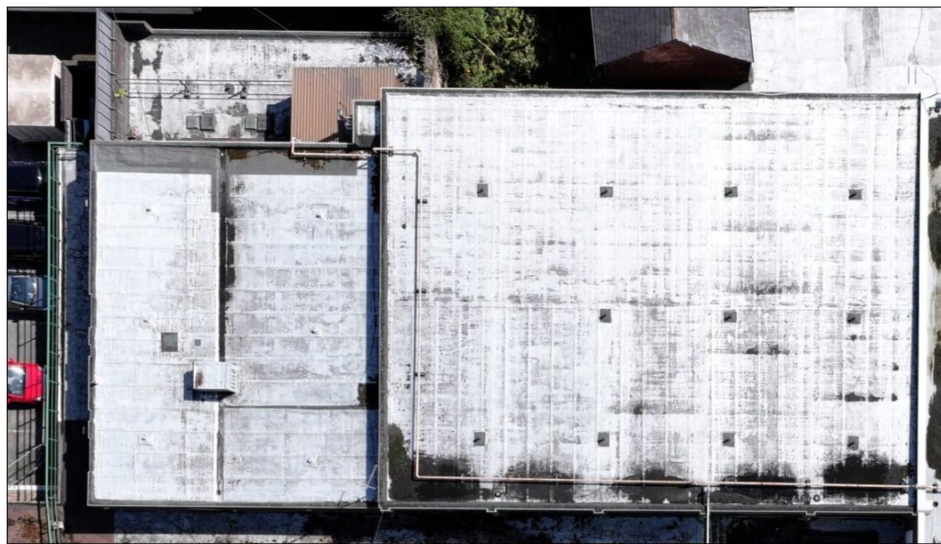
The flat roof to the covered internal walkway and external canopy appears to be asphalt with a retrospective applied reflective paint. The roof was not physically inspected due to concerns of RAAC instability and observed from vantage points and aerial images. The roof is in poor condition with crazing to surfaces and evidence of thermal expansion stress to the roof covering. Remedial repairs appear to have been applied in various areas using mineral felt. There is evidence of standing water to the roof generally.

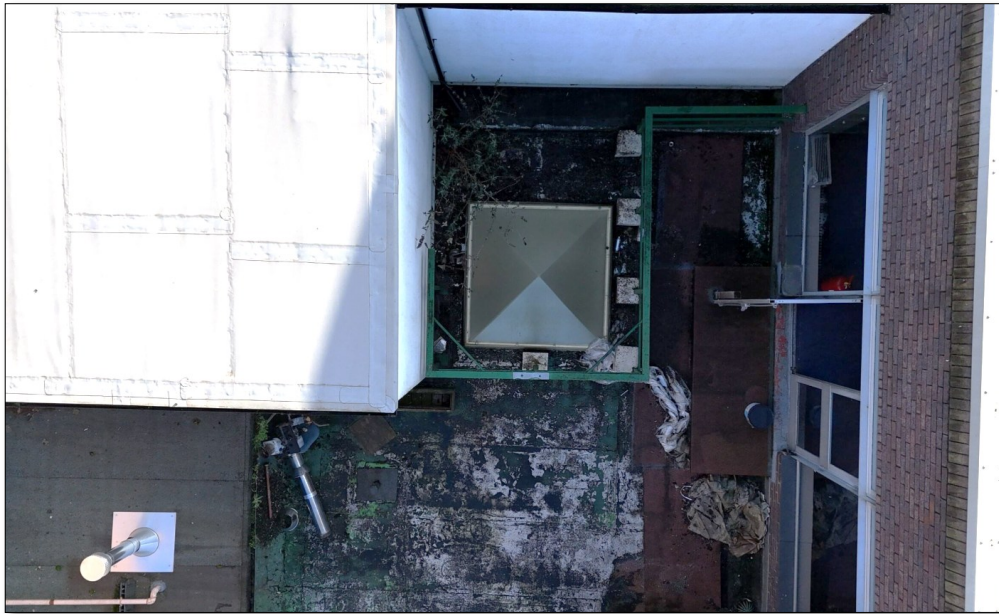
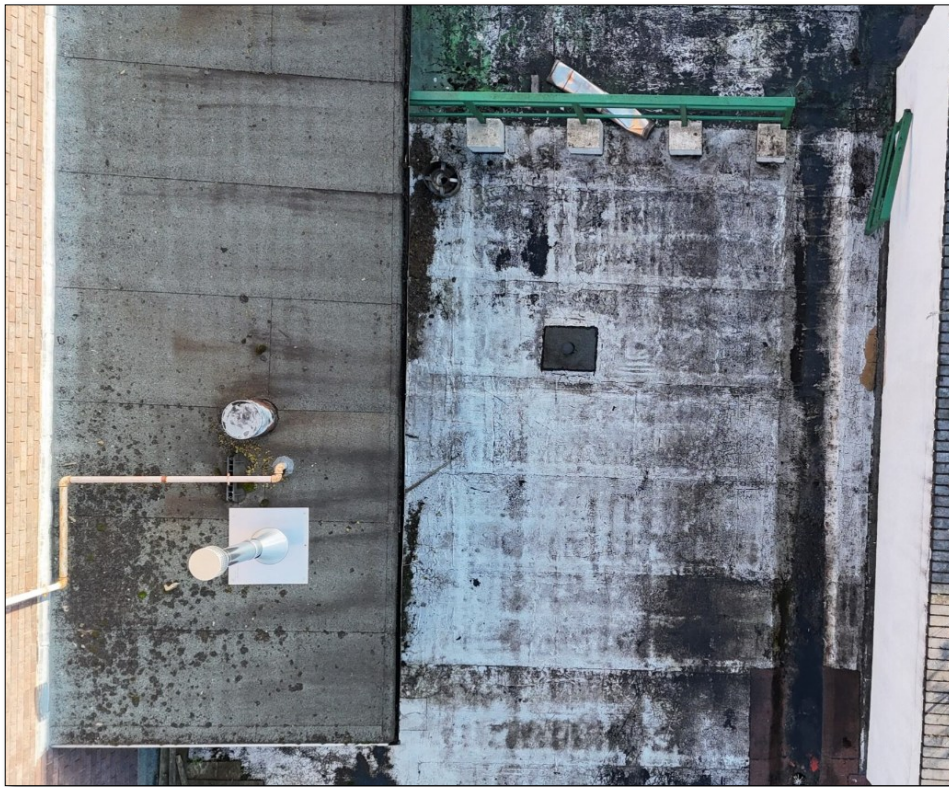
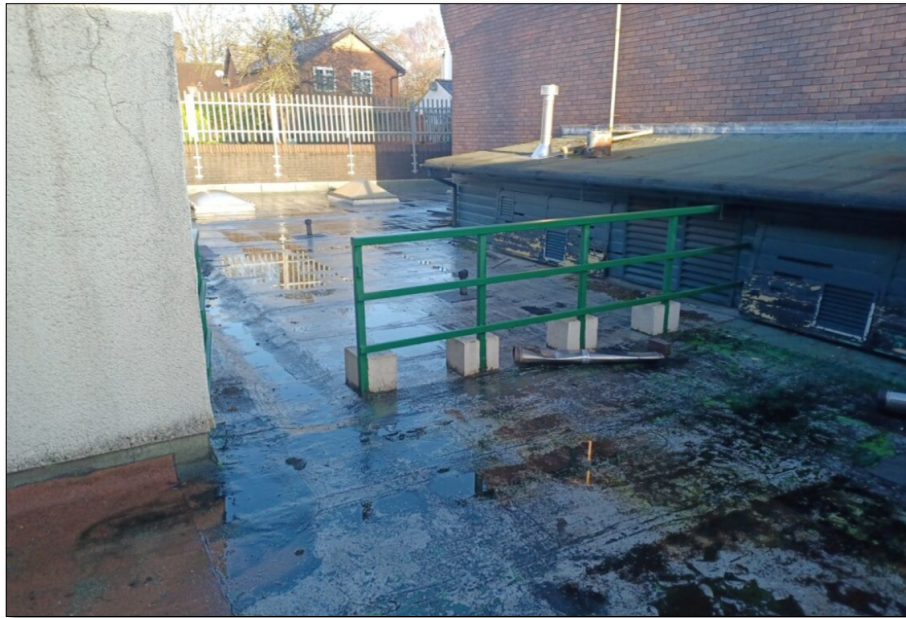
The enclosed flat roof covering appears to asphalt with a retrospectively applied reflective paint. The roof is in poor condition with crazing to surfaces and evidence of thermal expansion stress to the roof covering. Remedial repairs appear to have been applied in various areas using mineral felt. There is evidence of standing water to the roof generally, with drainage points of internal rainwater pipes to the areas below. There is minor evidence of moisture penetration to areas within the library, however no major leaks were observed. The roof contains a number of roof lights which would benefit from replacement during a roof replacement project. The RAAC structural deck is heavily propped due to results of previous reflection surveys and requires removal and replacement. The roof is beyond its economic life and should be replaced urgently and or as part of any RAAC replacement project.

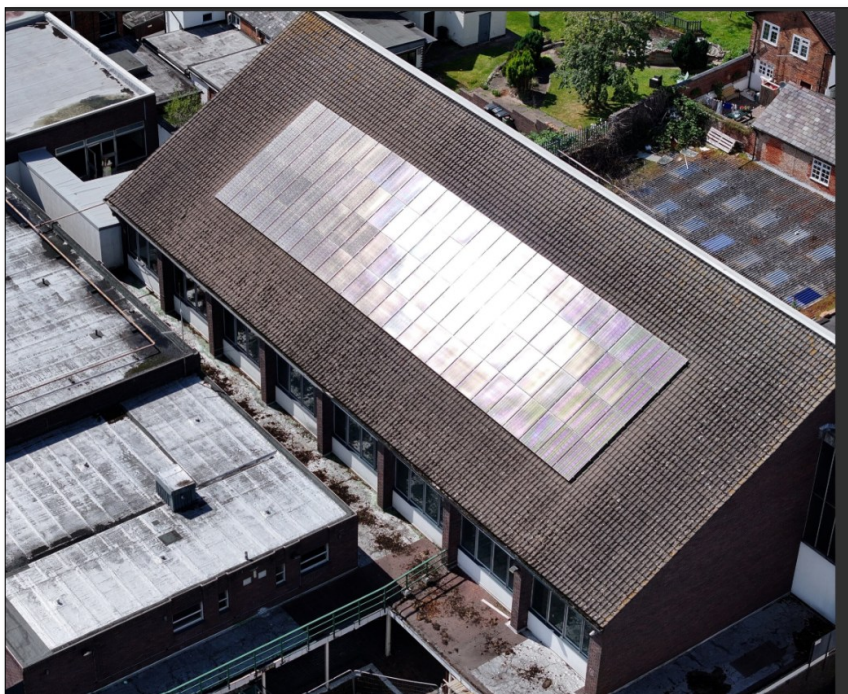
The market Hall roof is a pitched ridged construction finished with a concrete tiled roof. The roof tiles appear to be in reasonable visual condition. The verge pointing is showing signs of deterioration and requires re-pointing to help preserve the roof from water egress. Remedial works to the large area of skylights may be required with beading/flashing displaced and requiring remediation. Site staff comment on occasion roof leaks in the form of drips in heavy rain. The roof is also fitted with Photovoltaic Panels as noted in section 4.

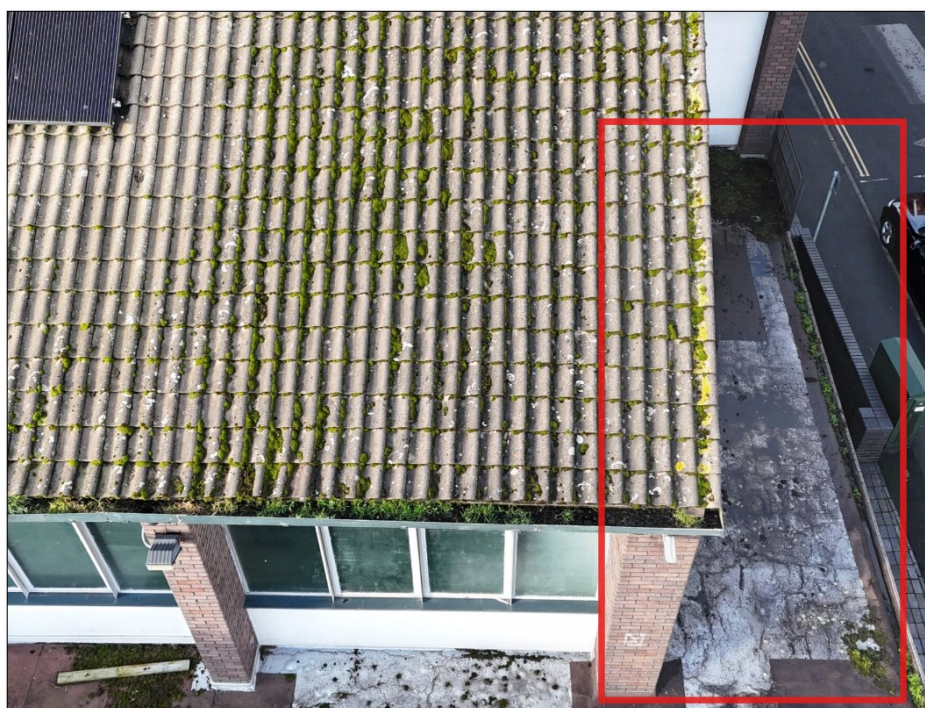
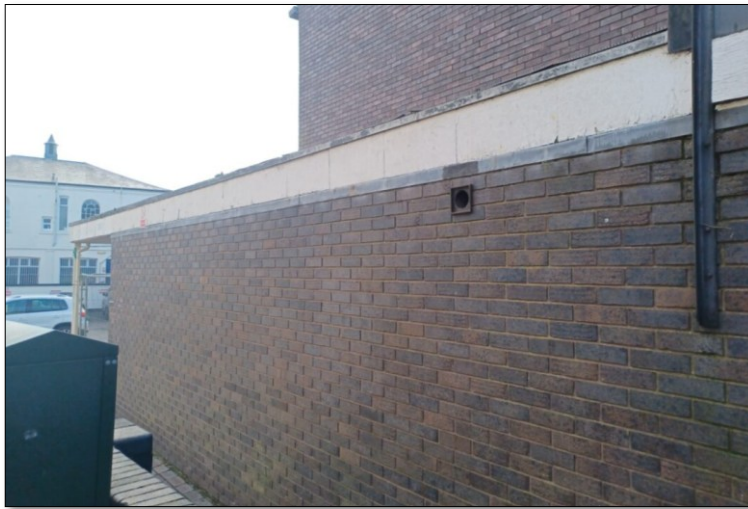
In addition, the Market Hall toilets and internal store have a flat RAAC roof structural connected as part of the external canopy walkway, with assumed asphalt flat roof of unconfirmed construction. The roof covering is in poor condition requiring re-roofing and the timber fascia is rotten in areas and in need of replacement and further investigation.

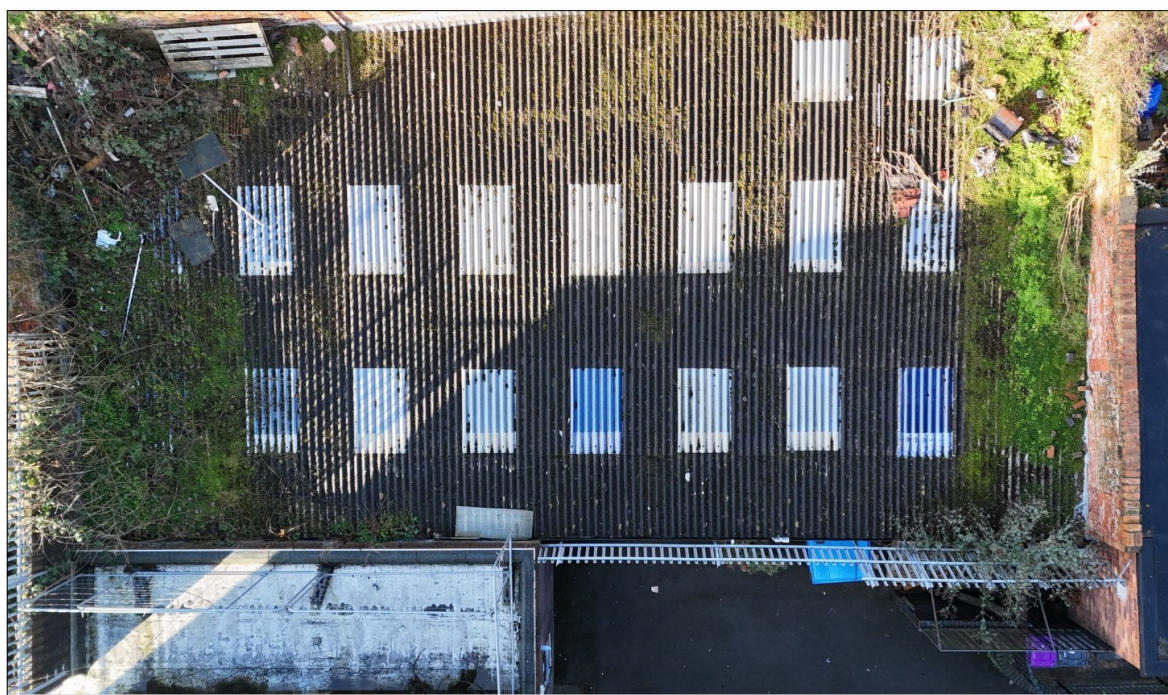
Market Hall – There is currently an internal vertical ladder access to roof void, which must be accessed via separate means onto the ceiling of the toilets/storeroom. This arrangement requires consideration by the operator of proper access and fall arrest measures plus a management strategy to safely manage access, plus ongoing annual inspection of ladder/fall arrest systems.

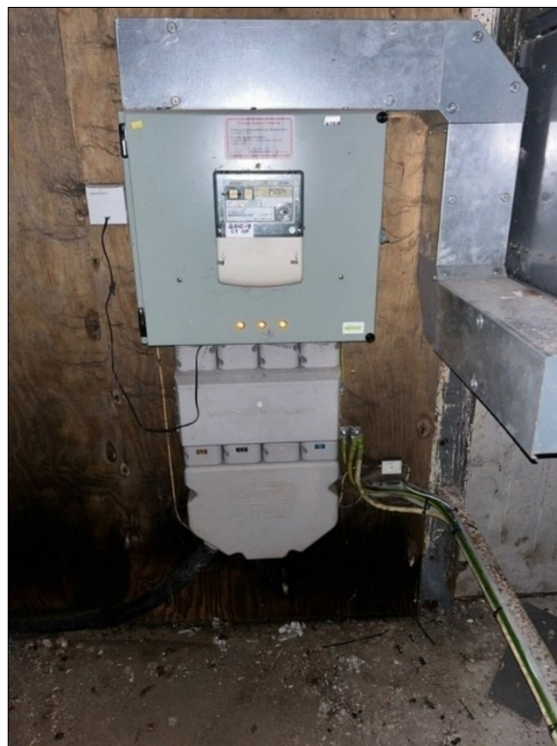
The property is served by a CT metered TNCS supply located within basement store 074 and feeds both the library and civic centre. The cutout is in good condition however basement environment requires improvement to dry out environment due to elevated levels of condensation/damp particularly the ply board cutout is mounted to due to ventilation system not operating. If plyboard requires replacement distribution network operator required to power down and remove cutout. Recommend installation of dedicated supply for the library to remove sharing of supply if the civic centre is to be transferred to Whitchurch town Council to ensure a clear division of maintenance responsibilities and repair. Last electrical installation condition report carried out on 27/02/2023 with a number of observations requiring action therefore unsatisfactory. No electrical minor works certificates provided to confirm whether remedials were completed. Recommend new Electrical Inspection Condition Report (EICR) carried out if no remedials have been completed due to lapse in time since inspection.

Condition Rating B-2  
DNO attendance and replace ply.

Condition Rating C-1  
Ventilation and tubular heating.

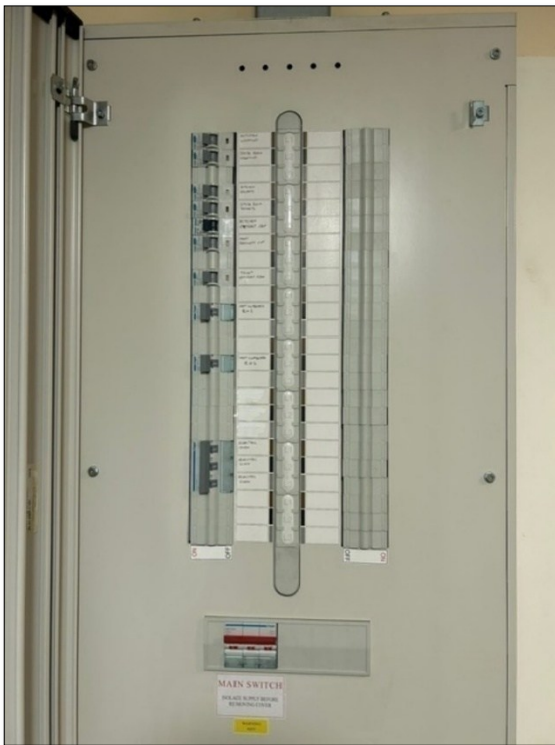
Number of three phase and single-phase distribution boards installed across site fed via aluminum armored cables, with a number of circuits not protected by RCD. Some new schneider electric distribution boards. Number of the Memera 2000, Crabtree Starline and MEM Shield 2 distribution boards are now obsolete and require updating to ensure business continuity. No surge protection on any of the distribution boards.

Condition Rating B-2  
Replacement obsolete distribution boards.

Condition Rating B-2  
Provide surge protection to every Distribution Board.

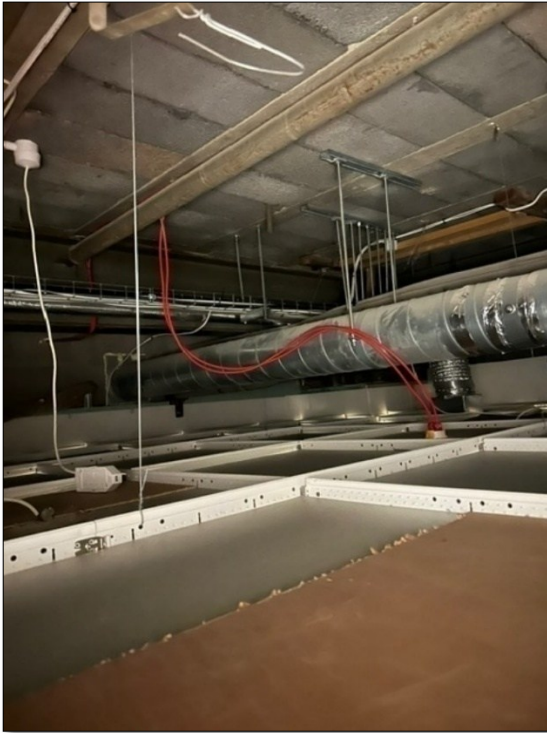
Ground floor area at the front of the property seems to be in good condition. First floor and hall area require improvement as not supported.

Condition Rating C-1

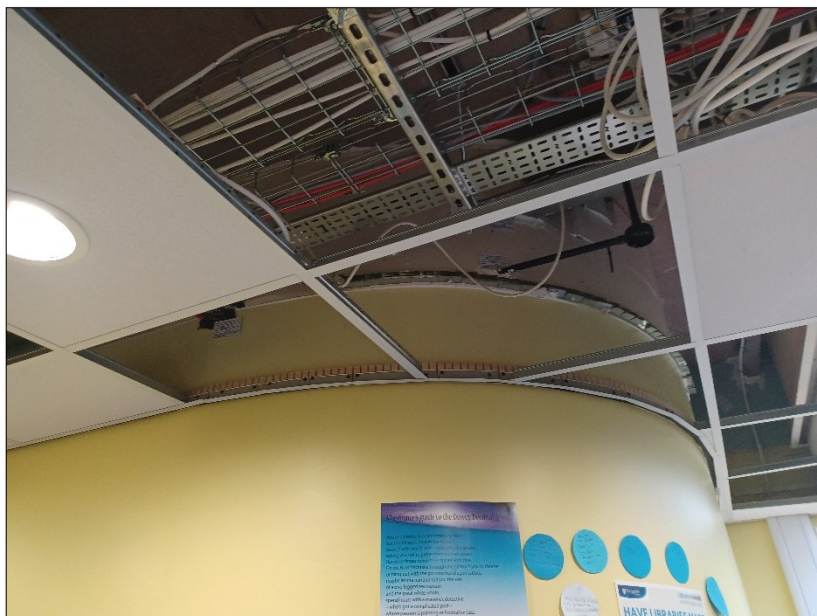
New basket and tray containment installed throughout.

Condition Rating A-4

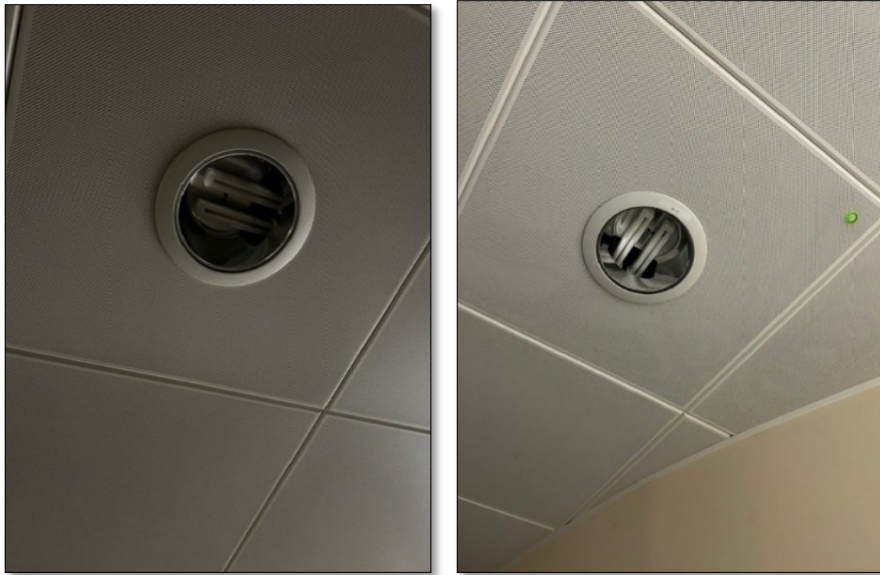
Lighting primarily consists of obsolete compact fluorescent lamps and fluorescent lamps with no presence or LUX level detection present. Lack of emergency lighting in number of areas to comply with BS 5266 with a large number of failures on the recent emergency lighting test schedule carried out 31/07/2023.

Condition Rating C-2

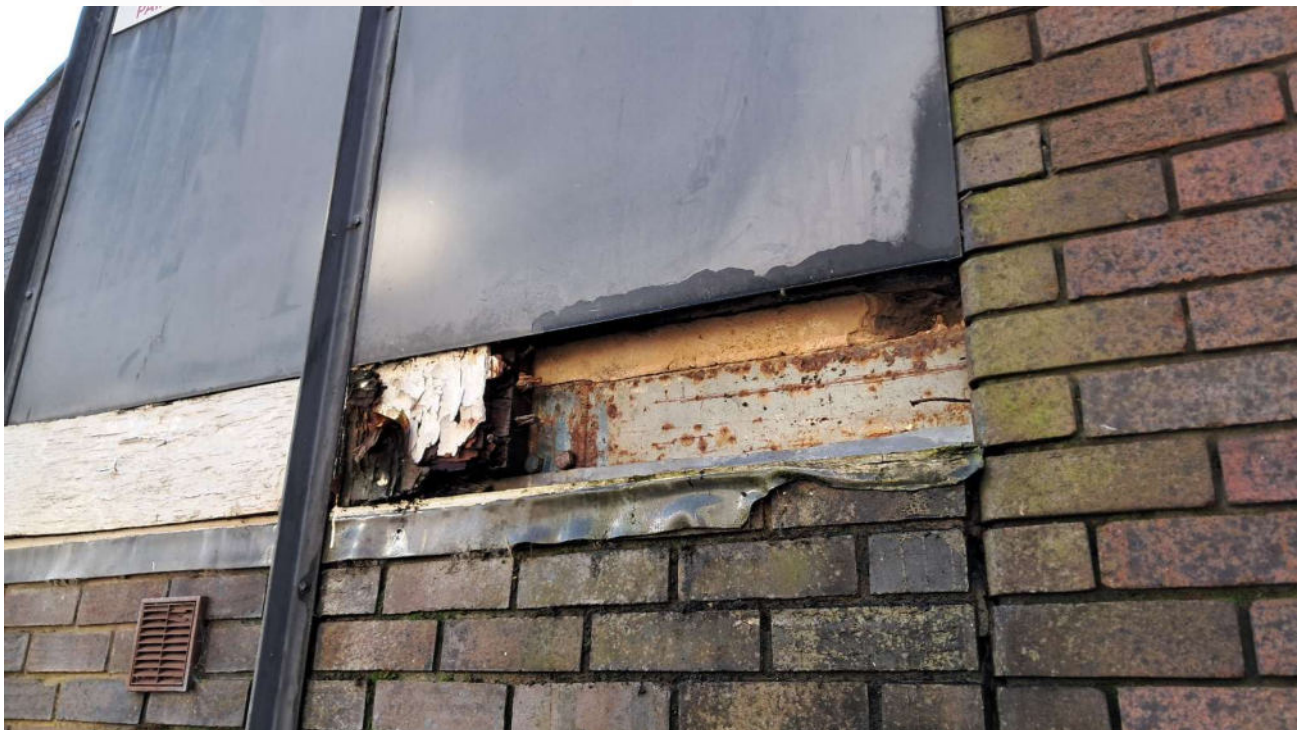
*Photograph 11 – Rear elevation of Market Hall close up damage of fascia board*

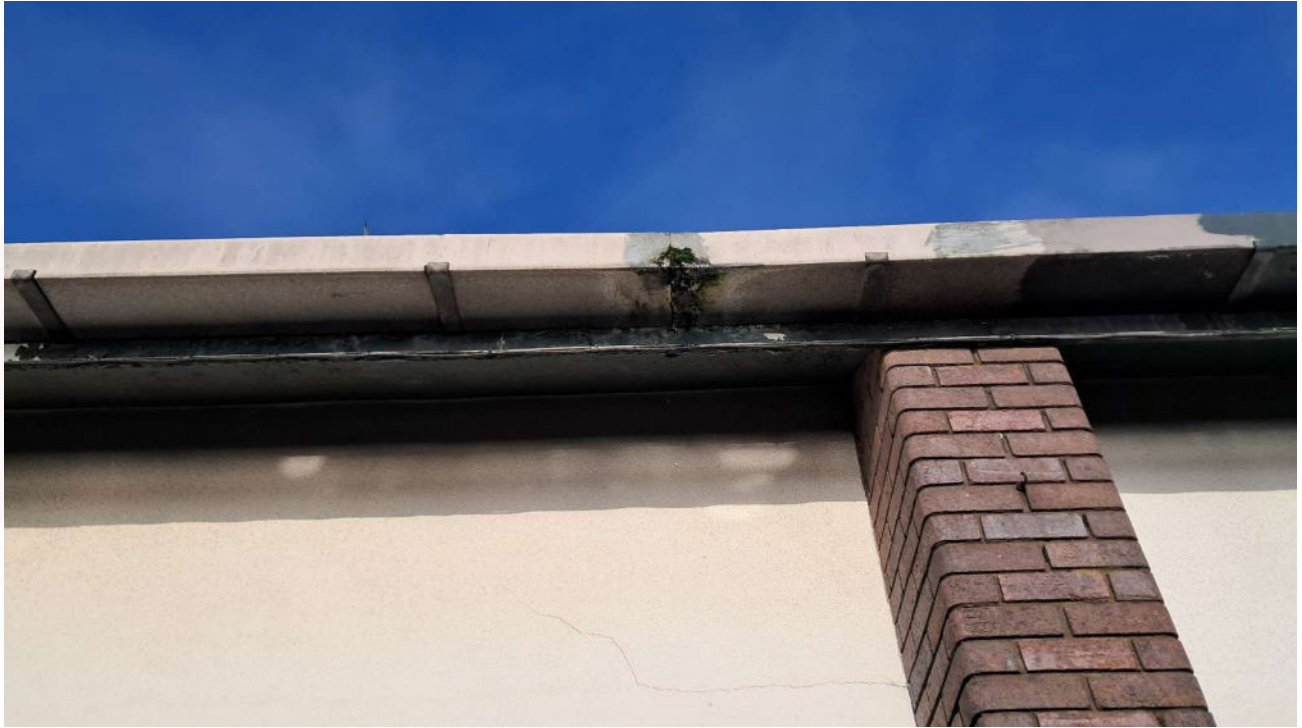
*Photograph 16 – Typical cracking to panelling above glazing, leaking gutters*

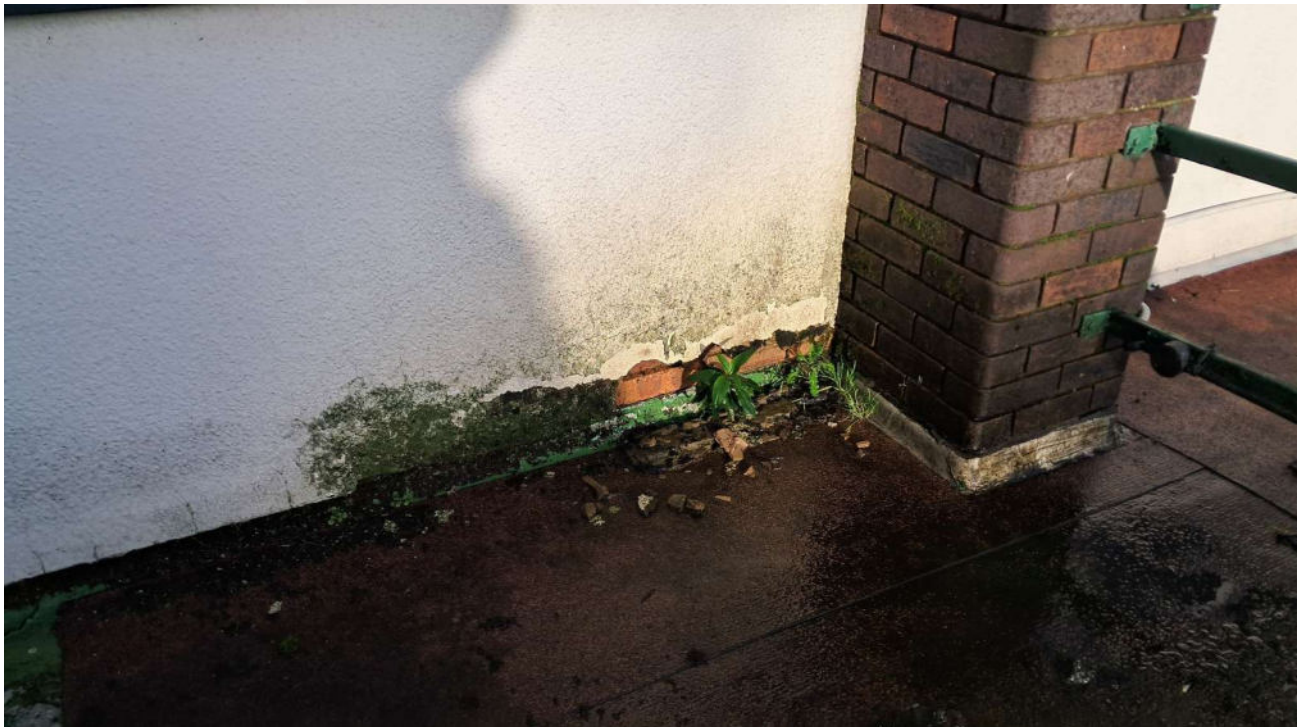
*Photograph 17 – Loss of mortar and algae staining*

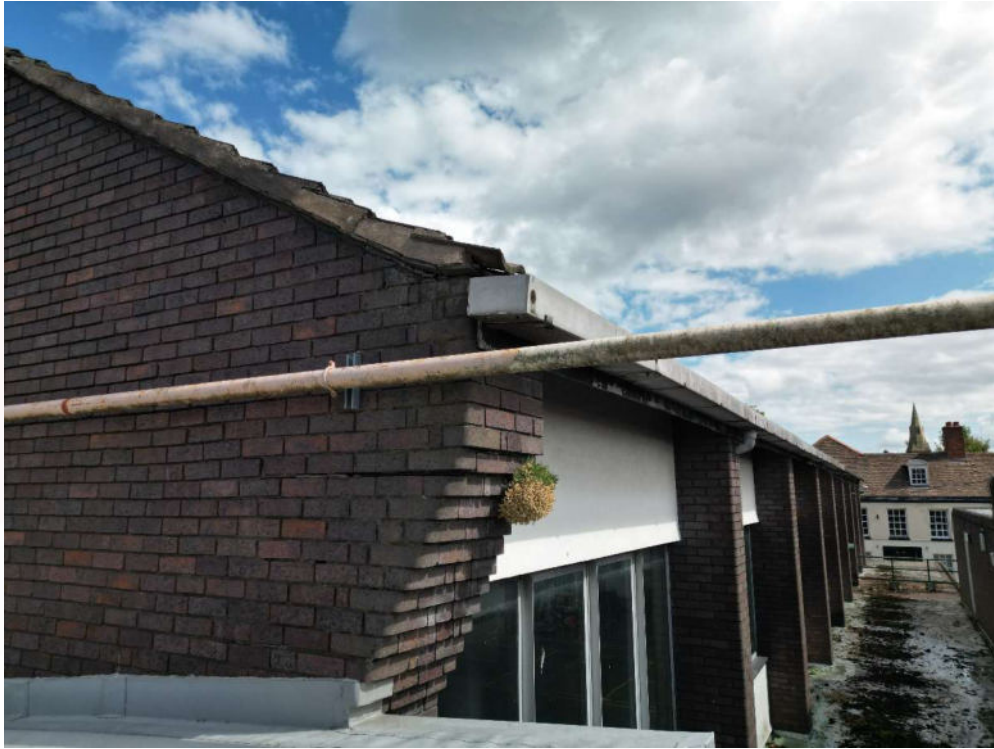
*Photograph 18 – Displacement and cracking to corbel on front gable elevation – no change*

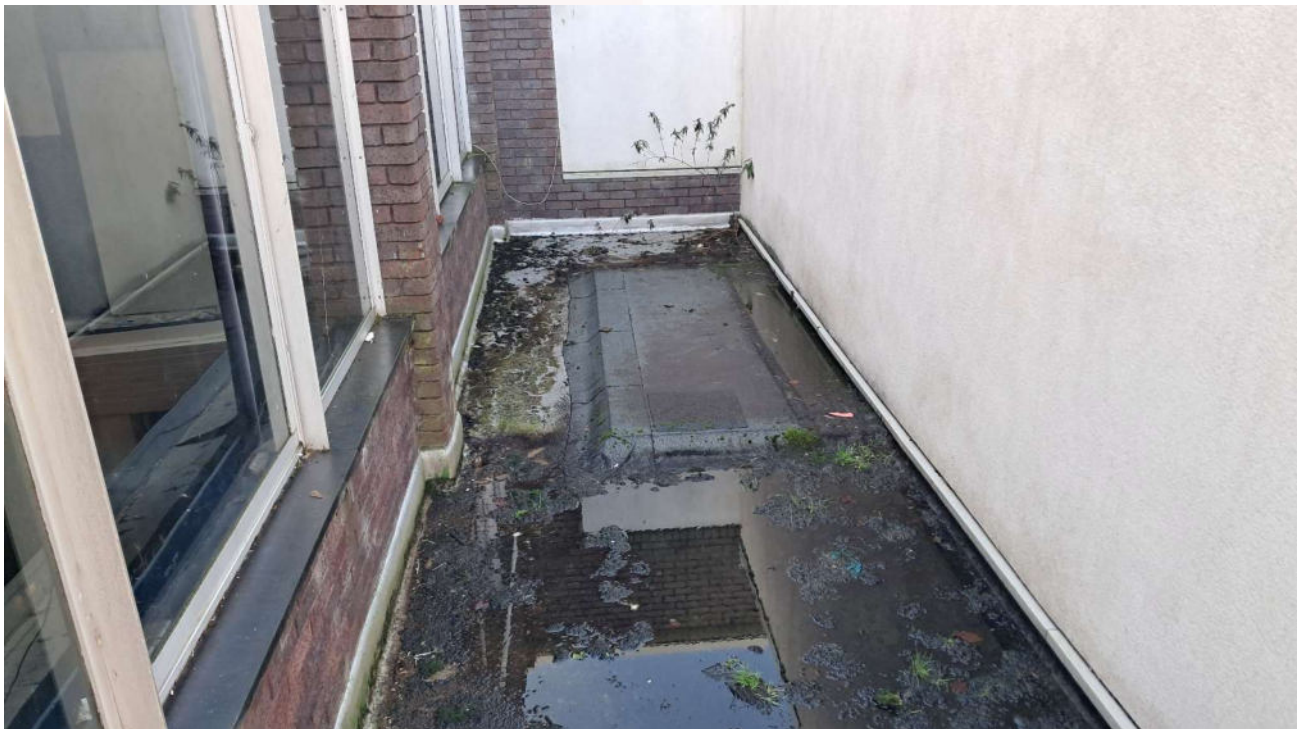
*Photograph 19 - Contained roof over corridor with no apparent drainage – standing water*

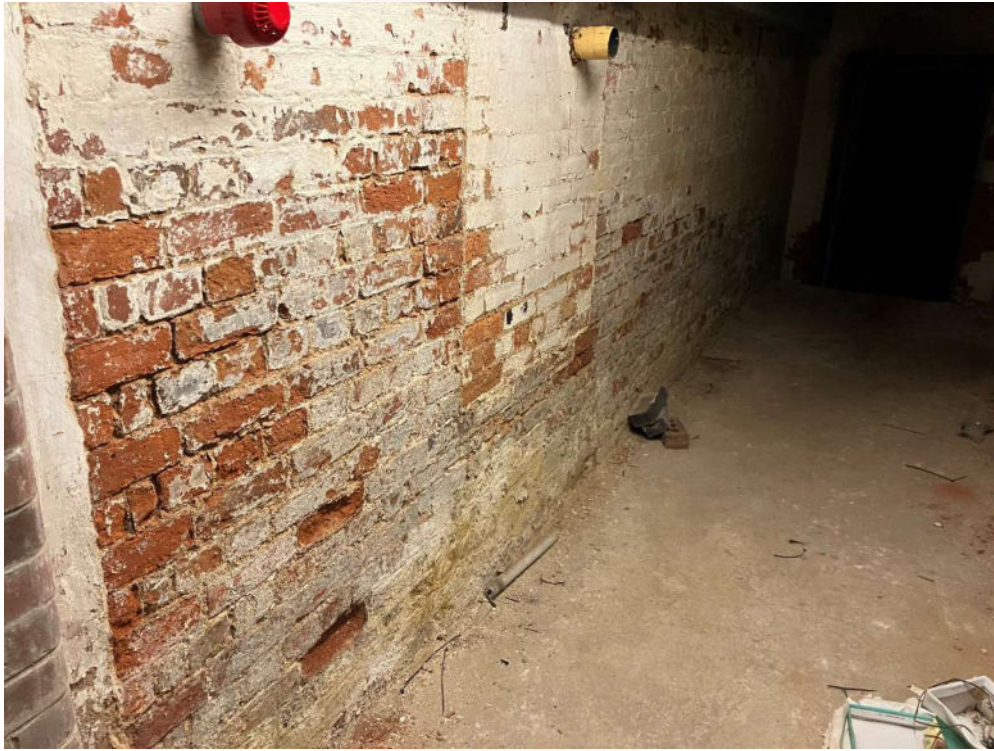
*Photograph 31 – Typical condition of brickwork in basement – no change*

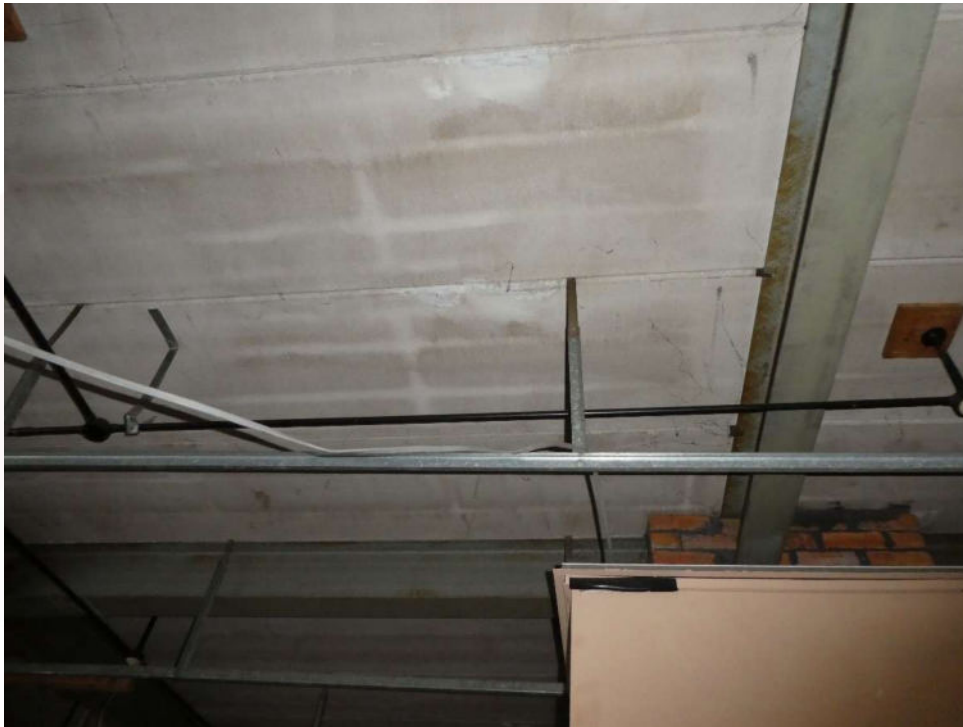
*Photograph 35 – Typical condition of RAAC Concrete over Lounge Bar – staining visible*

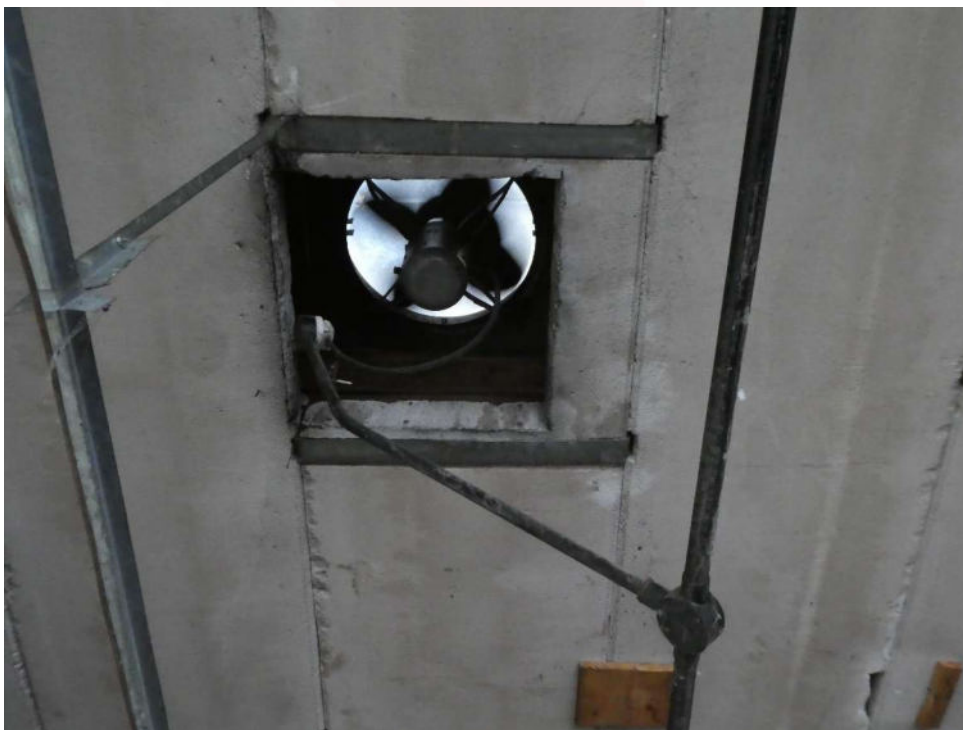
*Photograph 36 – trimming to opening over Edward German room on metal straps – water ingress evident*

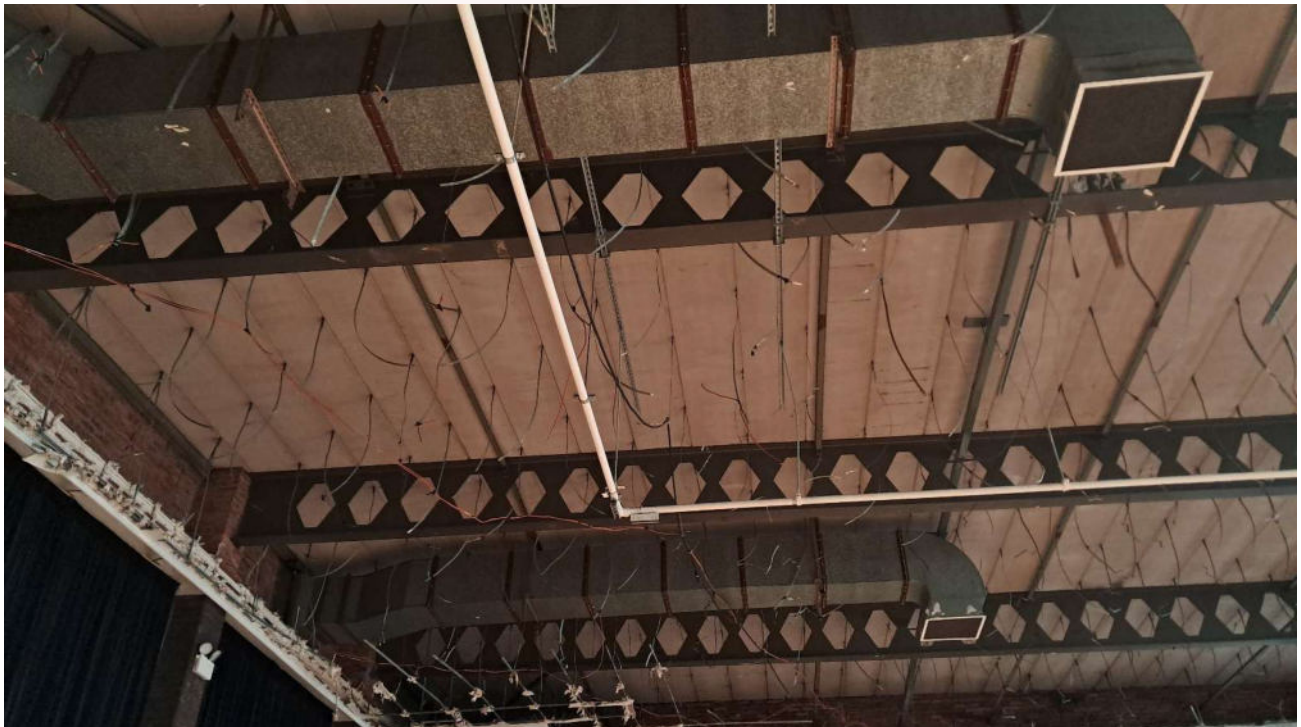
*Photograph 40 – roof arrangement over theatre hall – black lateral staining visible to isolated panels*

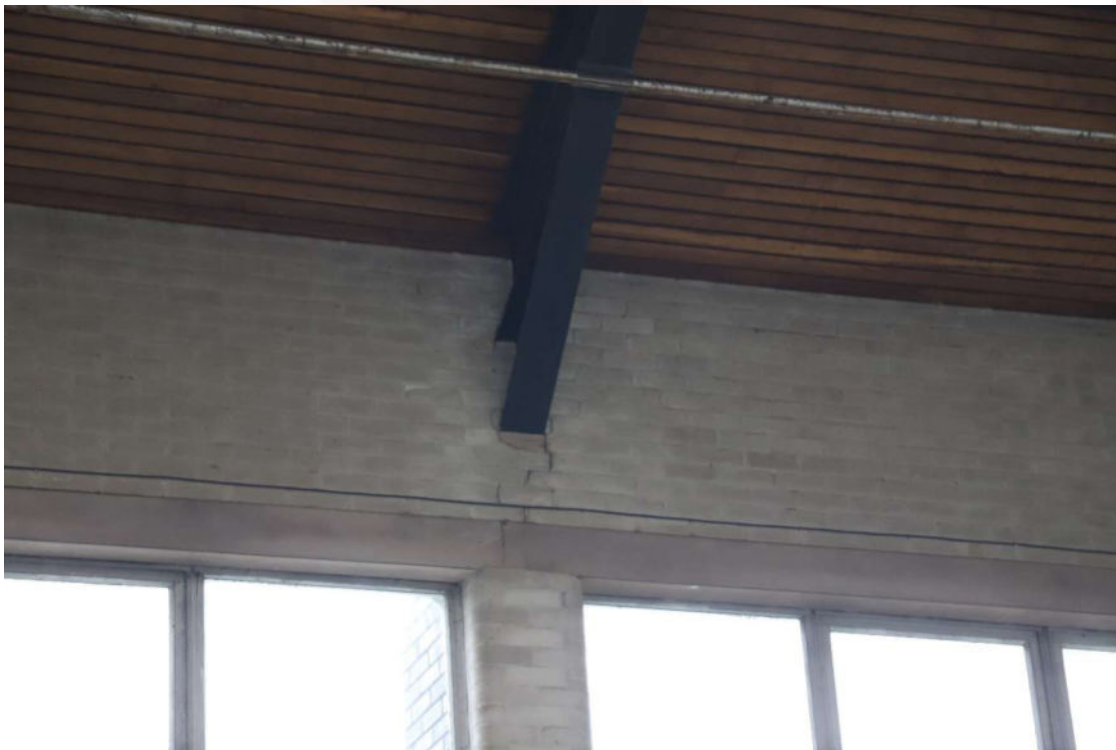
*Photograph 42 – Cracking at eaves of Market Hall portal frame – no change*

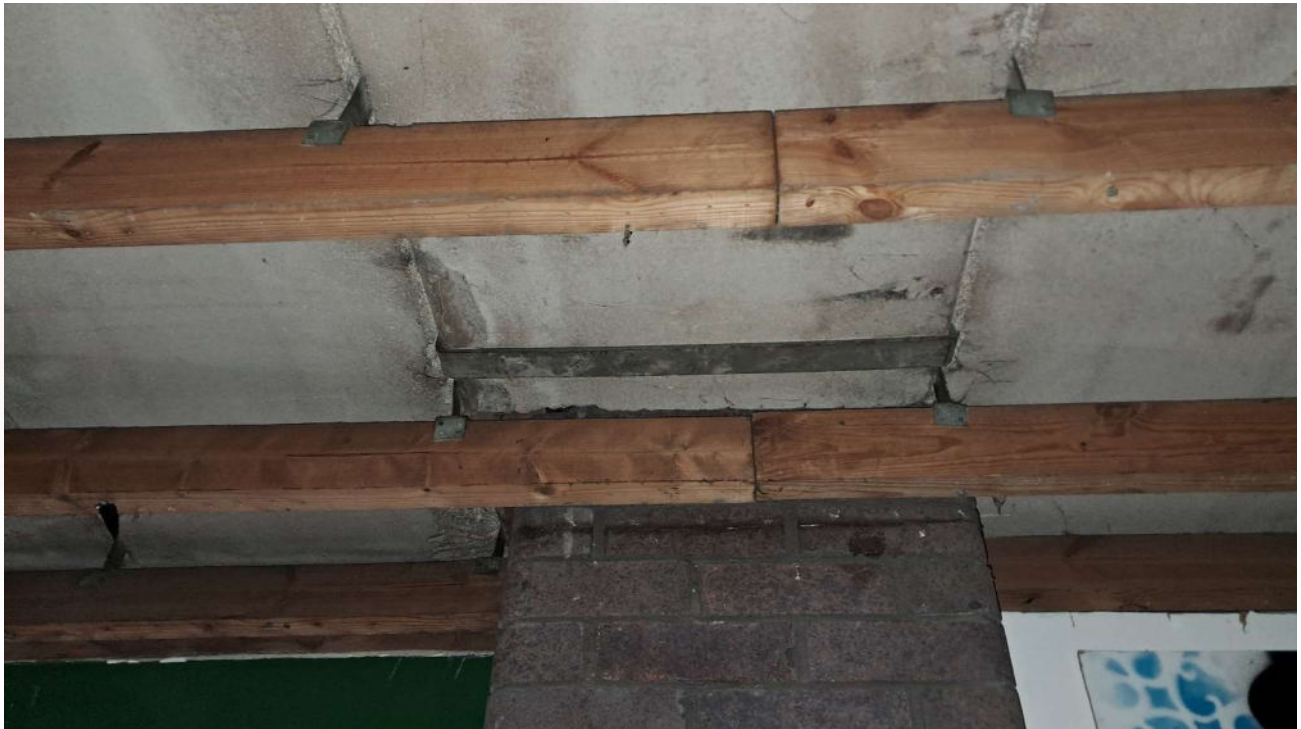
*Photograph 45 – typical arrangement of roof abutting column in corridor – staining visible*

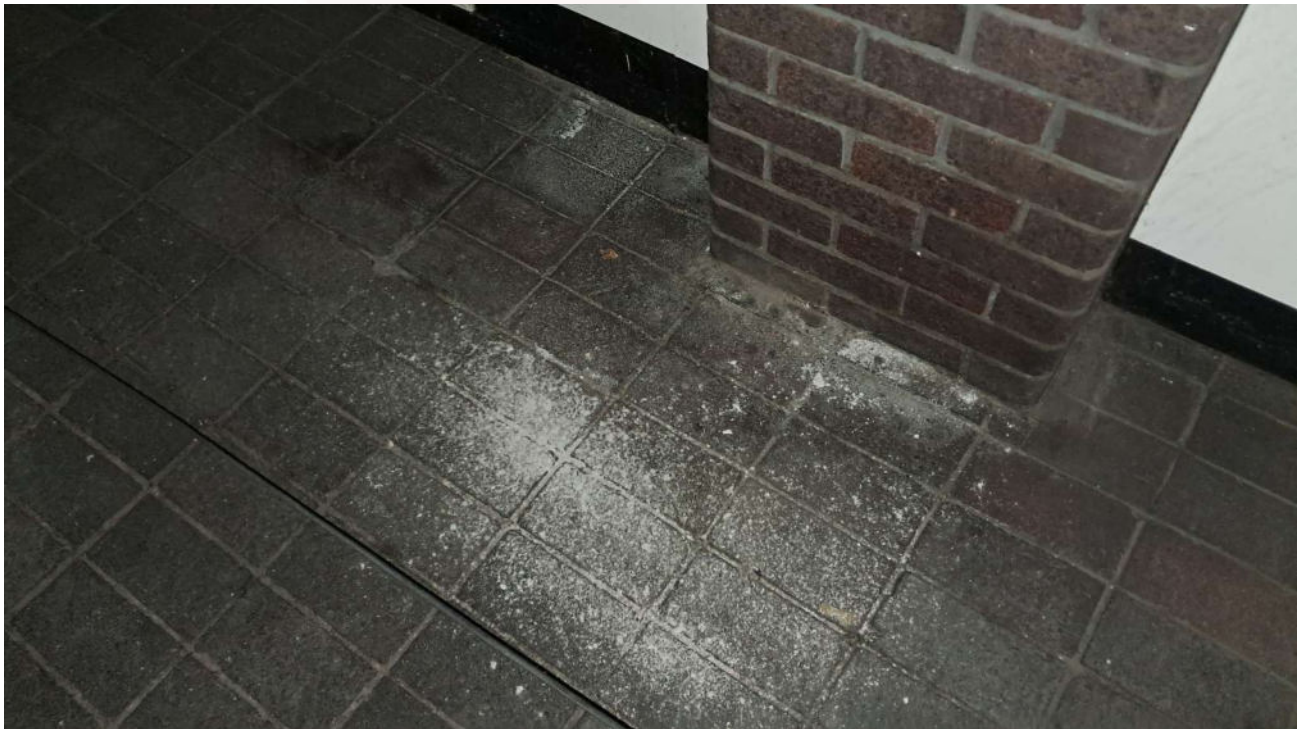
*Photograph 46 – detritus on floor beneath trimming*
