## **Building Condition Survey Report**

(NSDC018) Whitchurch Civic Centre & (6000) Whitchurch Library  
High Street, Whitchurch, Shropshire, SY13 1AX

**Date of Survey: January/February 2026**

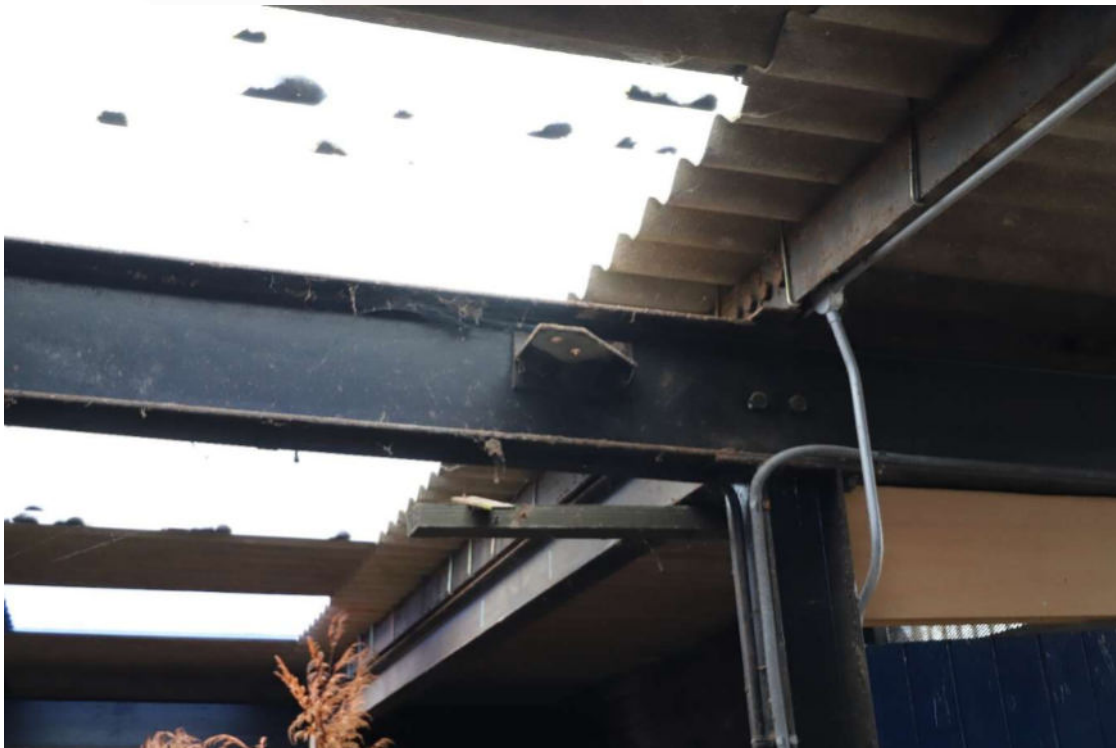
*Photograph 50 – Missing bracing to stores – no change*

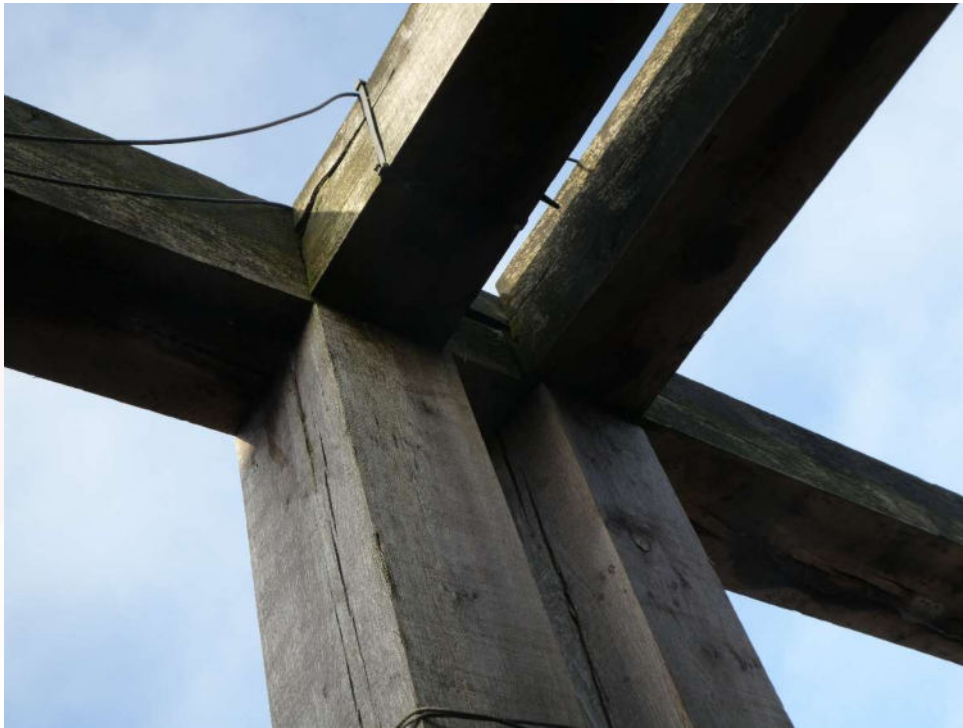
*Photograph 51 – splits and twisting to timbers on front balcony*

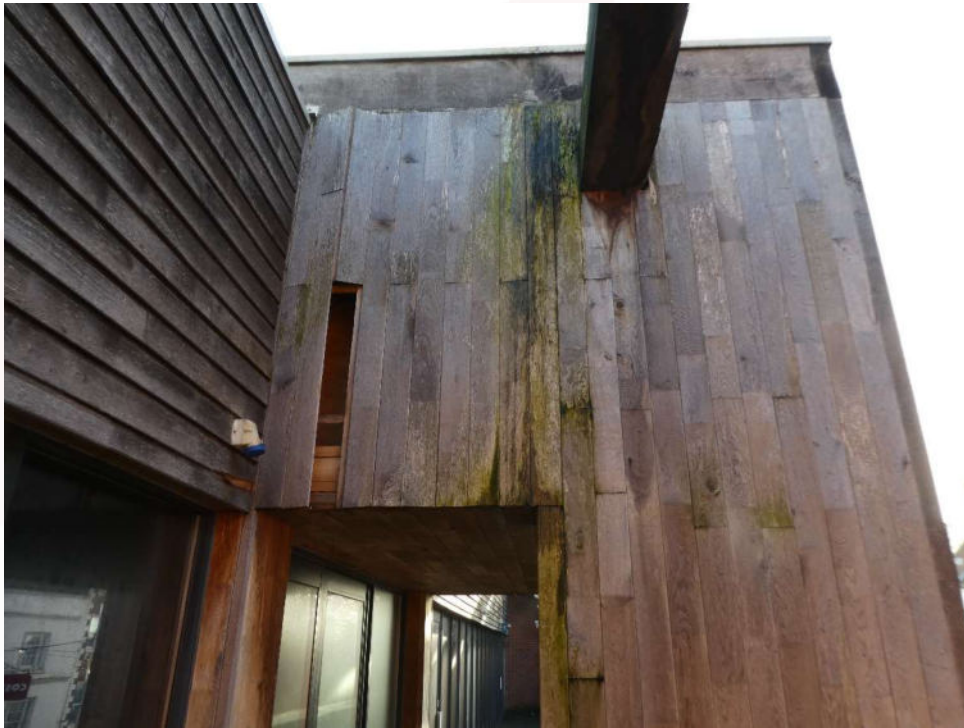
*Photograph 53 – staining to cladding and missing panel*

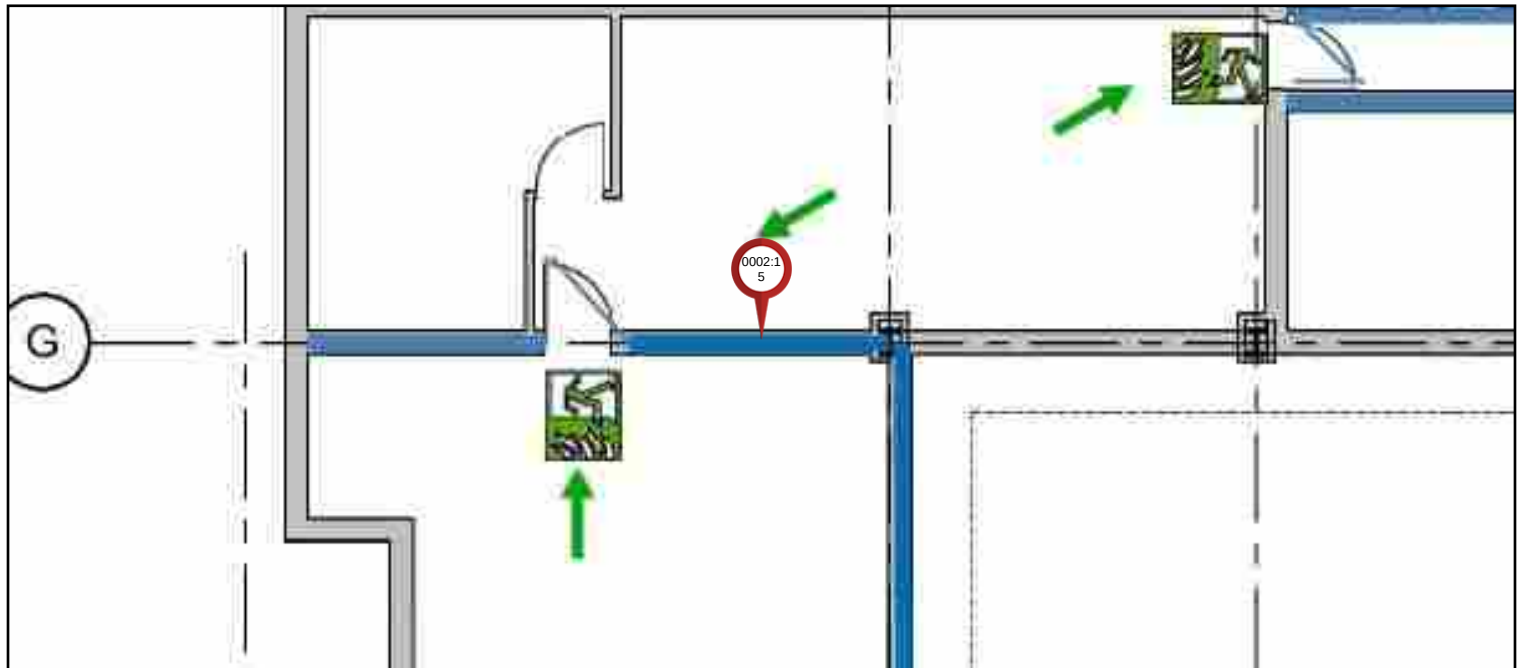
Fire compartmentation is to a reasonable standard - penetrations have been sealed with ablative mastic. Some cracking evident around large clustered cabling with ablative batt - consider replacing with HPE cable seal products.

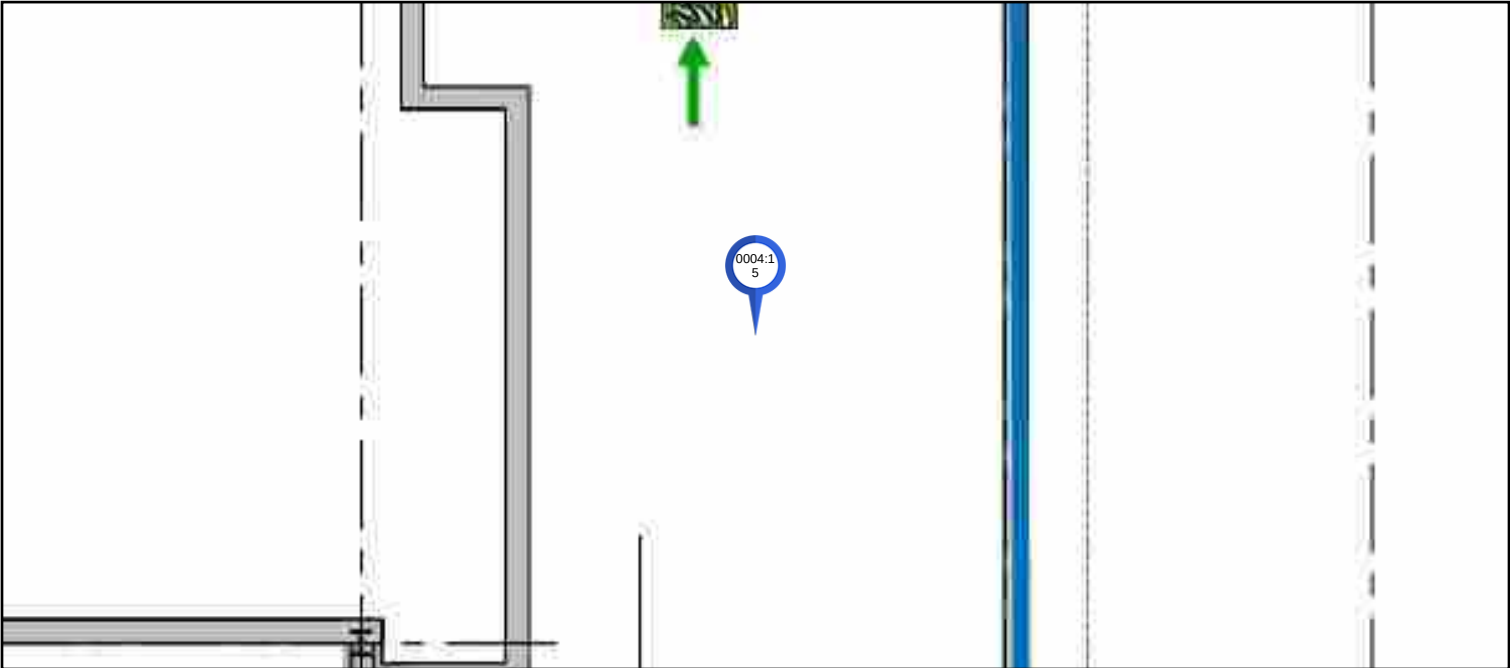
Comments: Damage to RAAC ceiling deck noted - no compartmentation issues related.

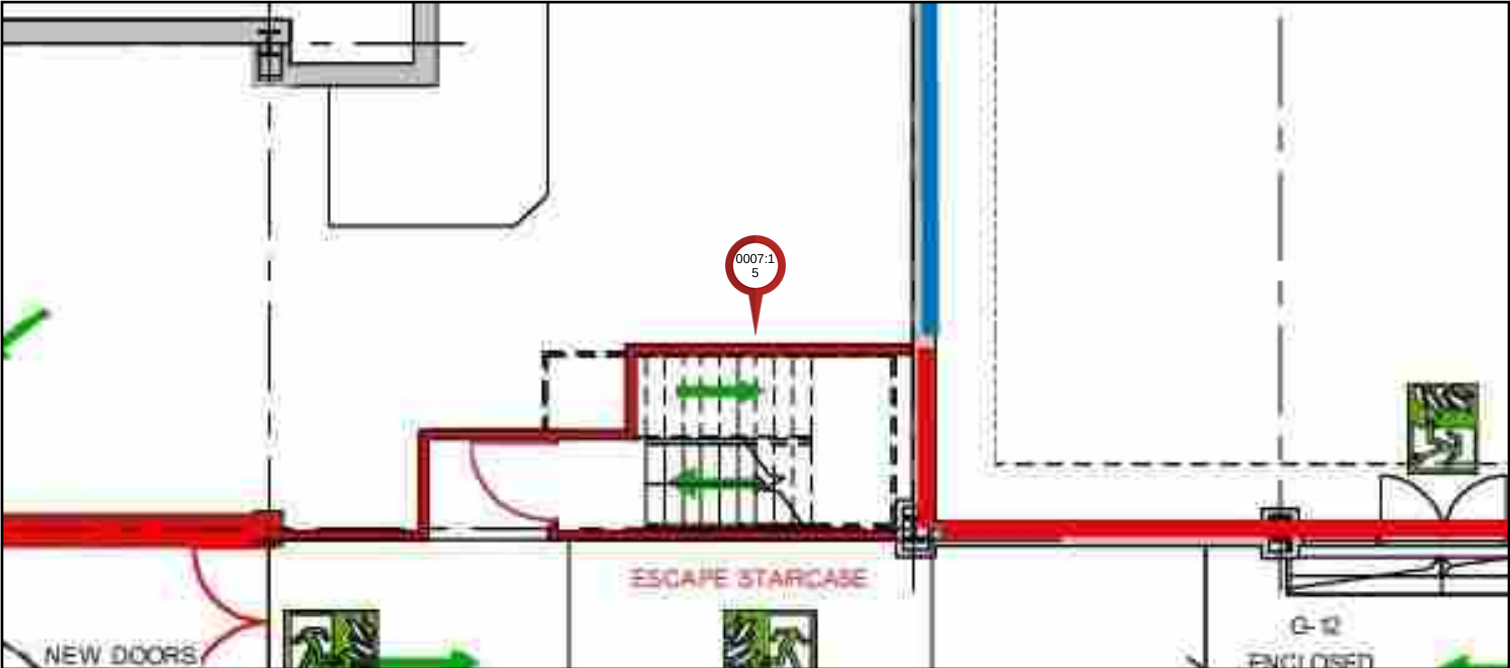
**Comments:**  
Cable penetrations seal is poor - cable conduit exposed. HPE to be replaced and made good.

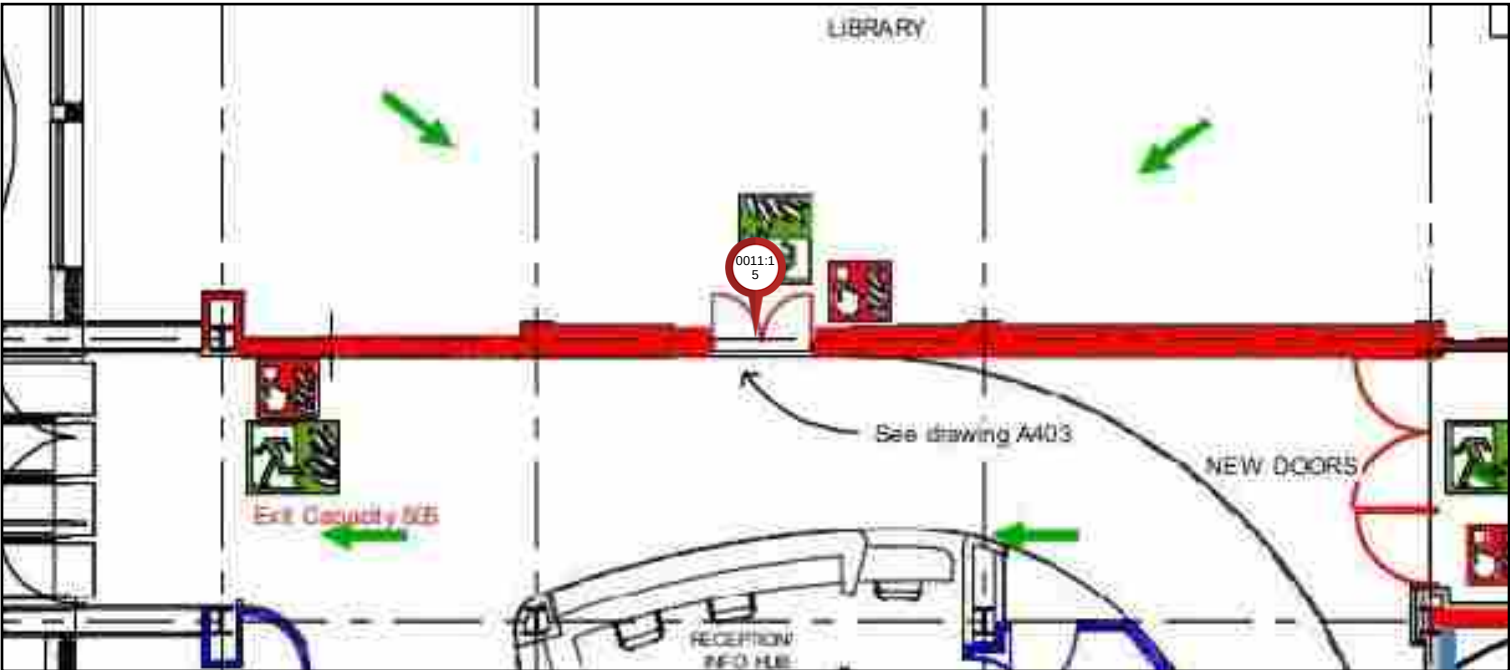
Some minor ease and adjust required of the doors noted where they do not freely close shut.

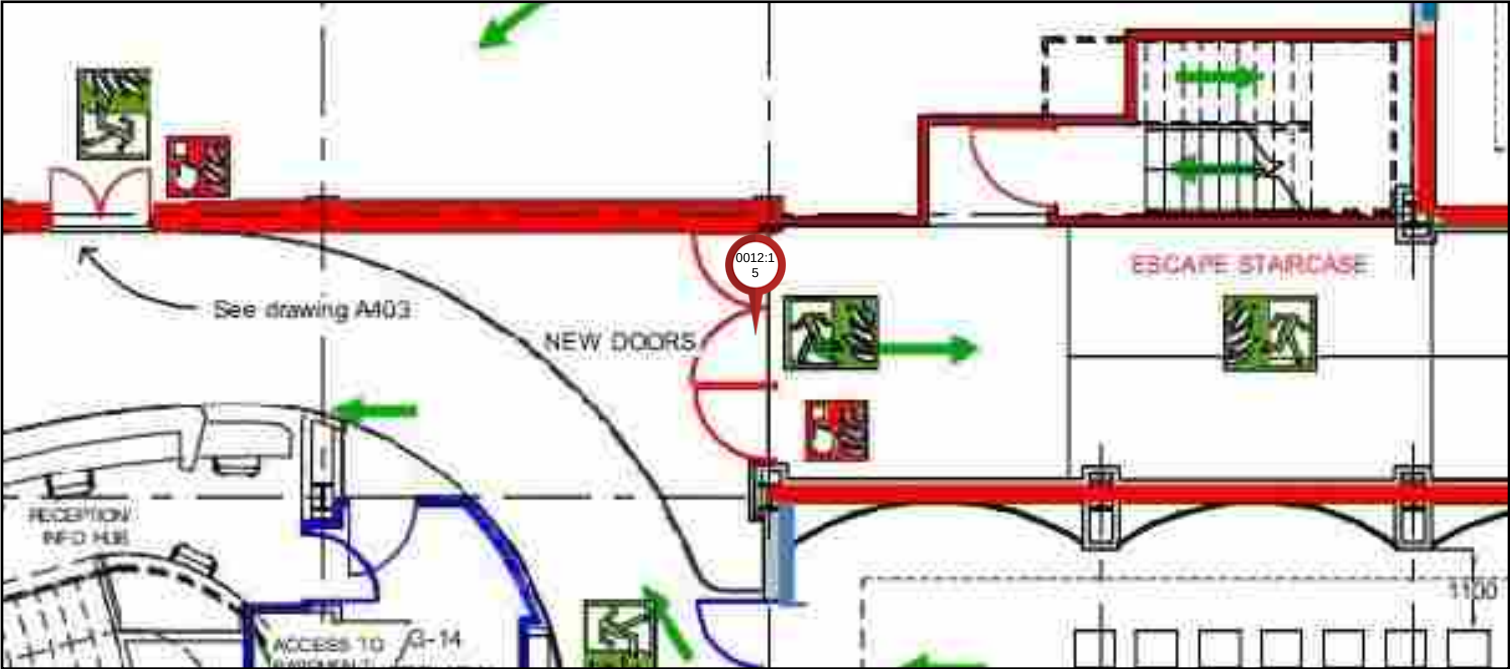
Head of frame damaged.

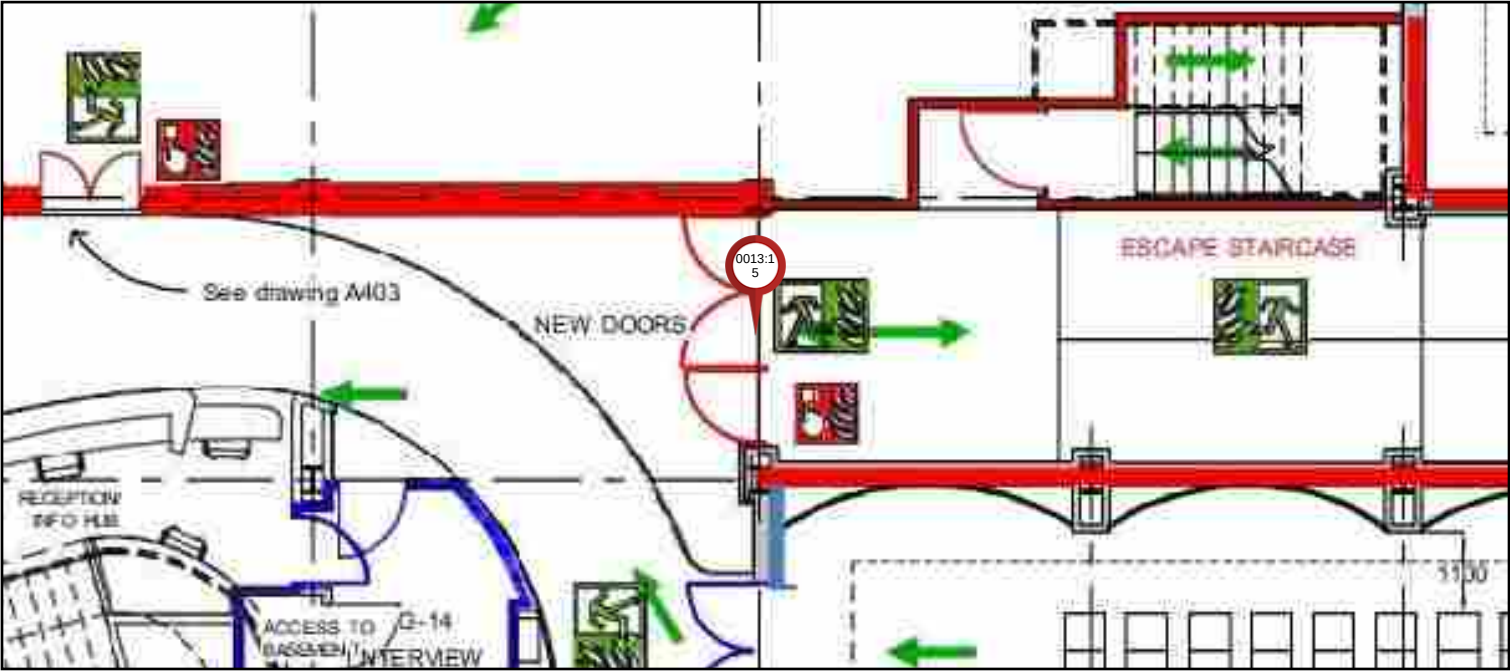
Comments: Board above fire door is in poor condition generally with damage noted around cable penetrations requiring re sealing. Edge of boards have not been scrimmed and jointed above the door.

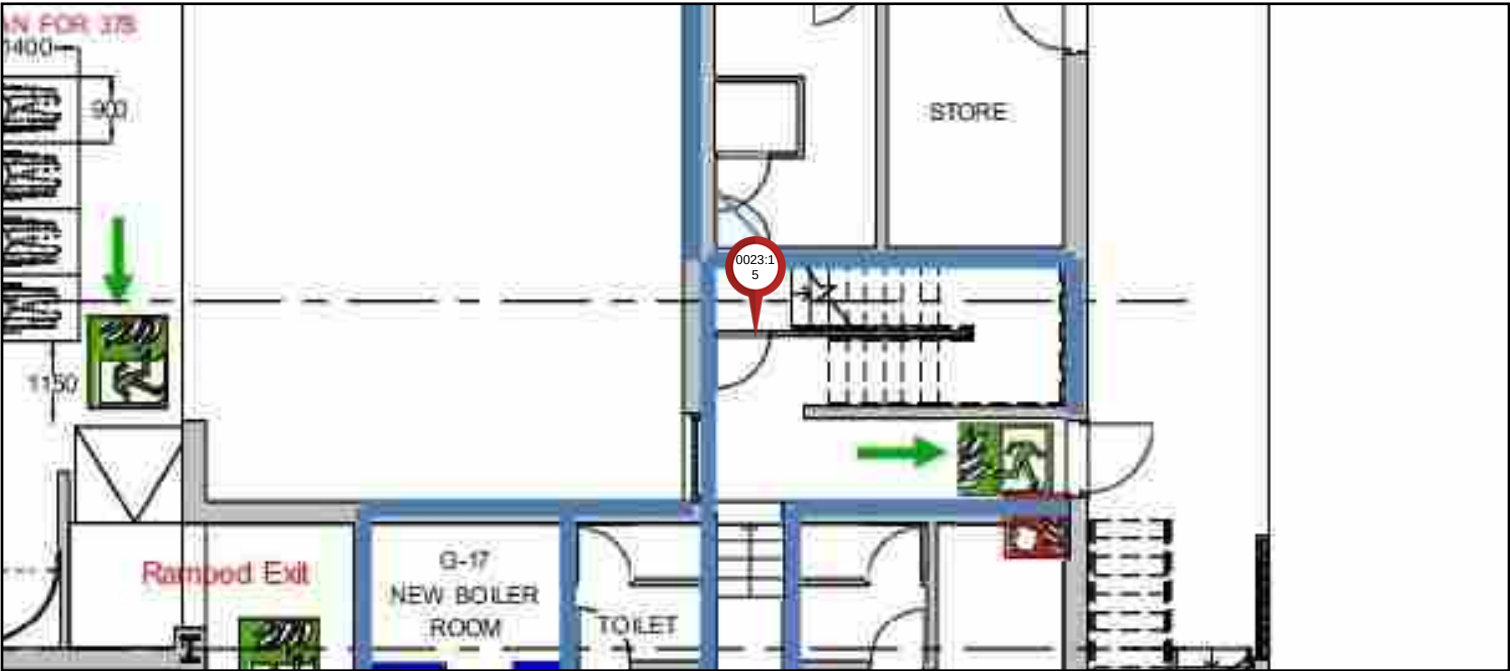
Replace Fire door - not fit for purpose. Inadequate door leaf, ironmongery and missing smoke seals.

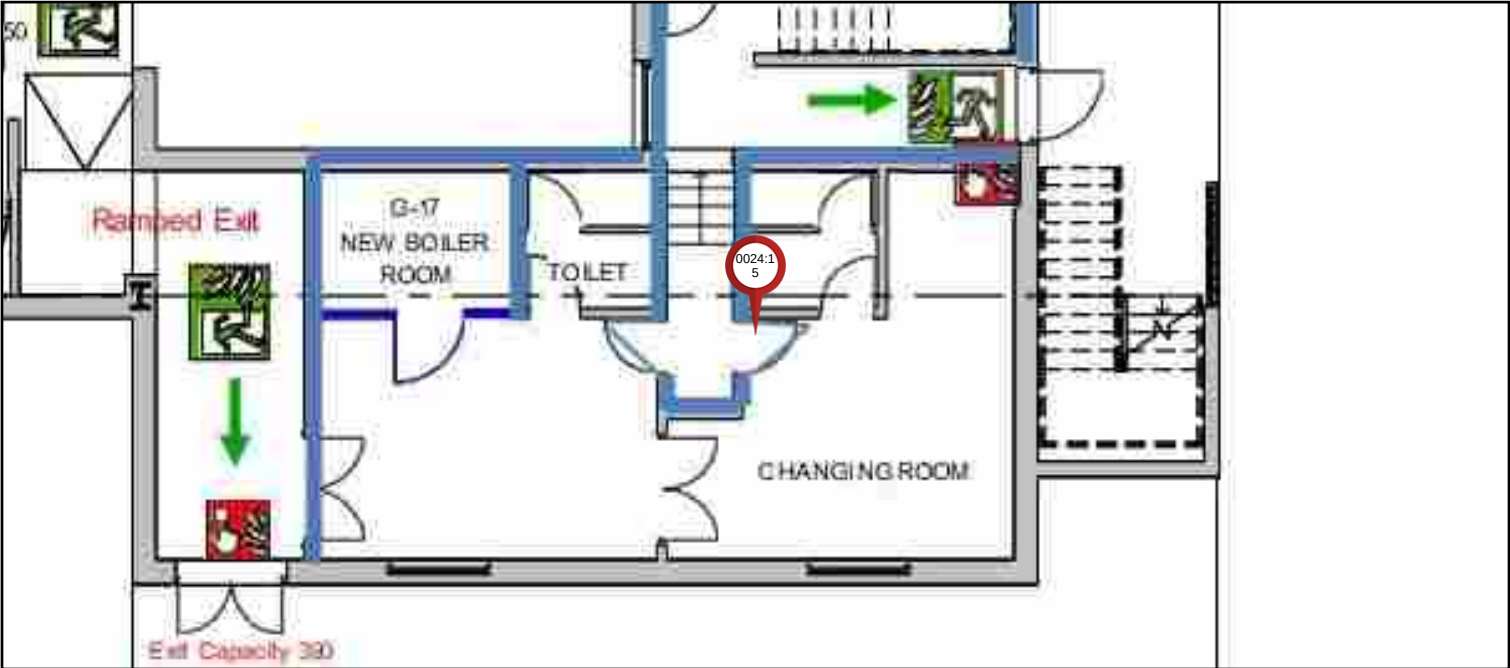
Replace Fire door - not fire rated and not fit for purpose - Door requires replacement.

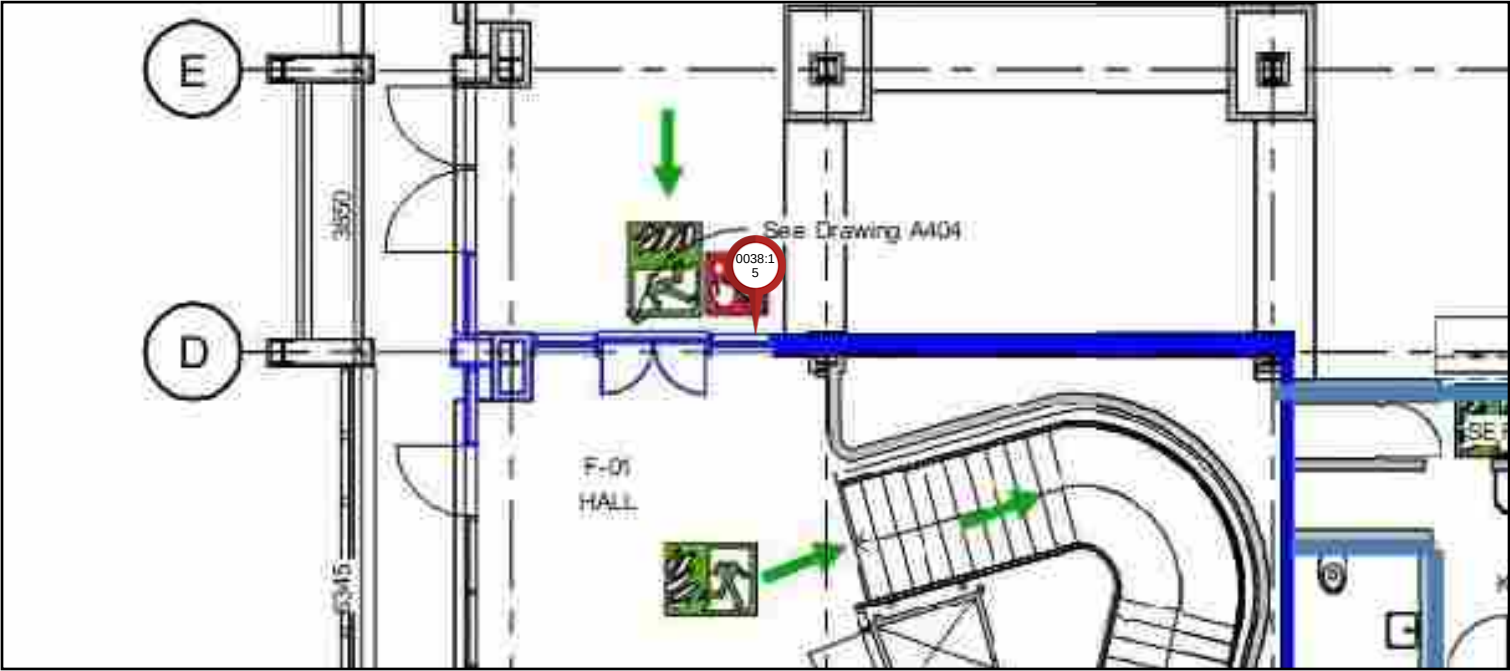
Compartmentation has been supplemented with what appears to be a fire rated curtain. No detail on product or rating. Fire rating to be confirmed. We were also unable to view structure behind the curtain. Some breaches and cable penetrations were noted. Curtain should be inspect annually.

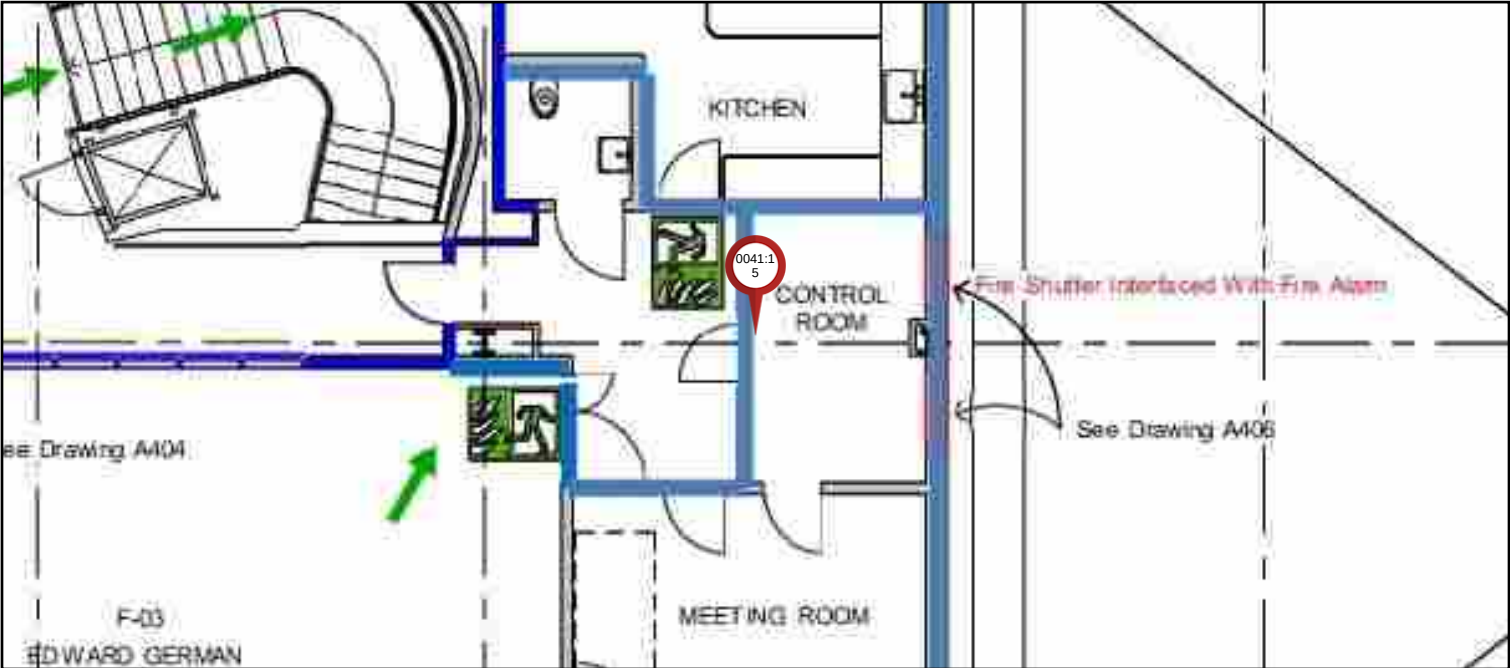
Replace Fire door - servicing the control room is inadequate. There is no clear indication of rating. The leading edges and intumescent strips are damage beyond repair. It is recommended that the door is replaced.
