## **Building Condition Survey Report**

(NSDC018) Whitchurch Civic Centre & (6000) Whitchurch Library  
High Street, Whitchurch, Shropshire, SY13 1AX

**Date of Survey: January/February 2026**

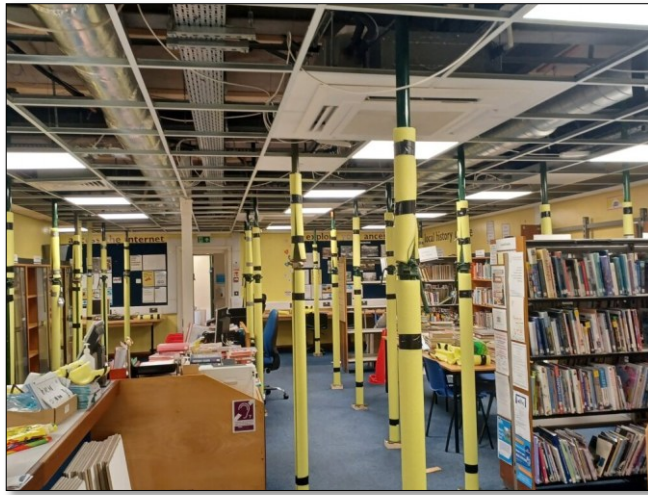
### **Condition Rating D-1**

The RAAC to the Library area is currently propped at 600mm centers by Acro props which require to be regularly inspected. RAAC panels to the remainder of the Civic Centre and Library (with noted deflection to the library area) remain in similar condition to 2024. It is suggested long term the RAAC panels are removed within a redevelopment or refurbishment project asap. Until such time then access should be exclusively restricted to only essential and trained personnel with suitable risk assessment and personal protective equipment.

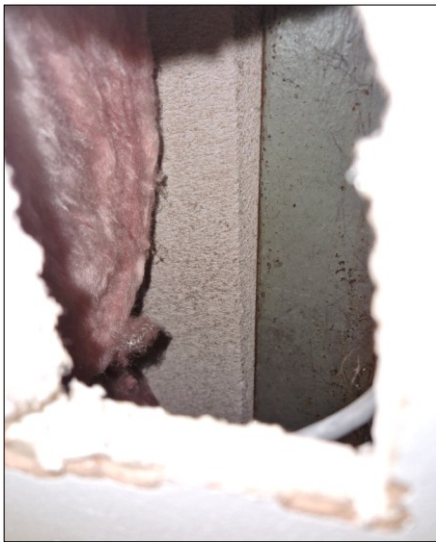
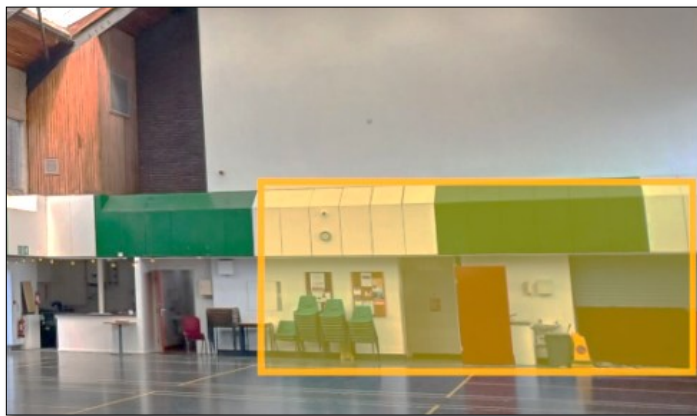
### Condition Rating D-1

Whilst the RAAC within the Market Hall is currently considered “Amber” condition as per IStructEng guidance, visual inspection is hampered by lack of access. It is suggested that the plasterboard ceilings and services are removed to allow proper and future inspection to determine any deterioration. Initial suggestion from structural engineers is also to provide propping to the corners of the effected toilet/store area as a precaution.

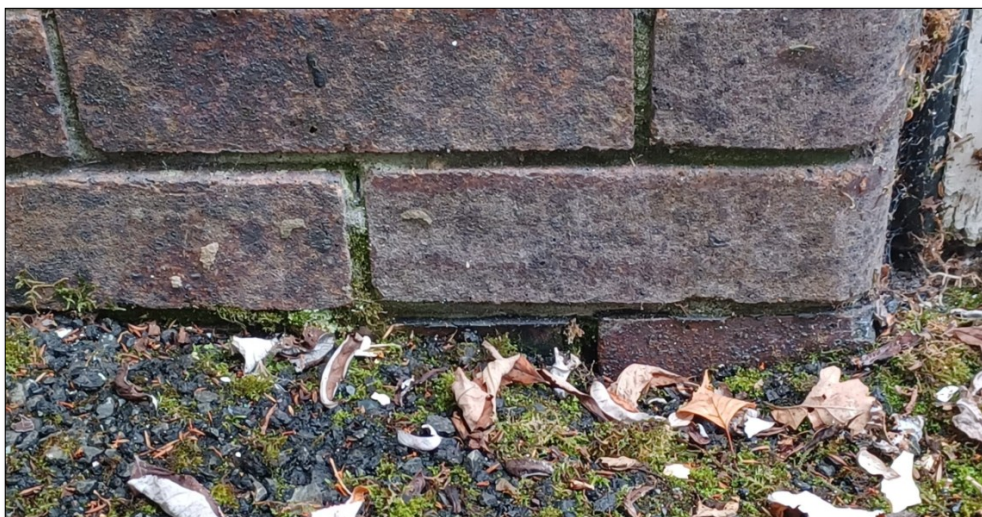
photograph below. However, no damp issues to the internal surfaces of the changing room were noted. Should this become a problem in the future, the ground level adjacent this area needs to be reduced to remove the breach or alternative retrospective damp proofing remedies.

Condition Rating B-3

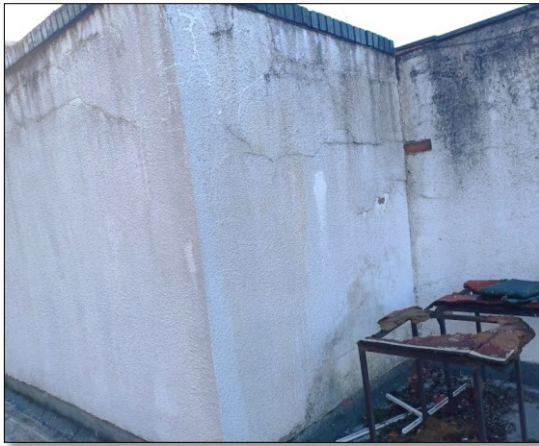
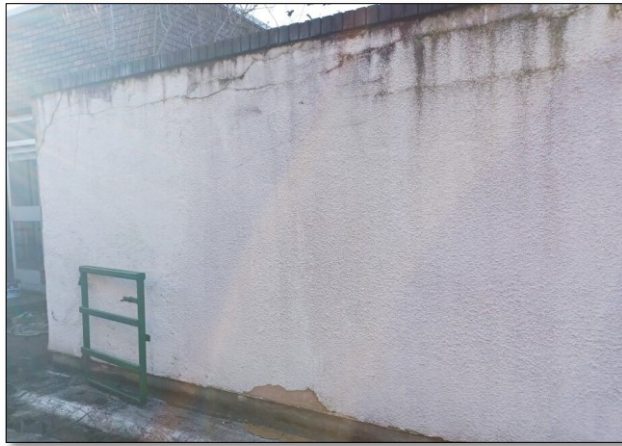
The external rear perimeter party garden walls to the library roof area have a textured render finish which show signs of hairline cracking. Additionally, the brickwork coping requires repointing. Monitor and conduct repairs as needed.

Condition Rating C-3

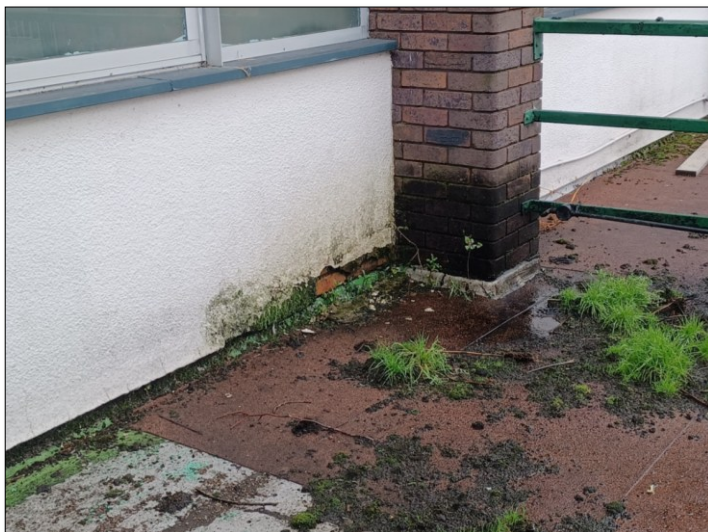
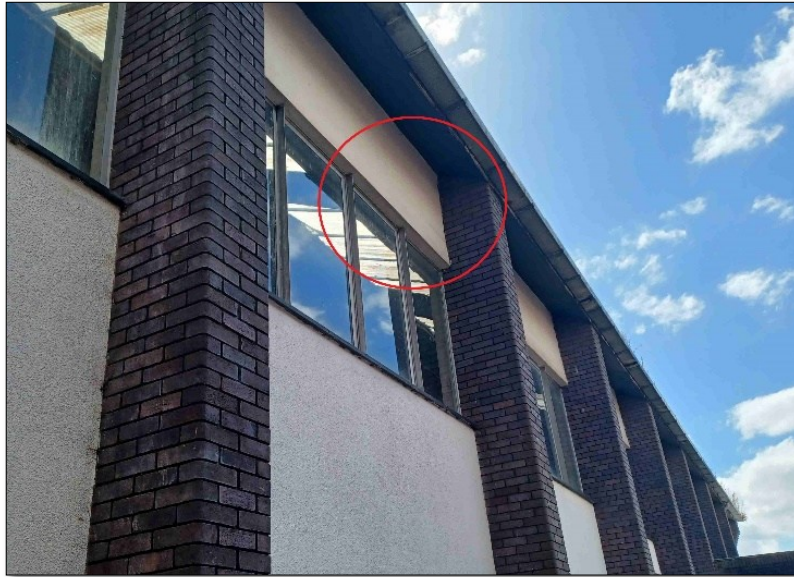
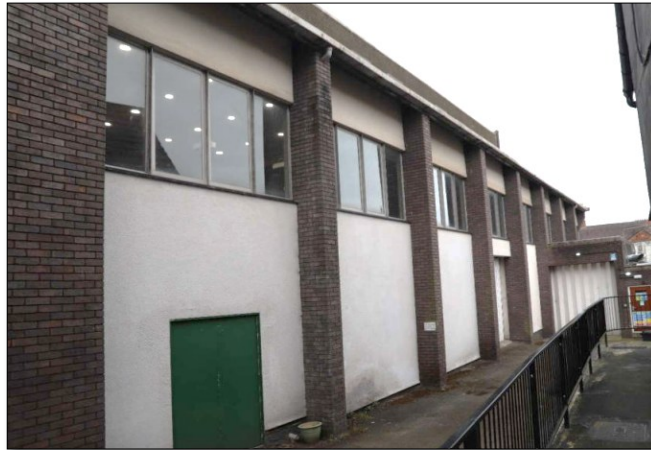
The Market Hall consists of a dark brown external brick laid in stretcher bond, surrounding a portal steel frame with lightweight silica brick to the internal skin. There is evidence of cracking the masonry eaves/corbels externally and internally of the gable walls and due to inherent defects of the construction movement and does not represent major concern at this moment however consider remedial works to the brickwork. Consider remedial work.

It is noted that a quantity of rendered panels to both north and south elevations of the Market Hall have hairline cracking suggesting a debonding to the surface key. Consider renewal of the render to prevent further deterioration and failure. However, it is also noted of deterioration to area of render due to leaking or overflowing gutters and rotten fascia's which also need to be cleared and renewed (see section 2.6 for details).

### Condition Rating C-2

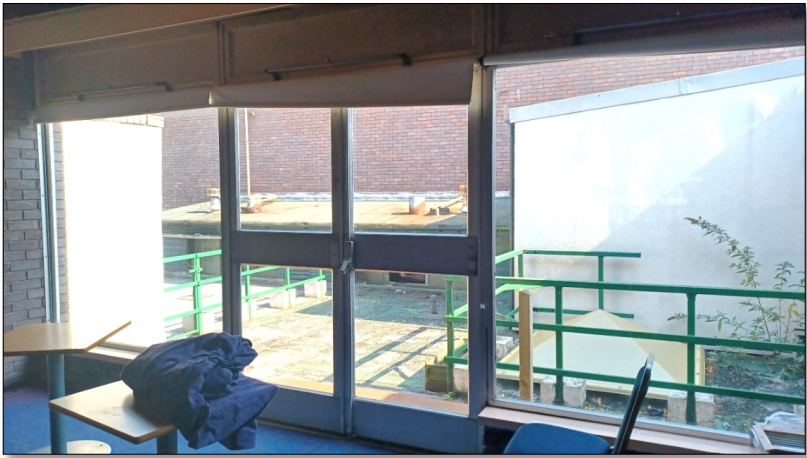
The external east elevation to the Merrie Berrie Bar/Lounge has aluminum anodised single glazed large pane windows and single door. These would benefit from replacement and upgrade.

Condition Rating C-3

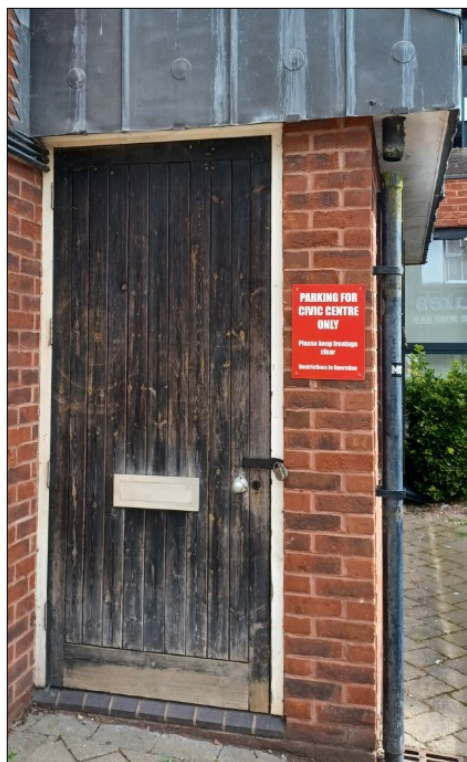
The external single timber door and frame appear in satisfactory condition, however, requires complete redecoration to prevent deterioration of the timber.

Condition Rating D-2

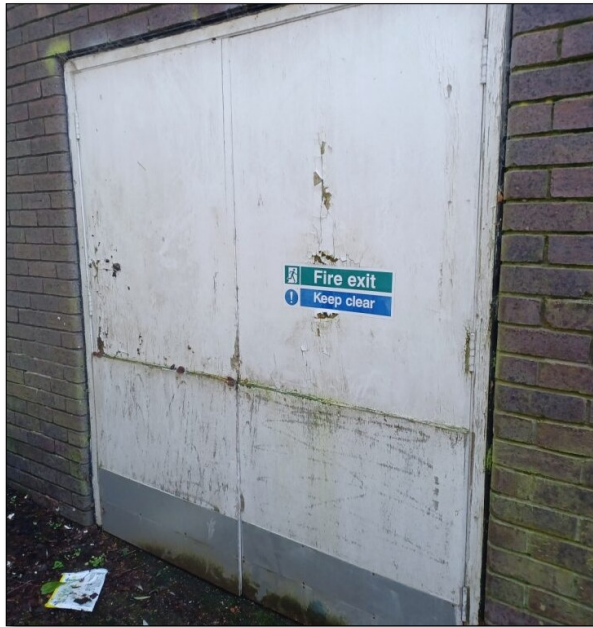
The external double timber fire exit doors leading to the external pedestrian egress are in poor condition and require replacement. It would be suggested to consider Aluminum powder coated doors for low maintenance and ease of exit door furniture.

Condition Rating C-2

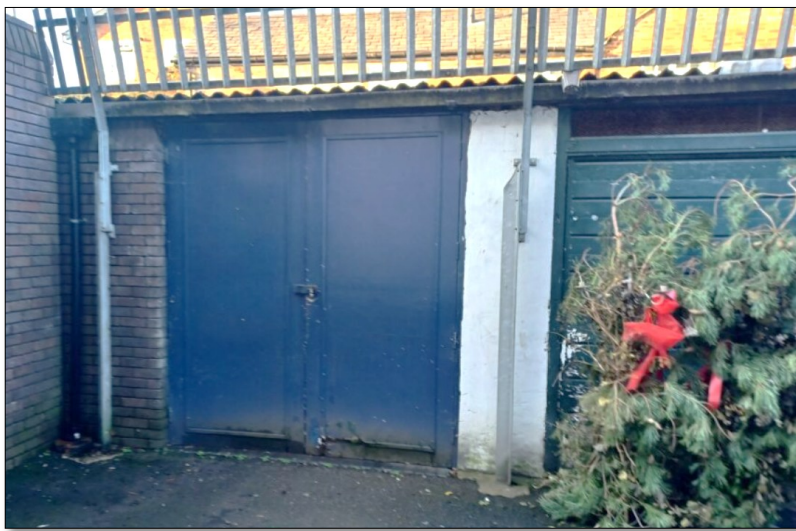
The modern up and over garage doors appear to be in working order. However, the timber external door would benefit from minor remedial works or consideration of replacement in the future.

#### Condition Rating C-3

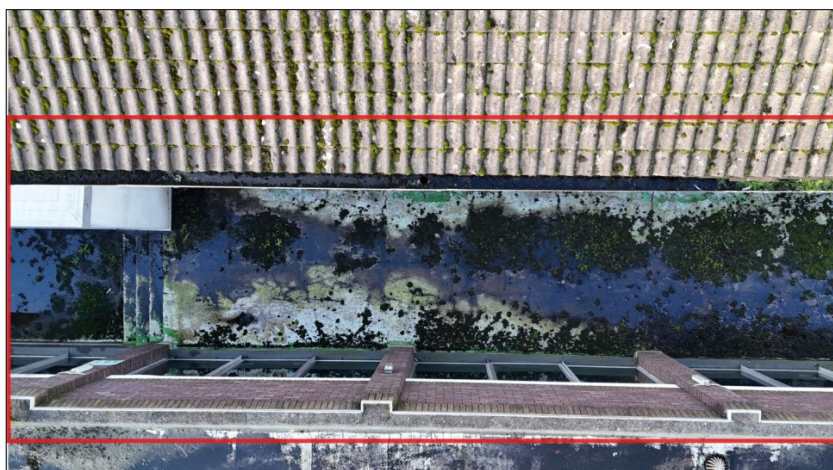
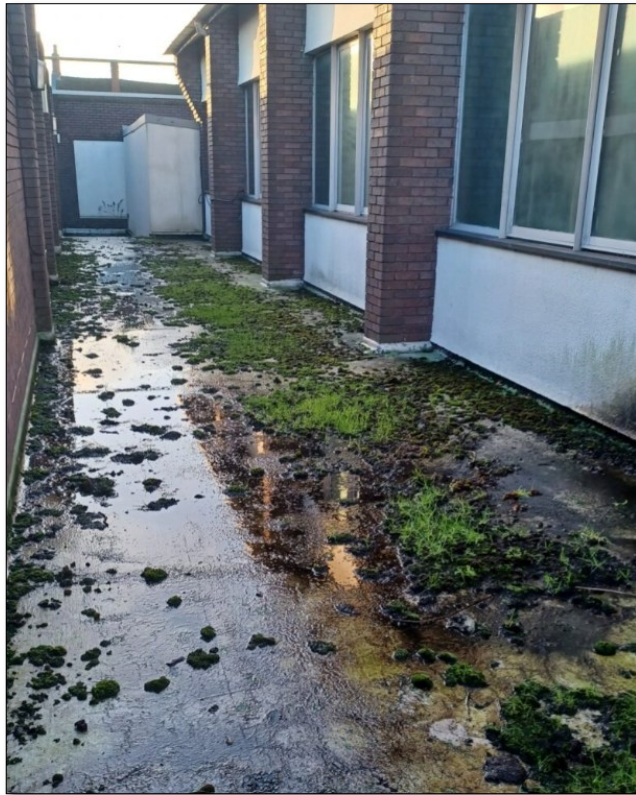
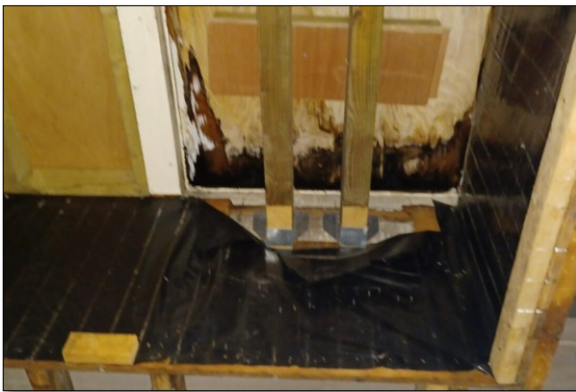
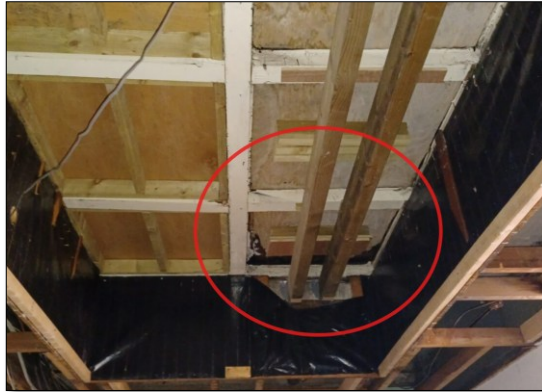
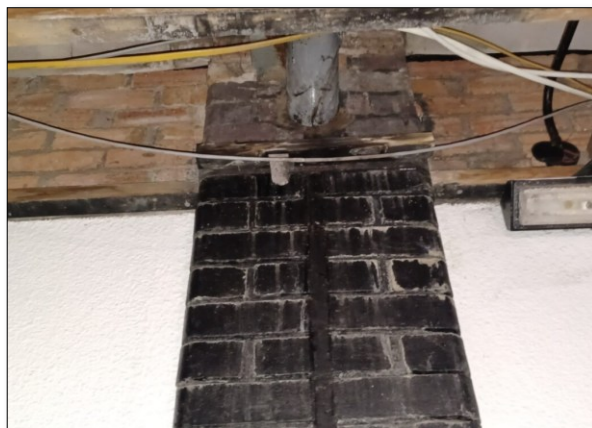
Provision and consideration of roof cleaning and cyclical rainwater management is required as per item 2.6, though this may be challenging due to the RAAC presence and general poor condition.

### **Condition Rating D-1**

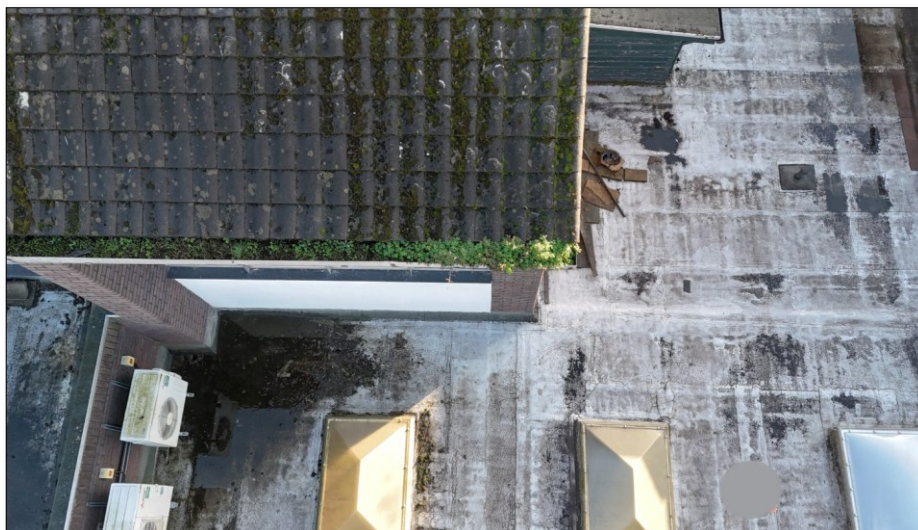
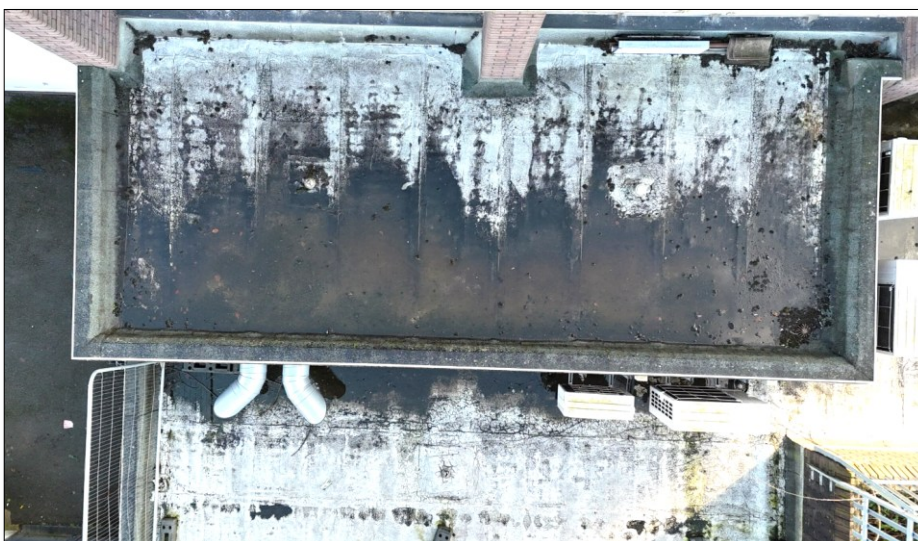
## **Library (roof 6) and Market Hall (roof 10 - Gas Blow Air Heater structure)**

The enclosed flat roof covering appears to asphalt with a retrospectively applied reflective paint. The roof is in poor condition with crazing to surfaces and evidence of thermal expansion stress to the roof covering. Remedial repairs appear to have been applied in various areas using mineral felt. There is evidence of standing water to the roof generally, with drainage points of internal rainwater pipes to the areas below. There is minor evidence of moisture penetration to areas within the library, however no major leaks were observed. The roof contains a number of roof lights which would benefit from replacement during a roof replacement project. The RAAC structural deck is heavily propped due to results of previous reflection surveys and requires removal and replacement. The roof is beyond its economic life and should be replaced urgently and or as part of any RAAC replacement project.

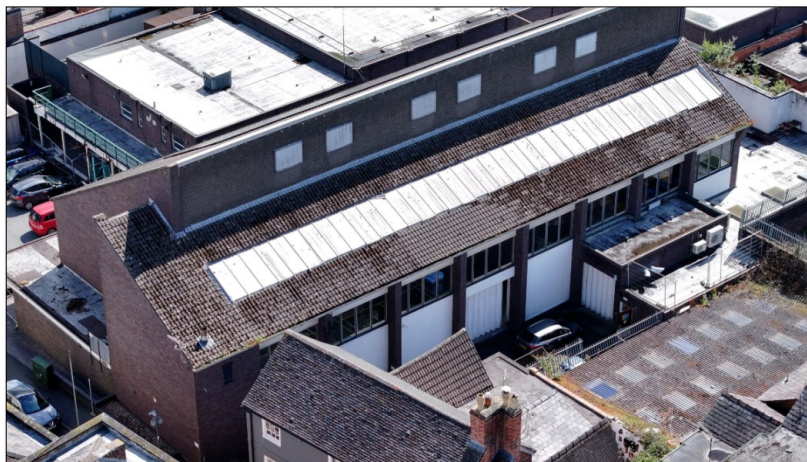
### Market Hall (roof 5)

The market Hall roof is a pitched ridged construction finished with a concrete tiled roof. The roof tiles appear to be in reasonable visual condition. The verge pointing is showing signs of deterioration and requires re-pointing to help preserve the roof from water egress. Remedial works to the large area of skylights may be required with beading/flashing displaced and requiring remediation. Site staff comment on occasion roof leaks in the form of drips in heavy rain. The roof is also fitted with Photovoltaic Panels as noted in section 4.

### Condition Rating C-3

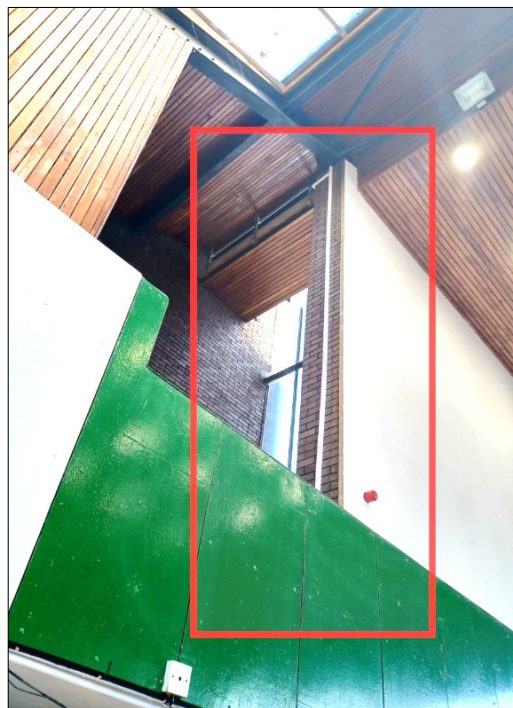
Market Hall – There is currently an internal vertical ladder access to roof void, which must be accessed via separate means onto the ceiling of the toilets/storeroom. This arrangement requires consideration by the operator of proper access and fall arrest measures plus a management strategy to safely manage access, plus ongoing annual inspection of ladder/fall arrest systems.

### Condition Rating D-2

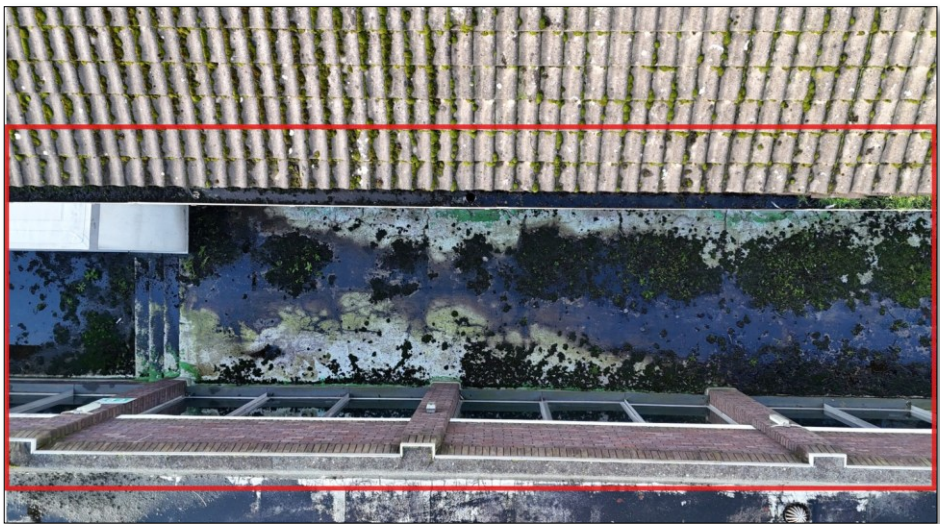
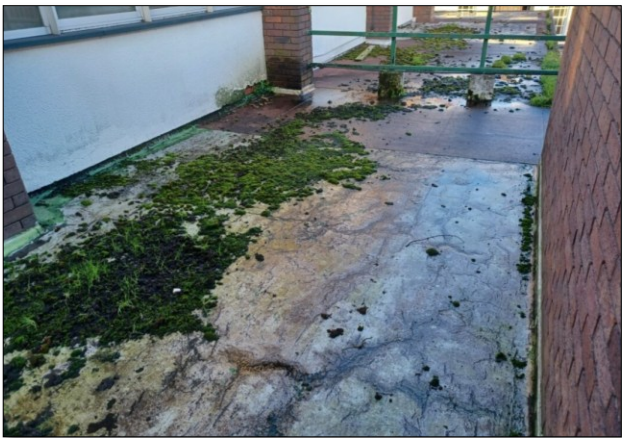
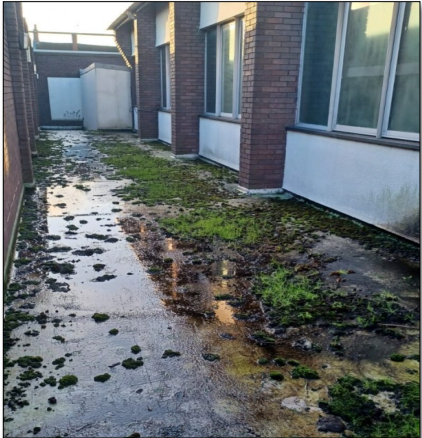
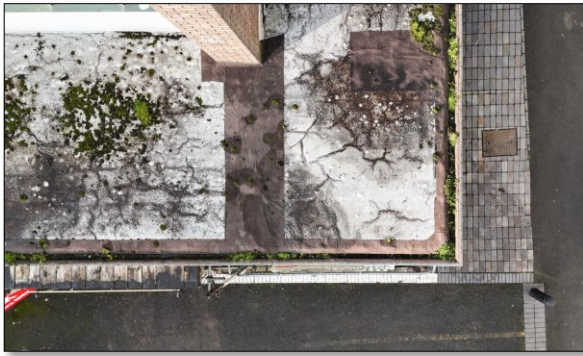
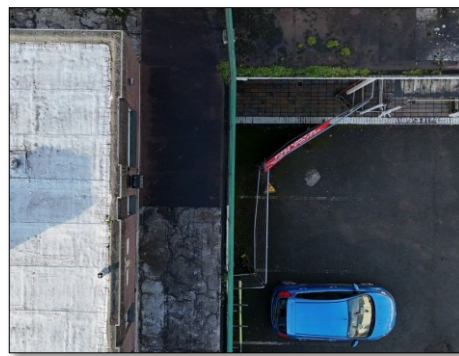
There are large quantities of detritus to the roof such as moss/vegetation and algae growth suggesting standing water helping propagate vegetation. Rainwater is also contributed from the Market Hall leaking/overspilling gutters onto the roof. Consideration of roof cleaning and rainwater management is required as per item 2.6, though this may be challenging due to the RAAC presence and general poor condition with any clearance including a risk assessment.

**Condition Rating D-1**

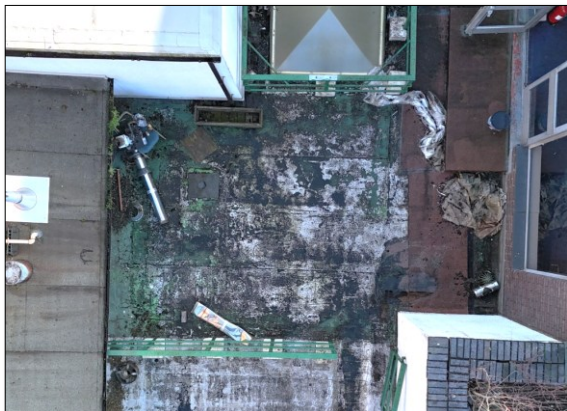
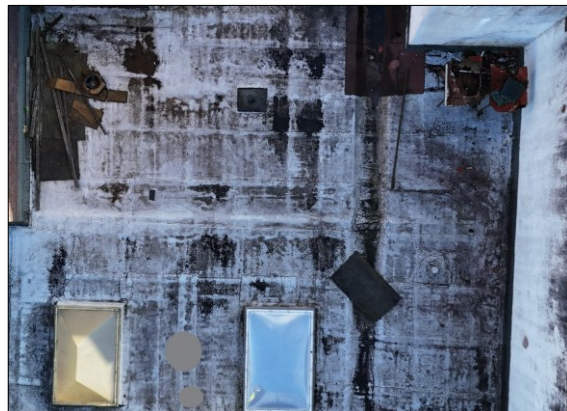
The existing flat roof has internal rainwater outlets within formed gutters on the roof and generally which disperse surface water internally through rainwater down pipes. Visual assessment has been from an aerial perspective. All roofs have general detritus and large items of debris such as replacement flu and materials from recent works to the Market Hall gas heaters that require to be removed asap to ensure they do not impact drainage of the roof and require clearing to help ensure rainwater goods operate as intended.

## Condition Rating – D-1

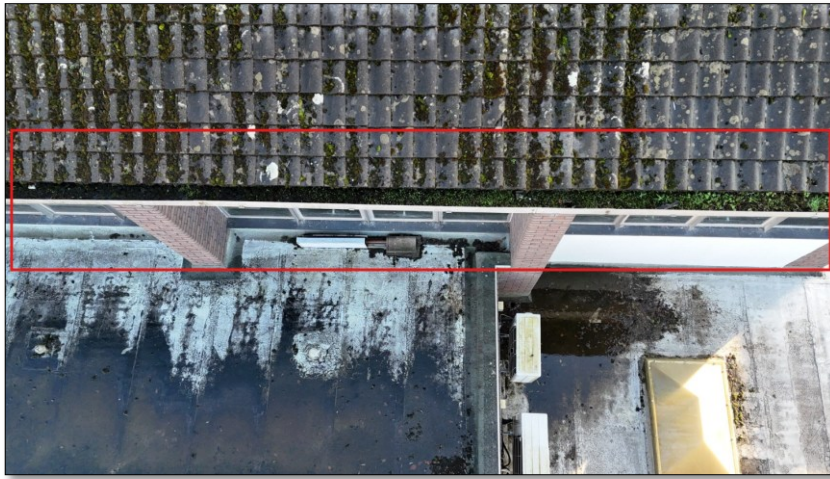
The box gutter to the south and north elevations of the Market Hall requires maintenance to clear it from debris urgently to prevent overflowing onto surfaces below and allow effective rainwater management. The gutter appears to be leaking at various joints and requires lining or ideally full replacement. A further high visual inspection would be needed to determine the level of remedial work.

## Condition Rating D-1

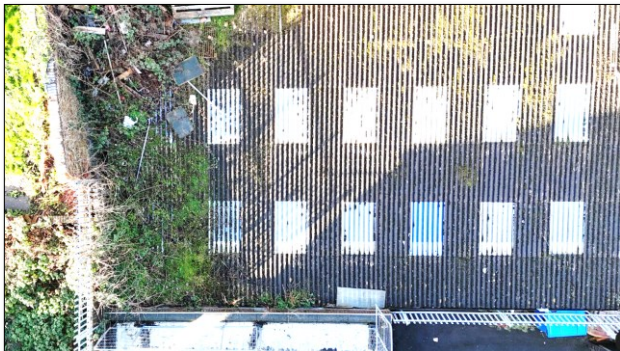
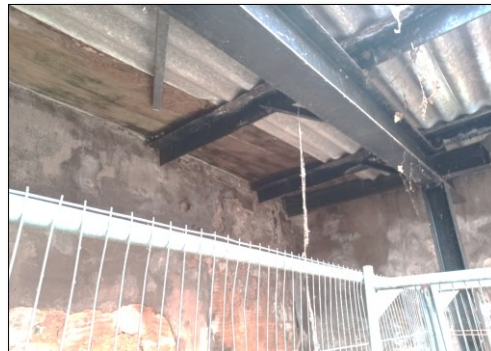
The existing external gutter, which abuts the rear area of the library welfare area, is blocked with vegetation debris and requires removal asap to ensure effective rainwater management and prevent overflowing saturating the library brickwork creating internal and saturated damp issues. It also would benefit from replacement as part of a roofing replacement. There is evidence of detritus and fly tipping to the roof of the external garage and may contribute weight to the roof or deflection damage etc. This should be considered for removal asap.

### Condition Rating D-2

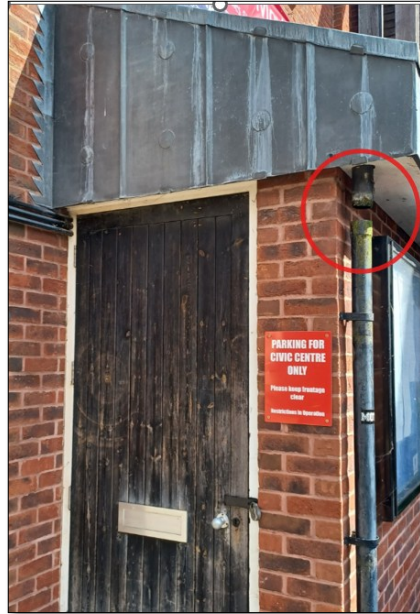
The front rainwater downpipe appears disconnected with collar missing and leaking rainwater onto brickwork. A repair should be carried out asap.

## Condition Rating D-1

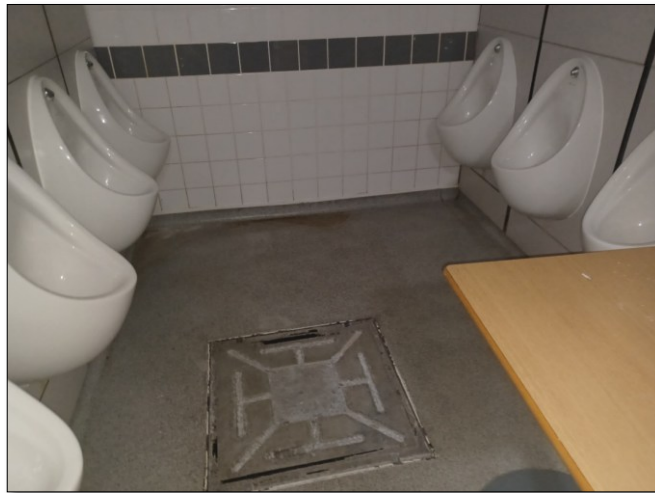
The ground floor male/female and accessible toilets have safety vinyl flooring which requires various repairs to joints and or manhole details. The floors also require cleaning.

Condition Rating C-3

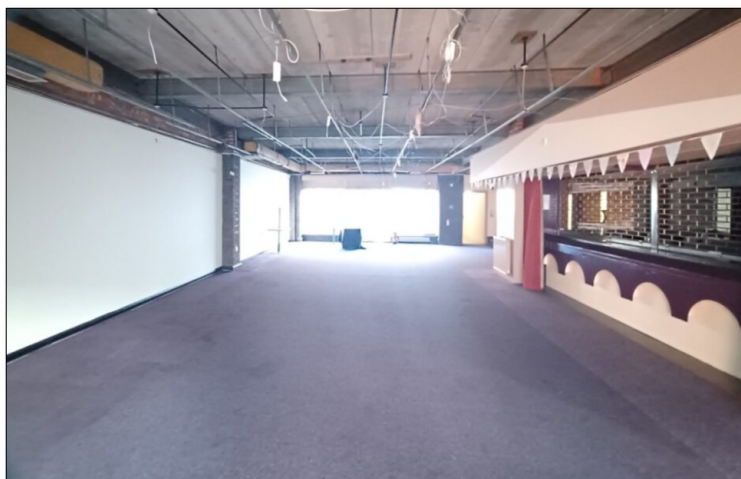
The first floor Merrie England lounge bar area has a carpet tile finish. Whilst the carpet is in reasonable condition it would benefit from cleaning or replacement as part of a refurbishment.

Condition Rating C-3

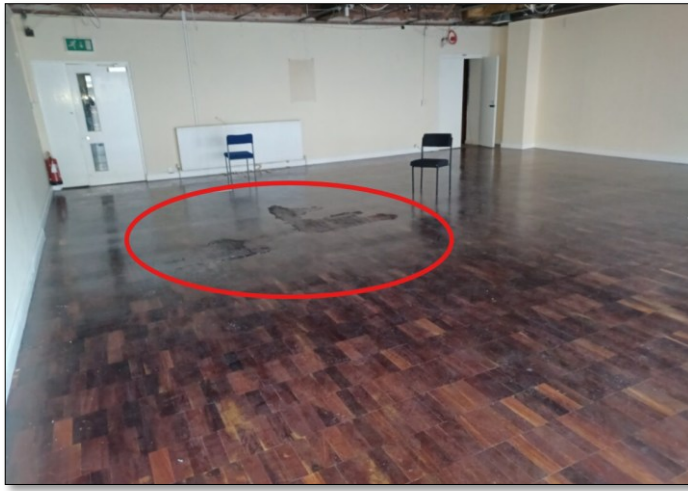
The first floor Edward German room has a decorative woodblock floor which is in reasonable condition. However, there is evidence of minor water staining from a ceiling mounted extract fan or spillage. The floor would benefit from cleaning and or a sand and seal treatment.

Condition Rating C-3

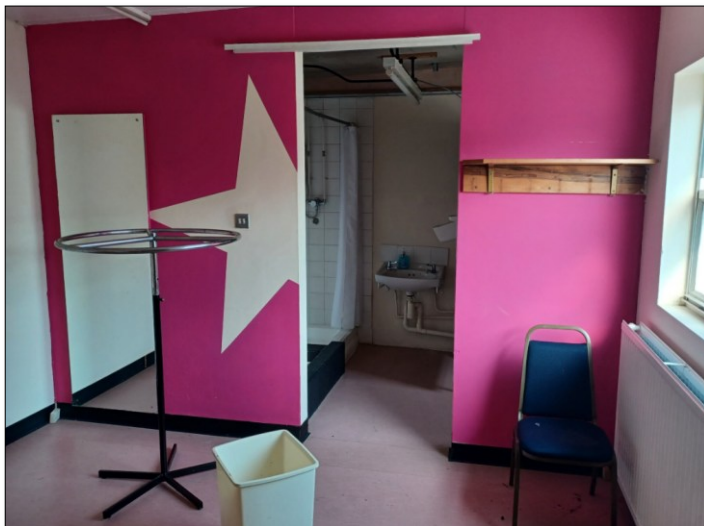
The changing rooms to the ground and first floor areas have a linoleum or safety vinyl floor finish which appears satisfactory though should be considered for replacement as part of any proposed refurbishment.

Condition Rating B-3

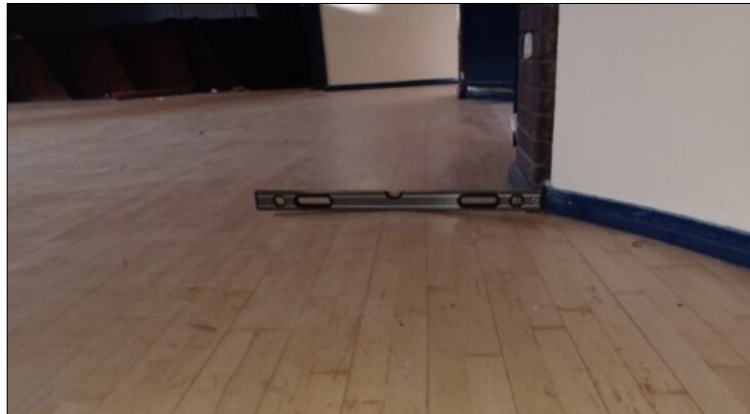
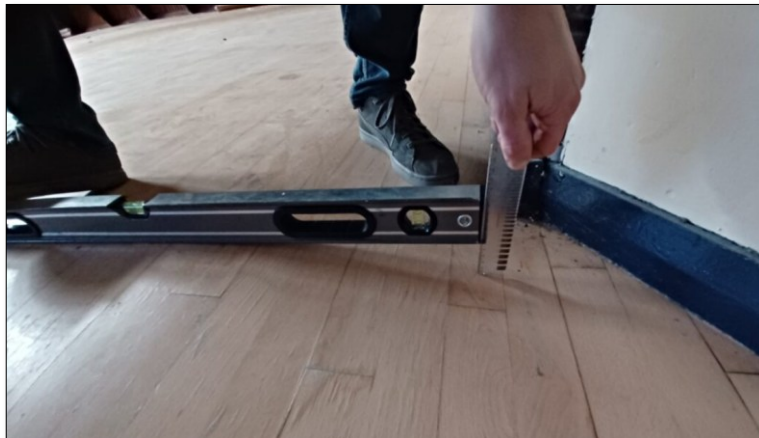
The Theatre's main auditorium floor appears to be a timber strip suspended and sprung floor. Whilst the floor would benefit from a sand and seal, the floor has significant defects resulting from heave effect to the section to the right area in front of the stage and orchestra pit. This is showing signs of excessive vertical movement of >50mm which has resulted in the floor "breaking its back" due to expansion – potentially due the impact of under floor moisture condensation levels following cold weather and a building without heating or moisture penetration from a unknown source. This requires some significant repair or consideration of whole replacement if reoccupied.

#### Condition Rating D-1

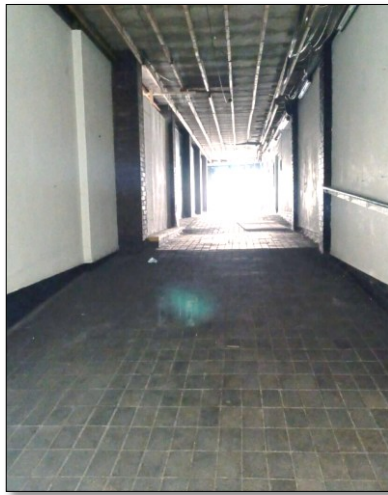
The covered walkway has a floor finish of quarry tiles which appear in a satisfactory condition.

Condition Rating B-3

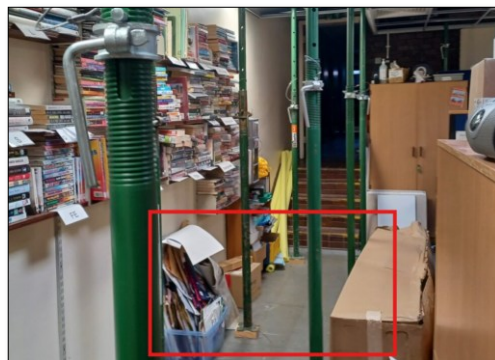
The rear staff area has a thermoplastic tile covering which appear to be Anthophyllite as noted on the Asbestos Management Survey, however noted in a satisfactory condition but would benefit from removal as part of a refurbishment project.

### Condition Rating B-3

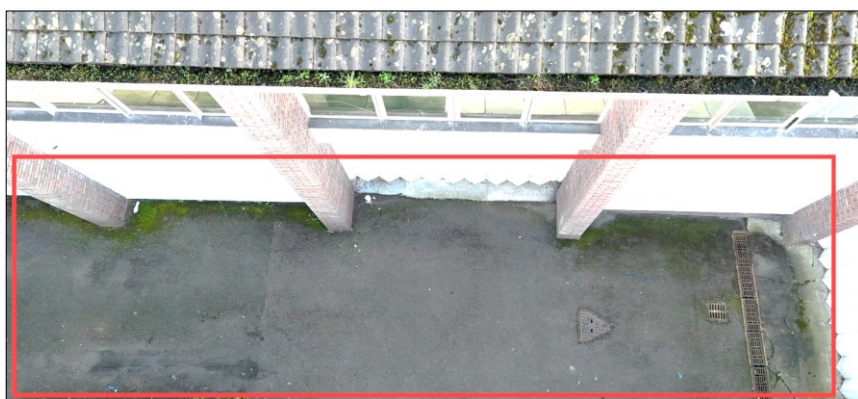
External vehicle access from St Mary's Street to the rear of the Library and External Garage store is of tarmacadam construction and in reasonable condition. However, the surface water drainage would benefit from clearing to prevent ponding and ensure surface water is drained. Clearance of surface vegetation adjacent to the market Hall is also required.

Condition Rating – C-2

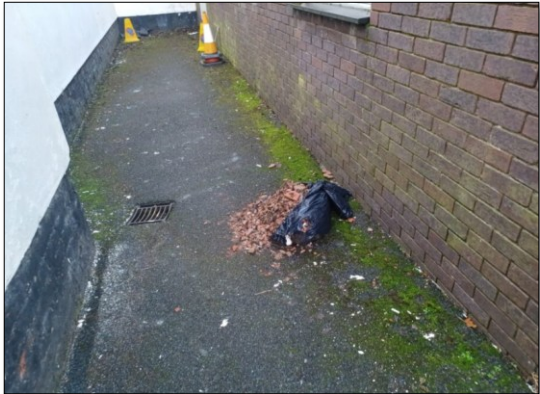
The external tarmacadam rear fire exit route from the ground floor changing rooms to the rear car park is in general satisfactory condition (note item 2.3) however would benefit from surface water gulley cleaning and vegetation removal.

**Condition Rating – C-2**

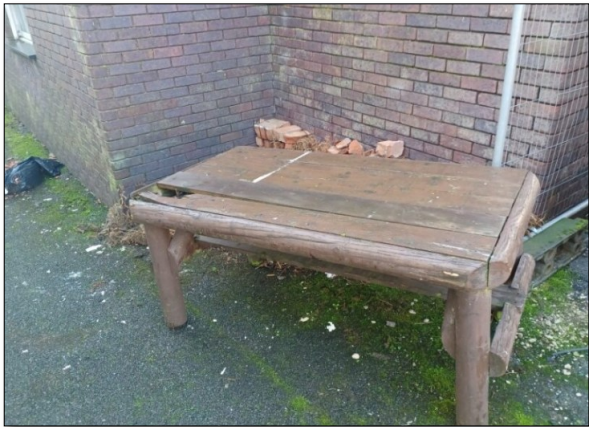
The existing rear area appears to be storing unknown items of a quantity of loose bricks and timber table. These should be removed from site asap to prevent unauthorised access or potential vandalism. Whitchurch Town Council have been informed and suggested to remove following the survey.

**Condition Rating – D-1**

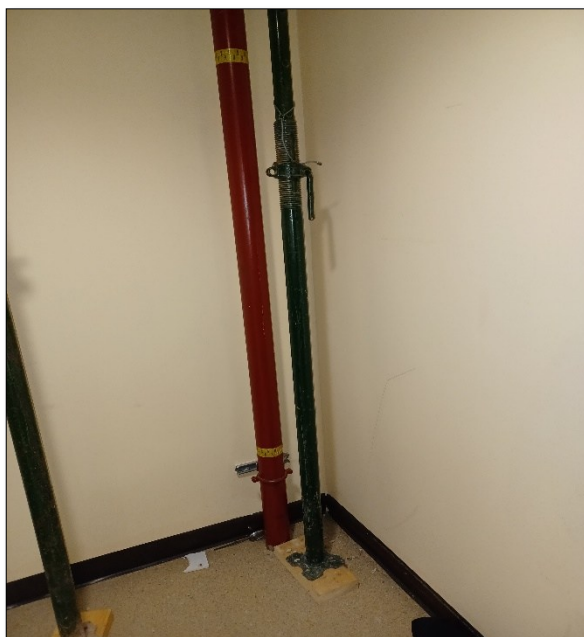
The gas meter is located at the front of the property. Incoming gas main enters the building in the front office and then travels up through into the ceiling voids (additional ventilation would be required) via the bar area and onto the roof, this then follows the length of the roof supported on brackets with a branch connection to the gas blower heaters that serve the Market and then to the rear of the property and down the boilers on the ground floor.

The gas pipe's condition is satisfactory but in need of anti-corrosion protection.

Condition Rating C-2

- Gas Safety test inspection carried out as part of the survey as information was not available. Whilst the gas tightness test passed, remedial actions were recommended as current standards to ventilate ceiling voids, additional sleeves to ceiling void pipework and purge/test points added. See gas certificate in **Appendix C** with remedial recommendations. Following this as of March 2026 the gas has been capped off at the boilers only (rear hall / stage areas) to allow the Market Hall gas heaters to remain operational.

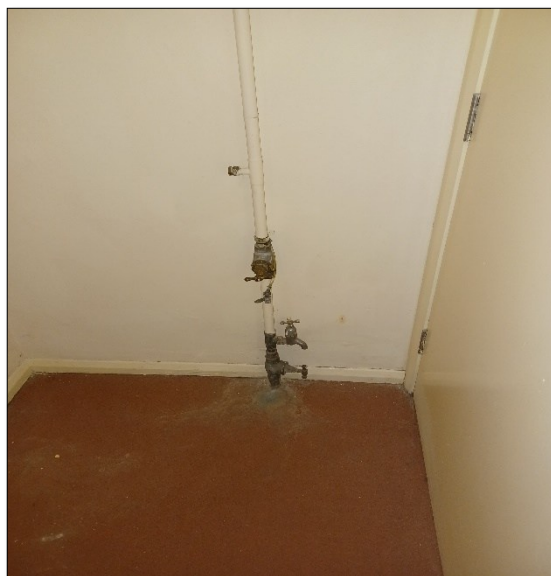
Mains incoming water main (MCW) supply enters at the rear of the property. Underground condition unknown.

Condition Rating – Unknown

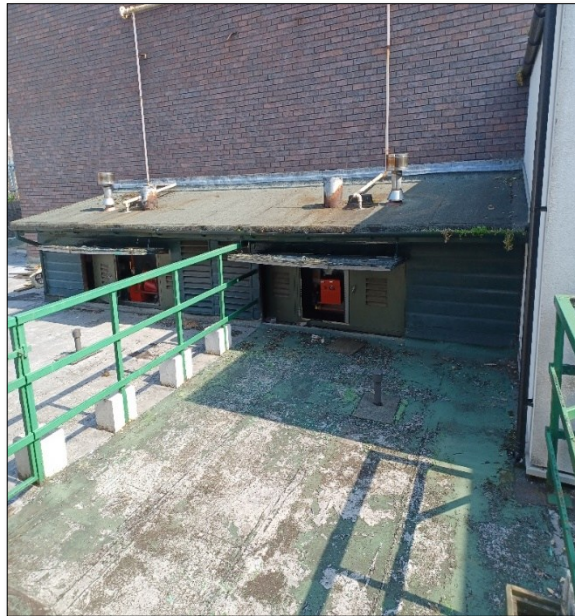
The market Hall is heated via 3no. gas fired warm air heaters. A redundant and capped of unit is located within the vertical riser to the north of the hall. The two active heaters currently providing heat are situated within a timber construction with felt roof located on the Library RAAC flat roof. Consideration of this is needed should the RAAC roof be replaced. Both heaters were found to have leaking flues and product of combustion leaks and isolated before leaving site. This has since been rectified via Whitchurch Civic Centre instruction and contractors. See **Appendix C** for the service report and remedial installation. following initial remedial works and recommissioning to remain operational in the short term. The gas fire blow heaters are near end of life and would benefit with replacement,

### **Condition Rating D-2**

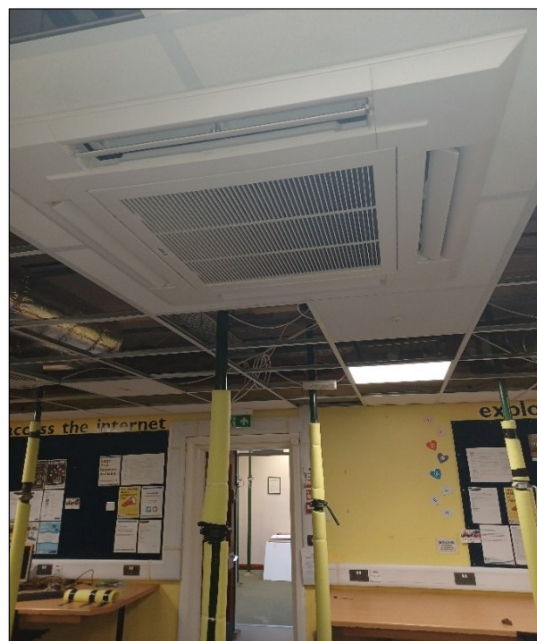
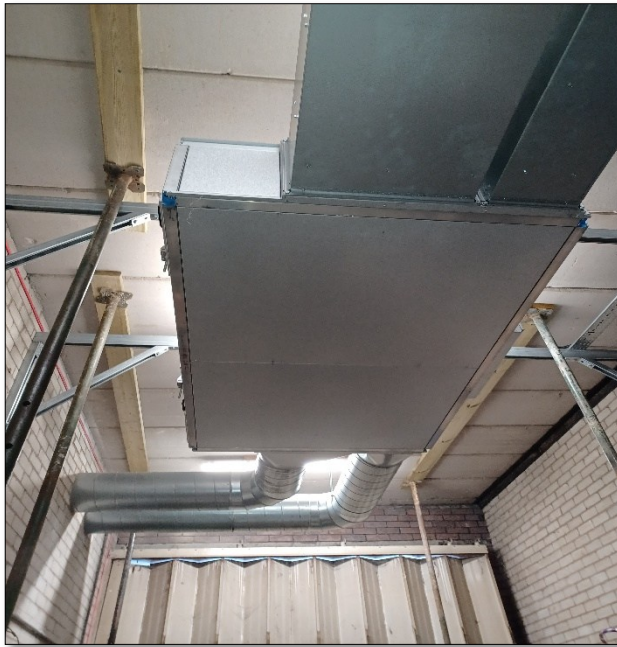
A new Air Conditioning and Heat Recovery Unit has been recently installed circa 2020/2021 and is in good operational condition. Consideration of removal and reinstallation may be required should the RAAC roof be replaced. Consideration of maintenance in the short term, with access via the RAAC Library roof will need to be determined.

Condition Rating A-4

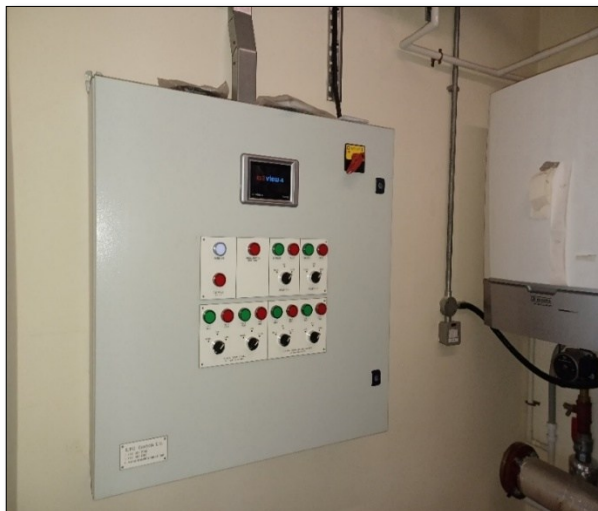
The gas fired boilers are controlled via a Building Management System control panel complete with a Trend iQ4 unit appears to be in good condition. This will control the heating completely with weather compensation. Additionally, the radiators have TRV's installed and are in various states of condition.

Condition Rating – A-4

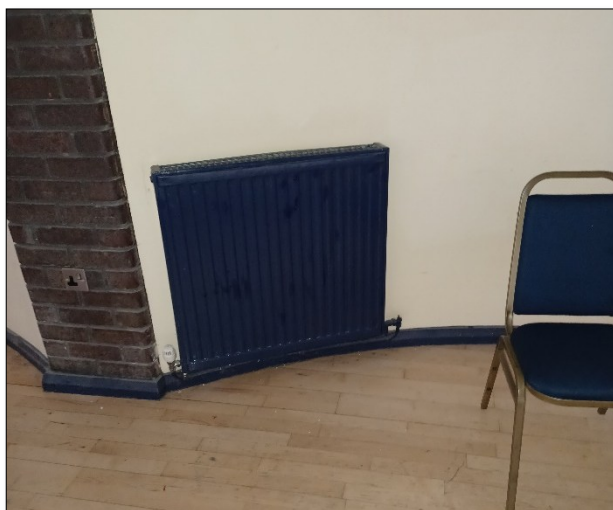
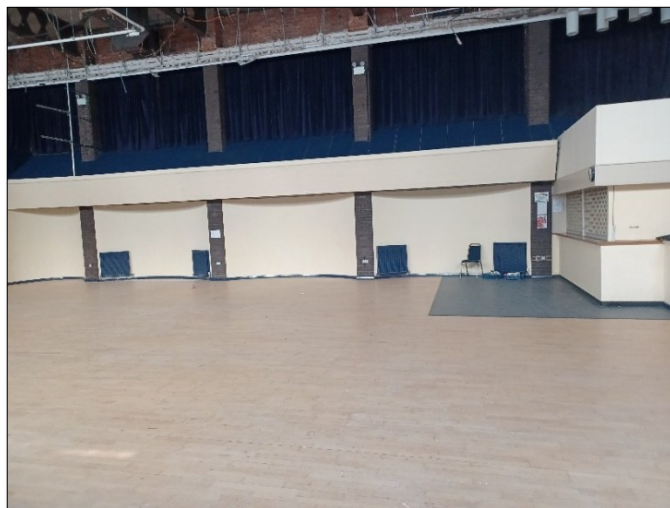
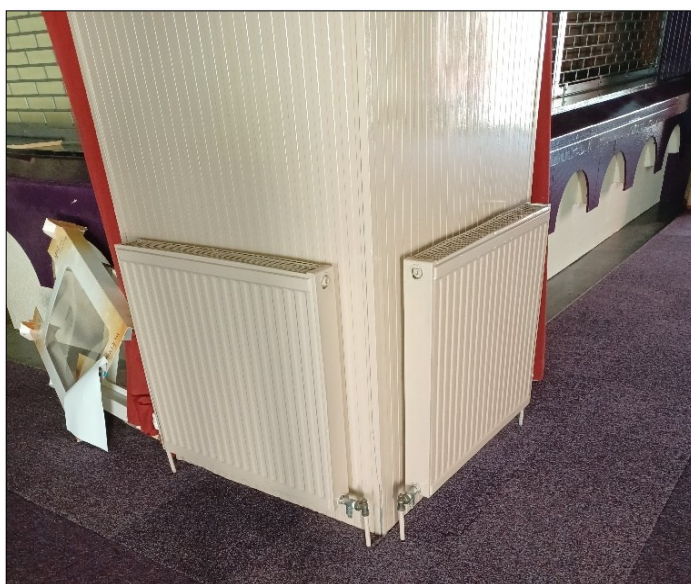
The heater emitters located in the reception area appear to be modern and satisfactory. The heat emitters located in the Theatre consist of old steel panel radiators that are in a poor condition and should be considered for replacement/upgrade.

Condition Rating C-3

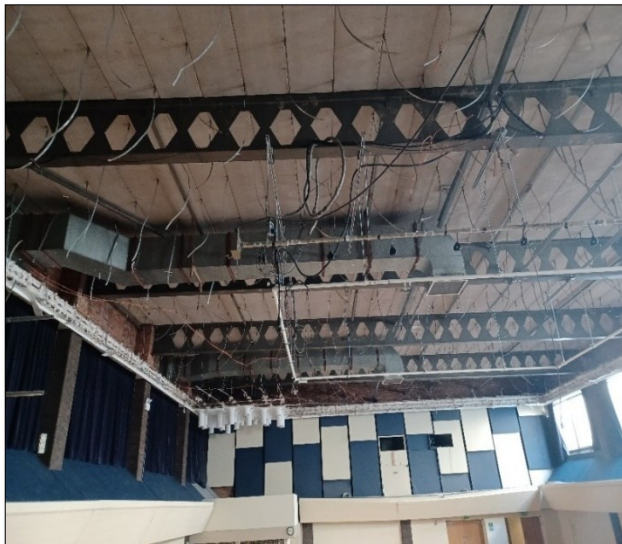
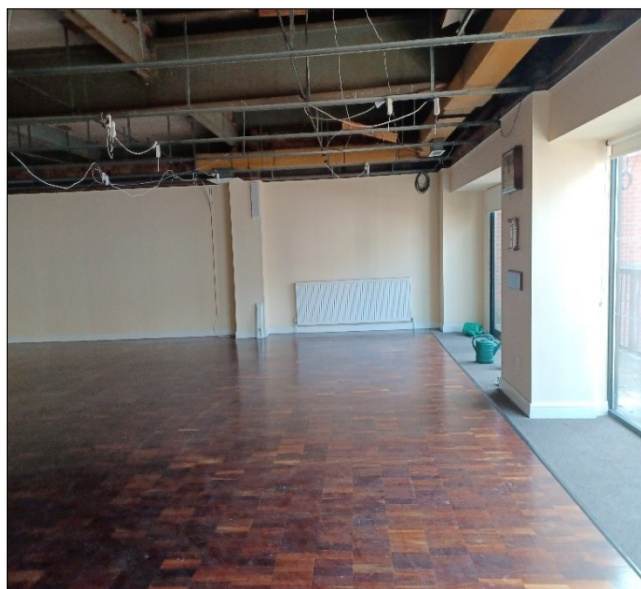
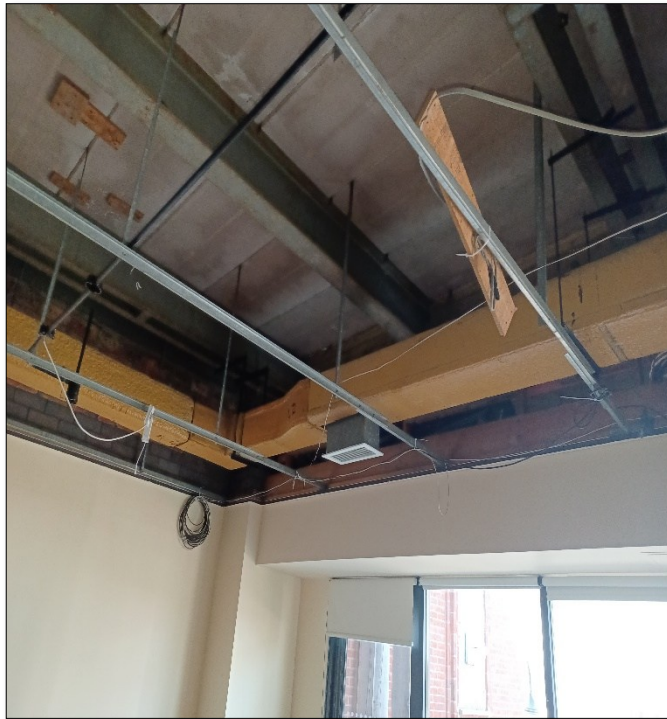
The ventilation system throughout the main property appears obsolete and within the Civic Centre contains what appears to be phenolic insulation which may require removal. The ducted ventilation located within the ceiling void of the Theatre appears to need replacement. Consider full replacement of ventilation systems as part of the main RAAC roof replacement work.

#### Condition Rating D-2

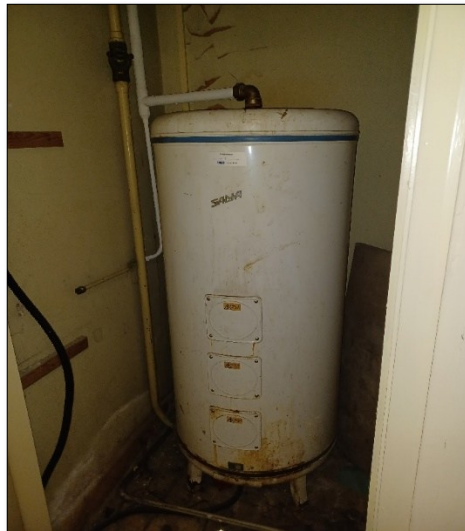
The first-floor changing rooms Domestic Hot Water is served by an existing Sadia water cylinder, which is need of replacement due to poor condition.

#### Condition Rating D-2

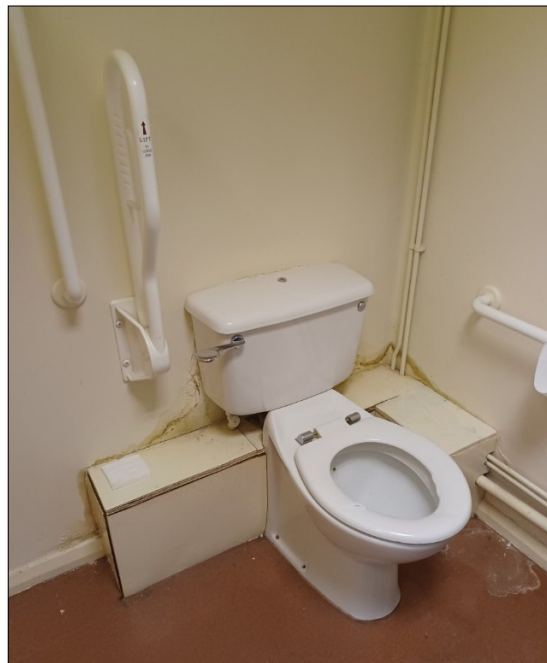
The accessible toilet to the rear of the social area appears to contribute to dampness to the walls likely from a leaking low level toilet cistern or condensation. Repair leak and redecorate effected areas.

Condition Rating C-2
