## **Building Condition Survey Report**

(NSDC018) Whitchurch Civic Centre & (6000) Whitchurch Library  
High Street, Whitchurch, Shropshire, SY13 1AX

**Date of Survey: January/February 2026**

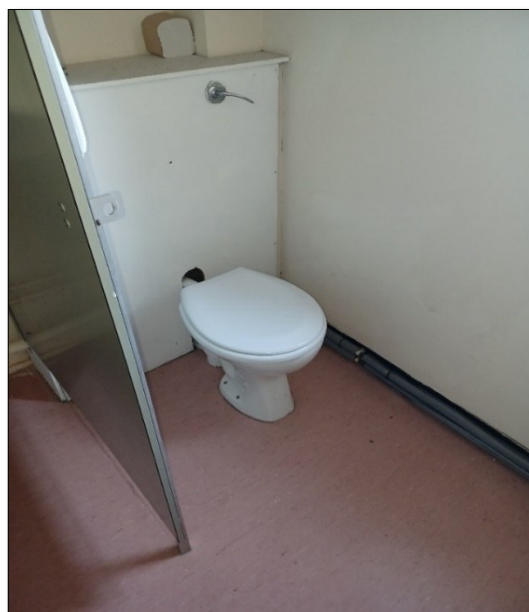
The first-floor changing shower & toilet facilities would benefit from a full upgrade.

Condition Rating C-3

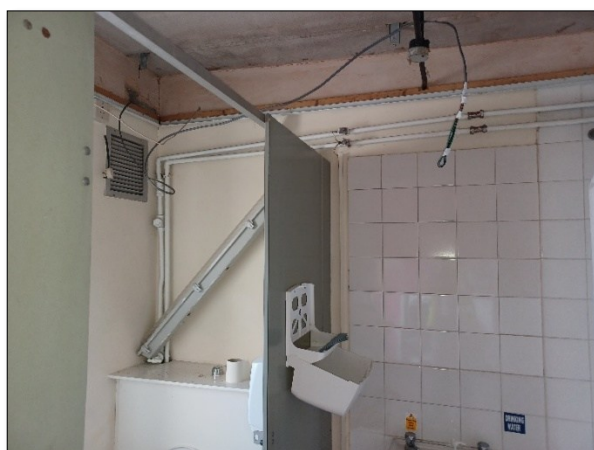
The male, female and accessible toilet appeared to be in working order and in general satisfactory condition.

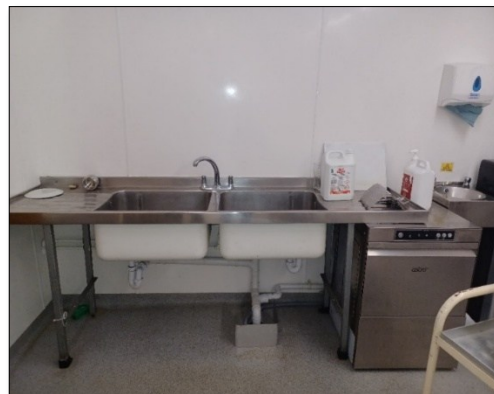
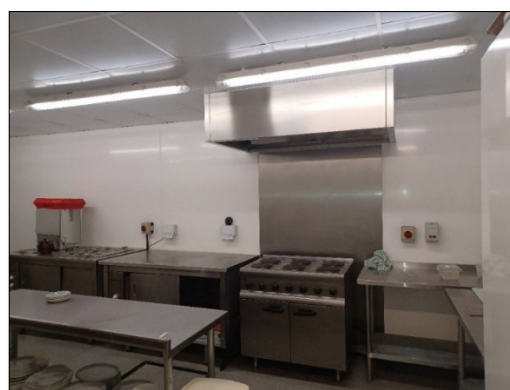
The ground floor Civic reception area is equipped with all fully functioning kitchen, which appears in general a satisfactory condition. The walls are clad in a phenolic hygiene board, and a hygiene rated suspended ceiling. It was assumed the extraction unit was an internal filter system.

Condition Rating B-4

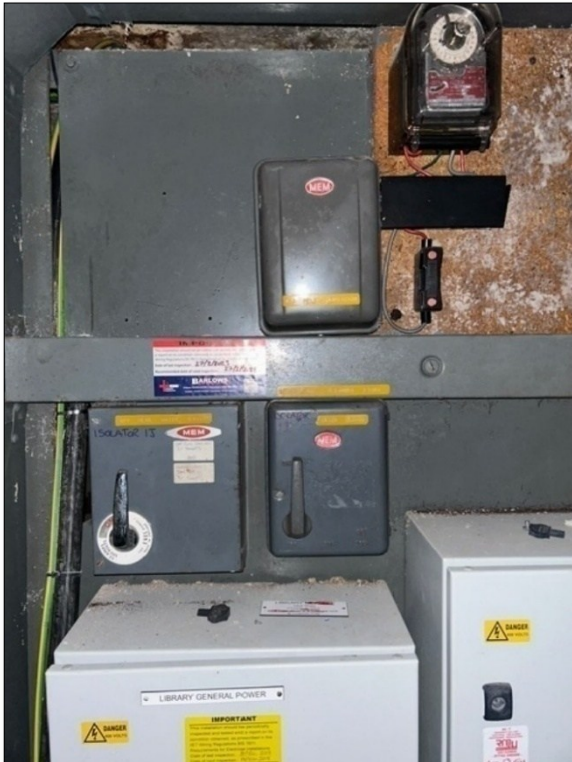
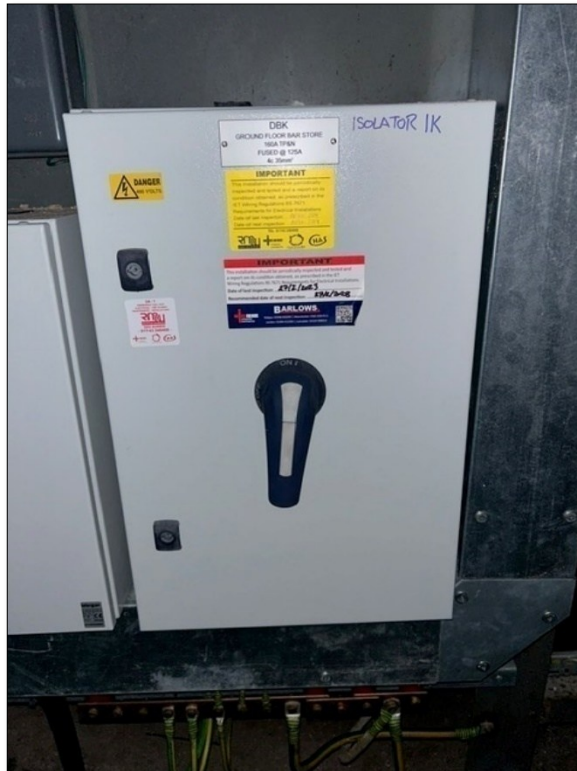
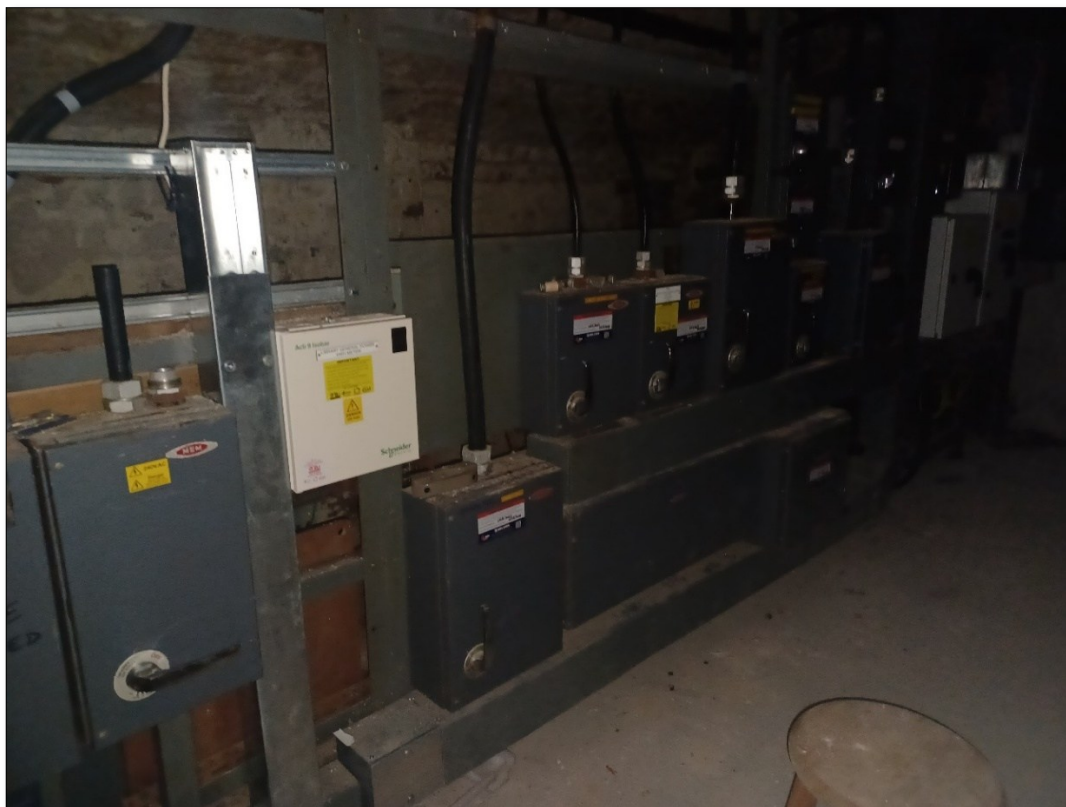
Busbar chamber located within basement store 074 has a mixture of new and old isolators fed from it. Number of isolators not labelled or no longer in use therefore recommend removal of redundant isolators and updating of distribution schedules.

No surge protection present.

Condition Rating B-2

Remove redundant equipment and create distribution schedule.

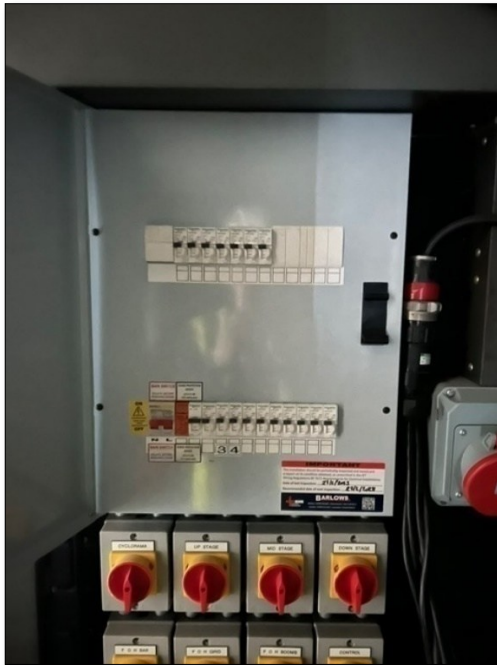
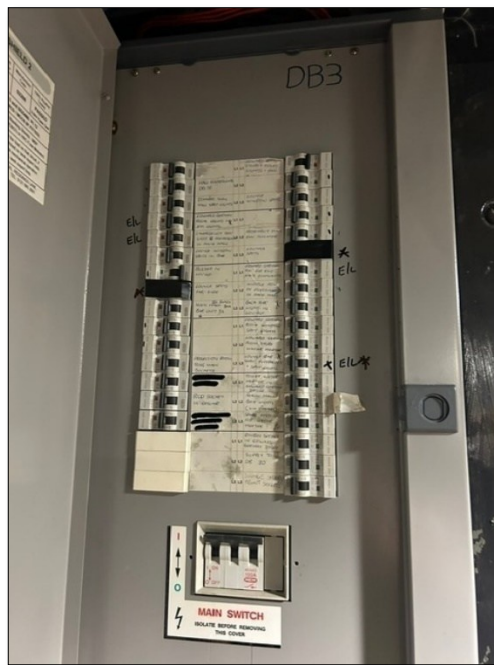
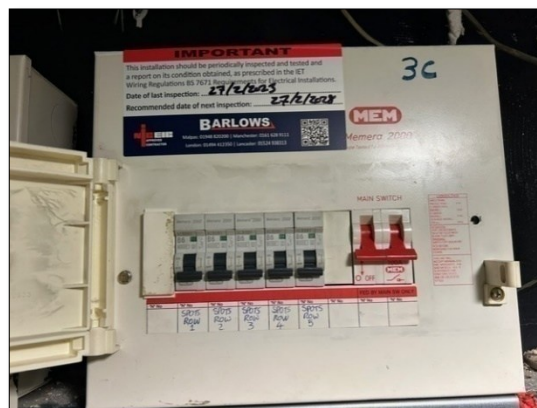
Number of three phase and single-phase distribution boards installed across site fed via aluminum armored cables, with a number of circuits not protected by RCD. Some new schneider electric distribution boards. Number of the Memera 2000, Crabtree Starline and MEM Shield 2 distribution boards are now obsolete and require updating to ensure business continuity. No surge protection on any of the distribution boards.

Condition Rating B-2  
Replacement obsolete distribution boards.

Condition Rating B-2  
Provide surge protection to every Distribution Board.

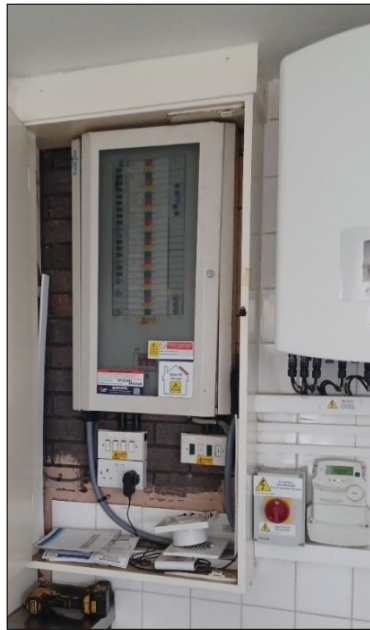
A Hager Three phase distribution board is located within the kitchen of the Market Hall and has a lack of RCD protection and surge protection.

Condition Rating B-2

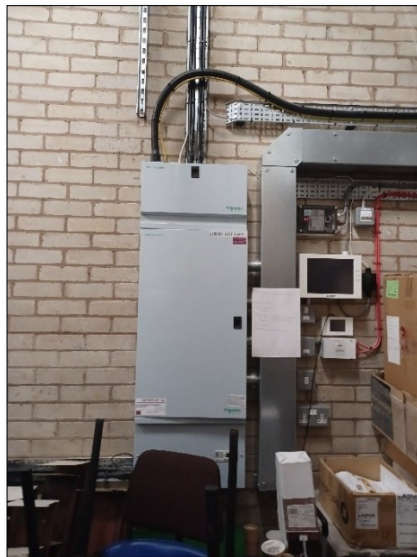
New Schneider Electric KQ load centre three phase distribution board with metering and surge protection.

Condition Rating A-4

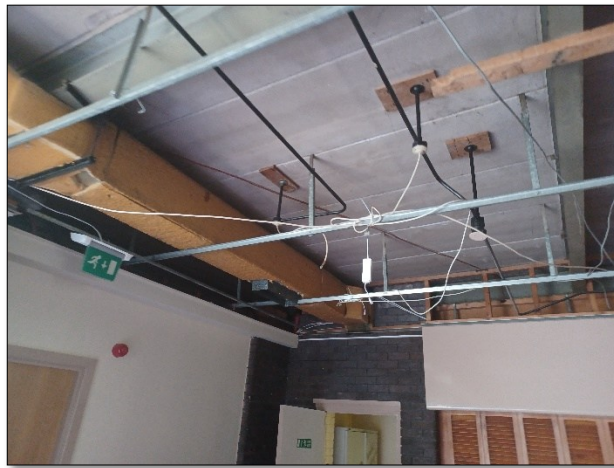
Ground floor area at the front of the property seems to be in good condition. First floor and hall area require improvement as not supported.

Condition Rating C-1

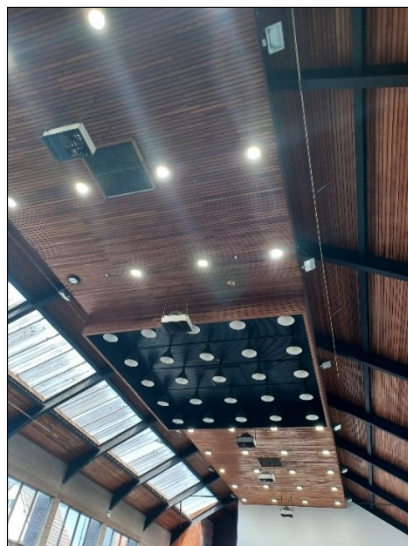
New LED lighting installed at high level, assumption that the asbestos containing material and lighting circuits have been removed and replaced. No operation and maintenance file available to confirm lighting levels, glare ratings and overall uniformity is compliant for the halls intended use. Large area in middle of the hall has no lighting. Recommended removal of redundant light fittings and replace faulty fitting. Recommendation that if the lighting design cannot be sourced a lighting survey is completed to ensure compliance.

Condition Rating A-3

Remove redundant lights and lighting survey.

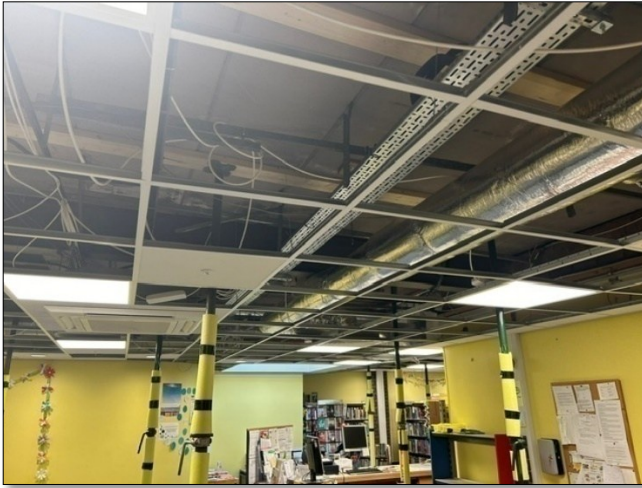
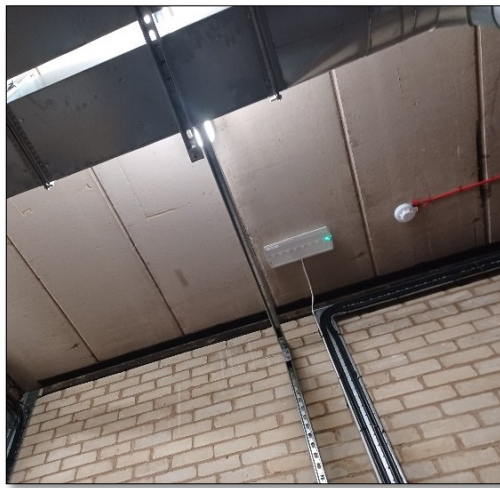
New recessed LED lighting with LUX level and presence detection control. Standalone emergency lighting to BS 5266 installed.

Condition Rating A-4

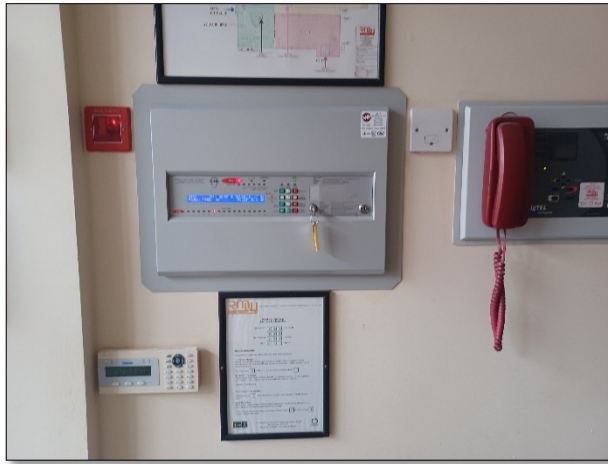
Haes Fusion addressable fire alarm panel covers all properties and is in good condition. Recommend system category is reviewed by fire risk assessor to confirm acceptable as Market Hall has no automatic fire detection. Last fire alarm inspection carried out 31.07.2023. Recommend standalone fire alarm panel is installed within the library if the civic centre is to be transferred to Whitchurch Town Council to ensure a clear division of maintenance and repair responsibilities. Provision should be advised through a suitable fire risk assessment.

Condition Rating A-4 – condition of panel and existing devices.

Condition Rating D-1  
Fire risk assessment.

Condition Rating A-3  
New standalone fire alarm system within library linked to civic panel.

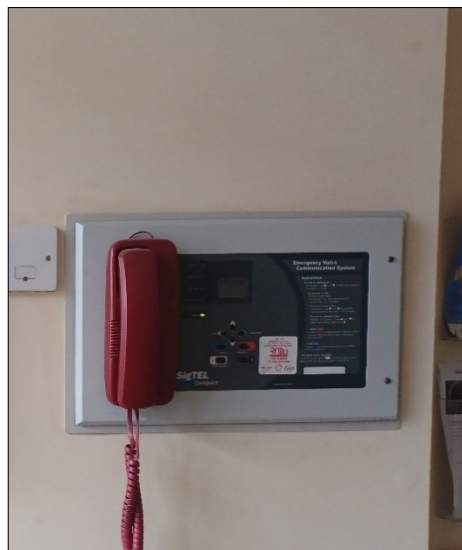
Sigtel compact disable refuge alarm installed at the main entrance with a single remote outstation located on the 1<sup>st</sup> floor landing. No annual inspection reports available, but system is operational.

Condition Rating A-2

Carry out inspection of panel to ensure battery backup satisfactory.

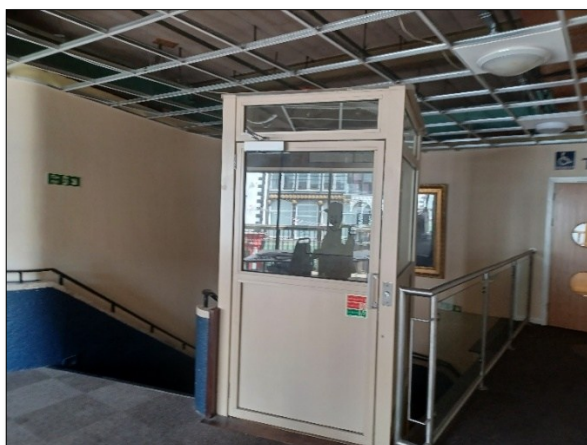
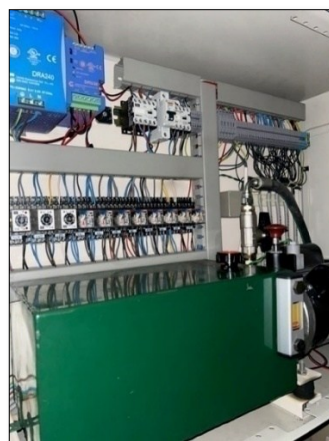
No lift inspection reports provided or Lifting Operations and Lifting Equipment Regulations (1998) inspection reports.

## Condition Rating D-1

Lift and LOLER inspection required.

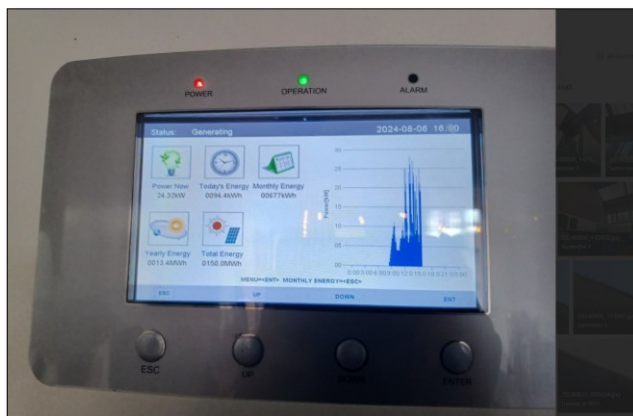
No information was provided to verify the installation, and the satisfactory operation of the installation could not be verified. However, the inverter and display panels appeared to indicate the installation to be operational on the day of the survey.

Condition Rating A-4

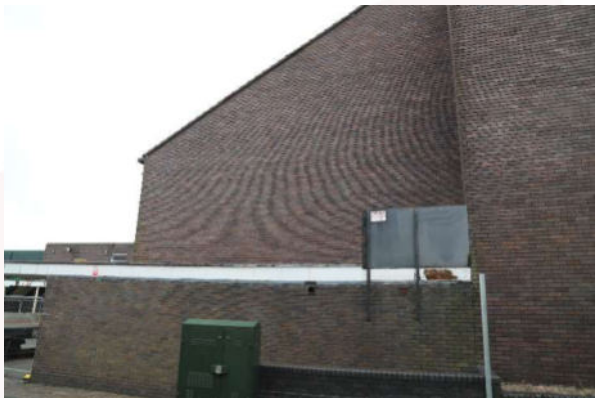
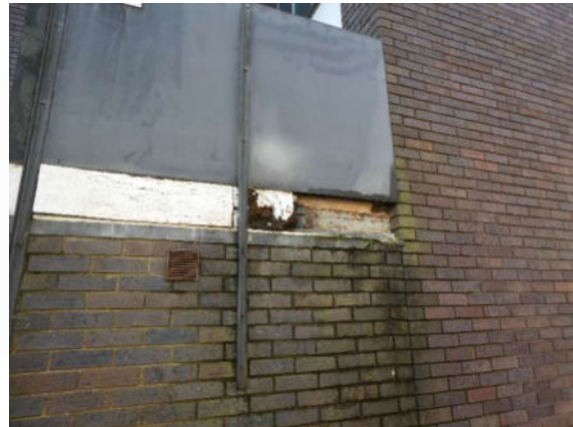
The condition of the timber fascia to the low level roof on the rear of the Market Hall does appear to have become worse since the 2024 inspection.

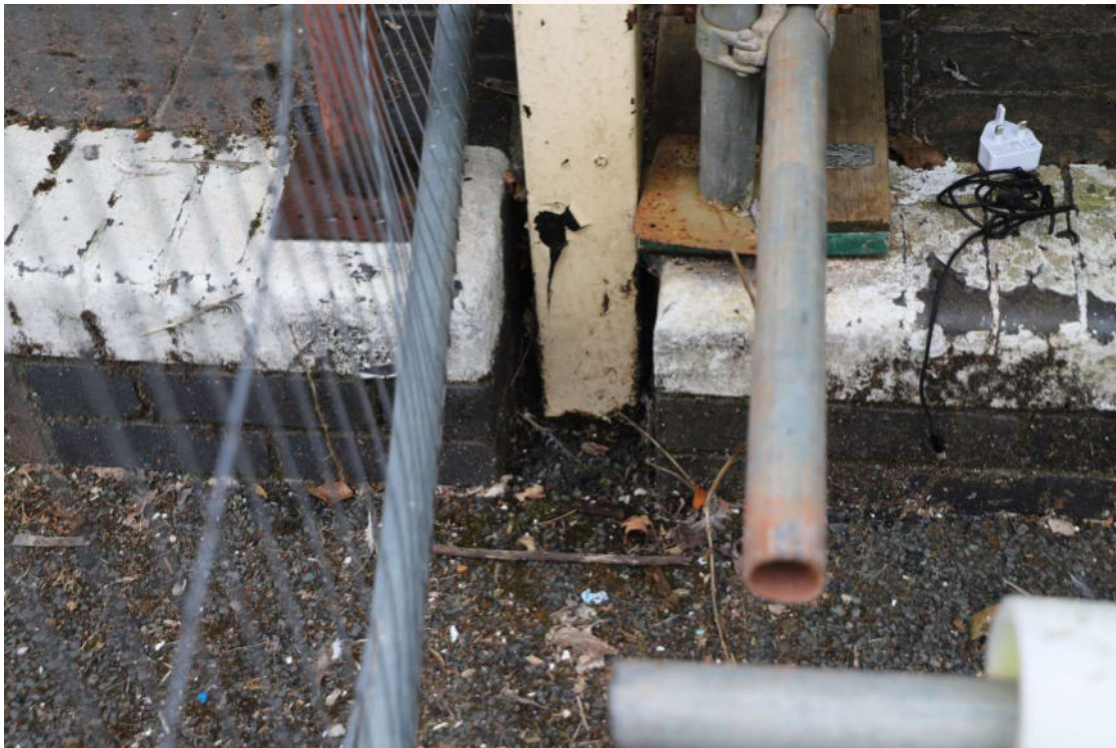
*Photograph 7 – Loss of section to base of column supporting canopy in contact with ground – no change*

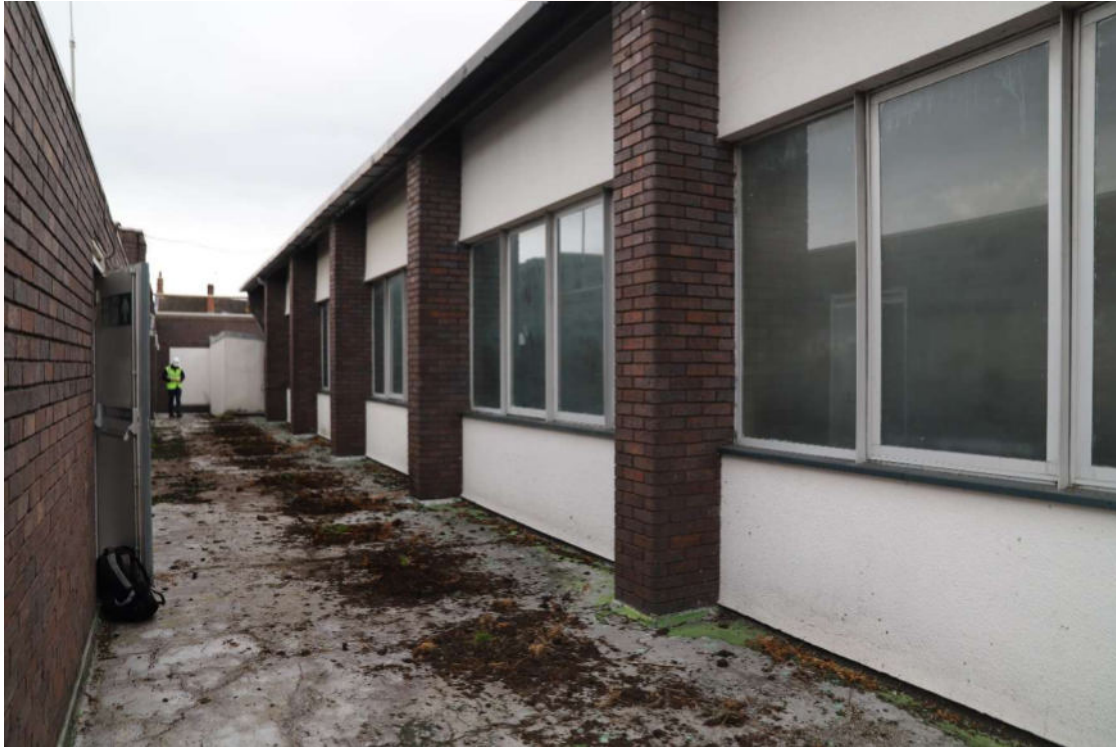
*Photograph 14 – Right side elevation of Market Hall at high level above corridor (2024)*

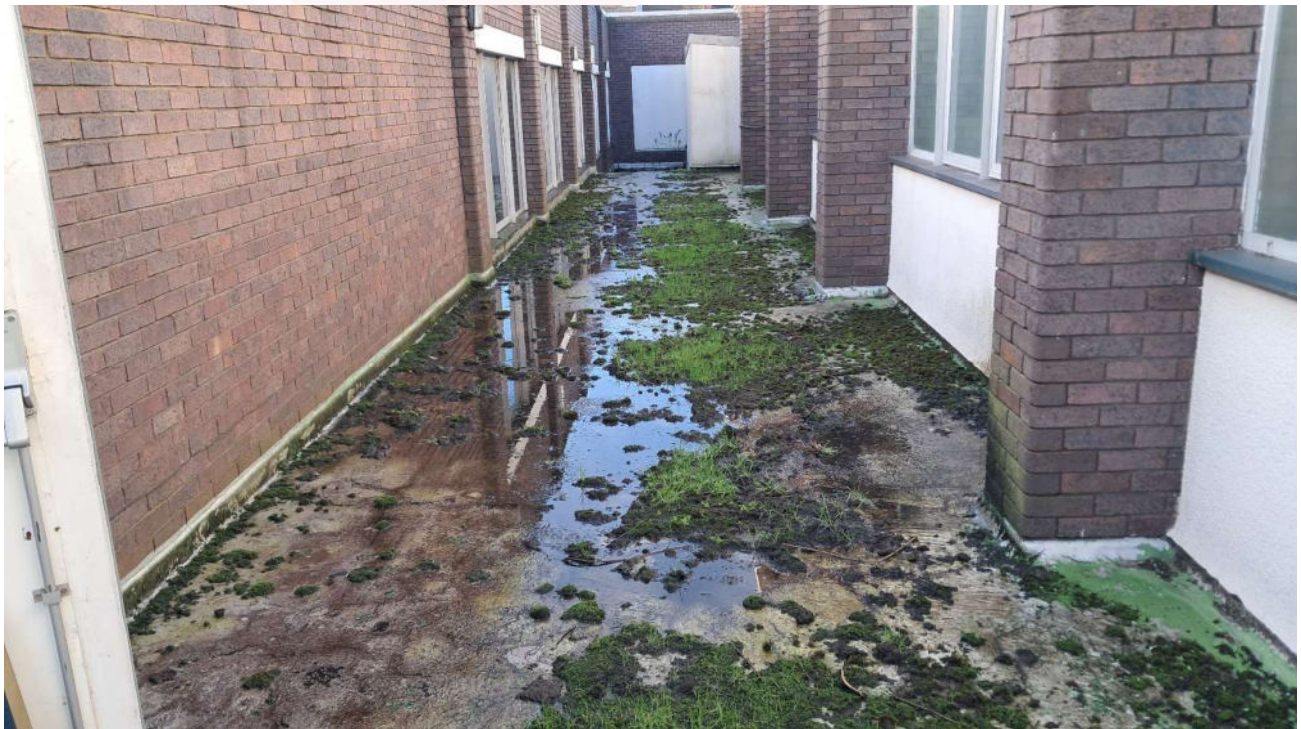
*Photograph 15 – Right side elevation of Market Hall at high level above corridor (2026 update) – note standing water*

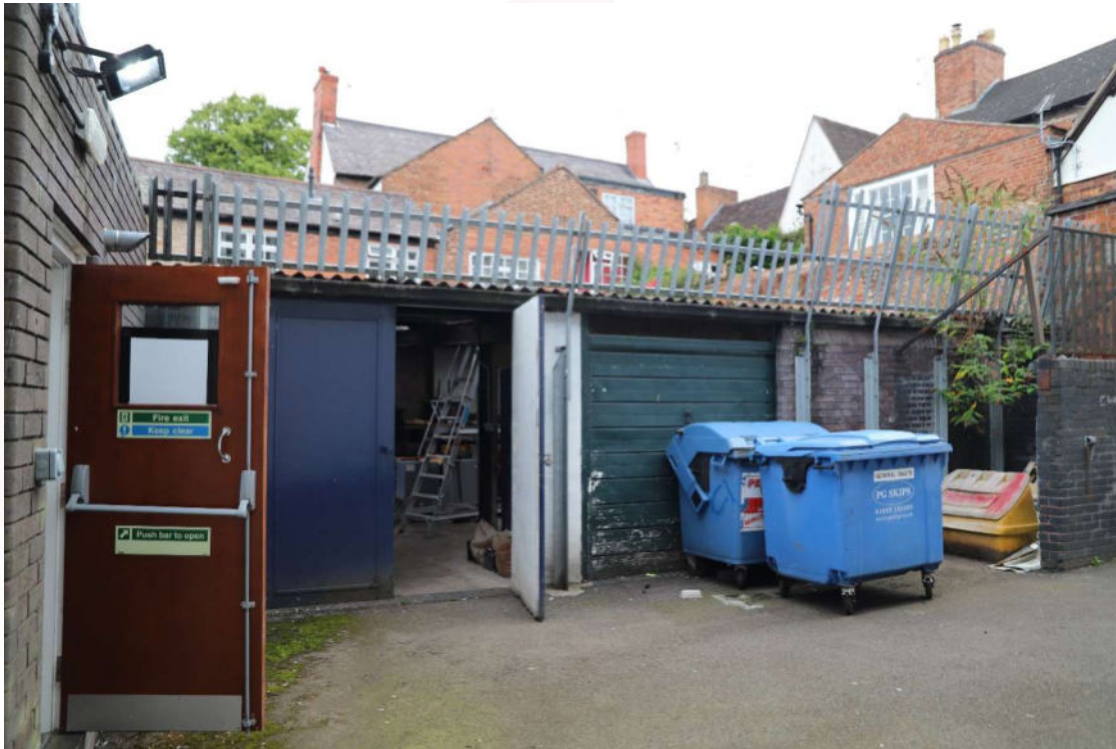
Photograph 20 – External Stores – no change

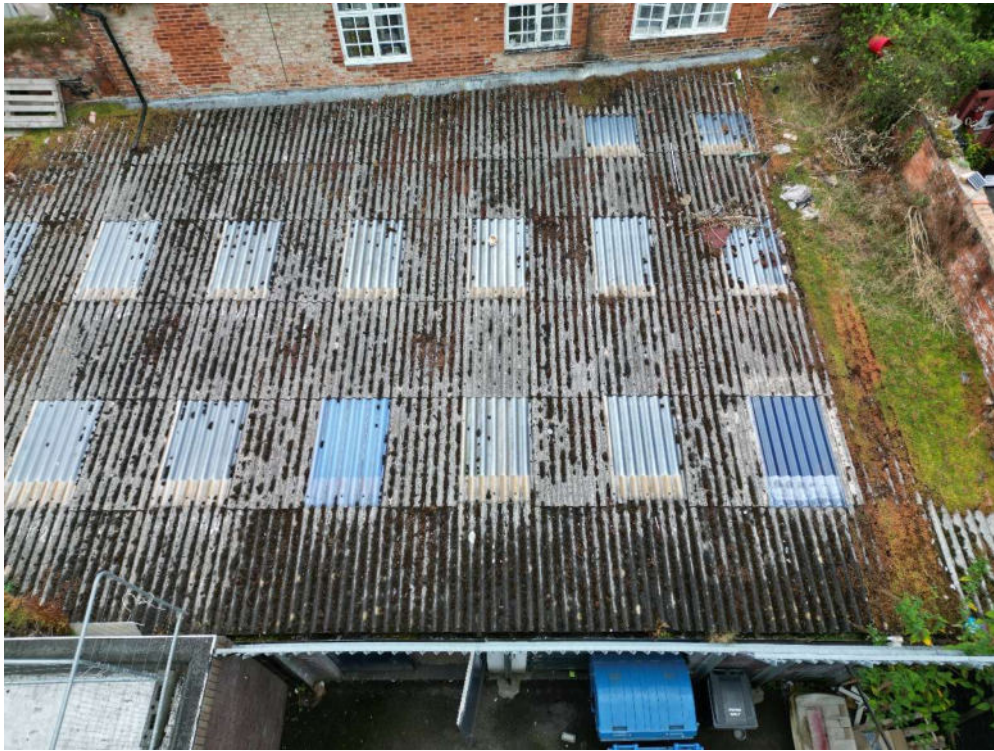
*Photograph 30 – Roof over stores 2024 for comparison*

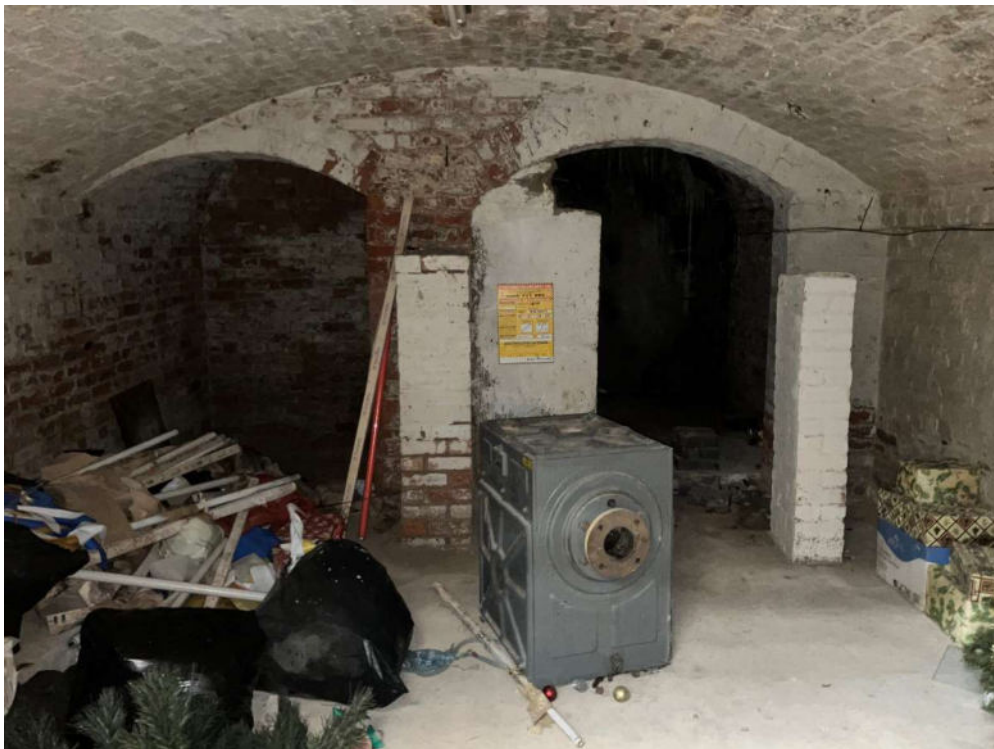
*Photograph 32 – Typical arrangement of basement – no change*

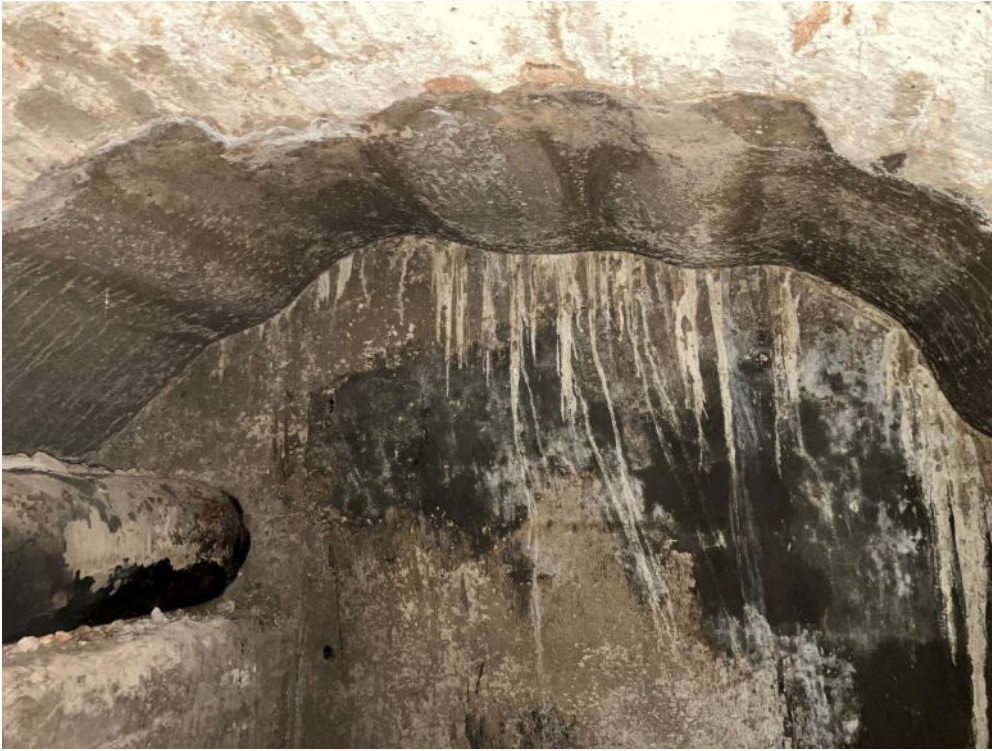
*Photograph 33 – Damp to front of basement – no change*

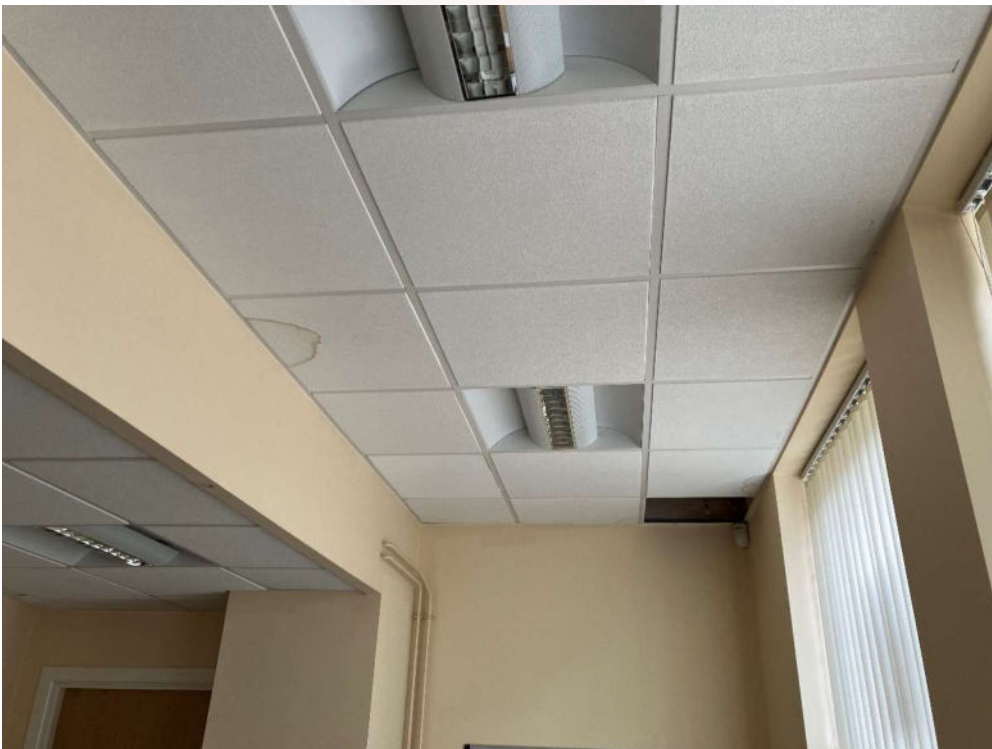
*Photograph 34 – evidence of water ingress to offices – no change*

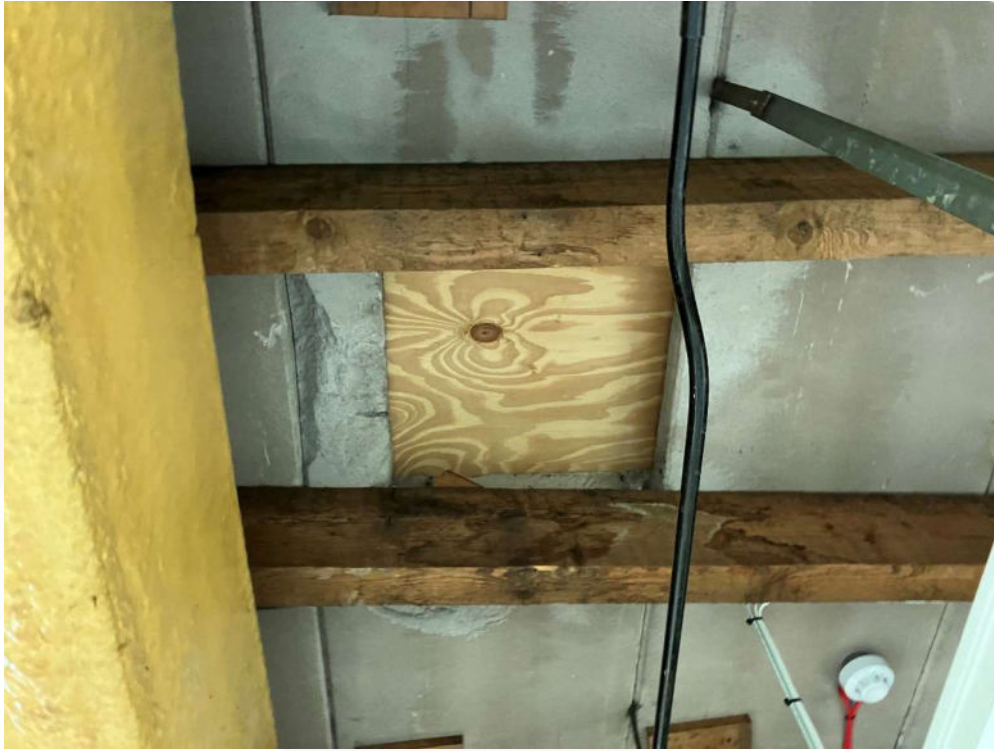
*Photograph 37 – timber trimming to opening in roof over kitchen area to first floor – no change*

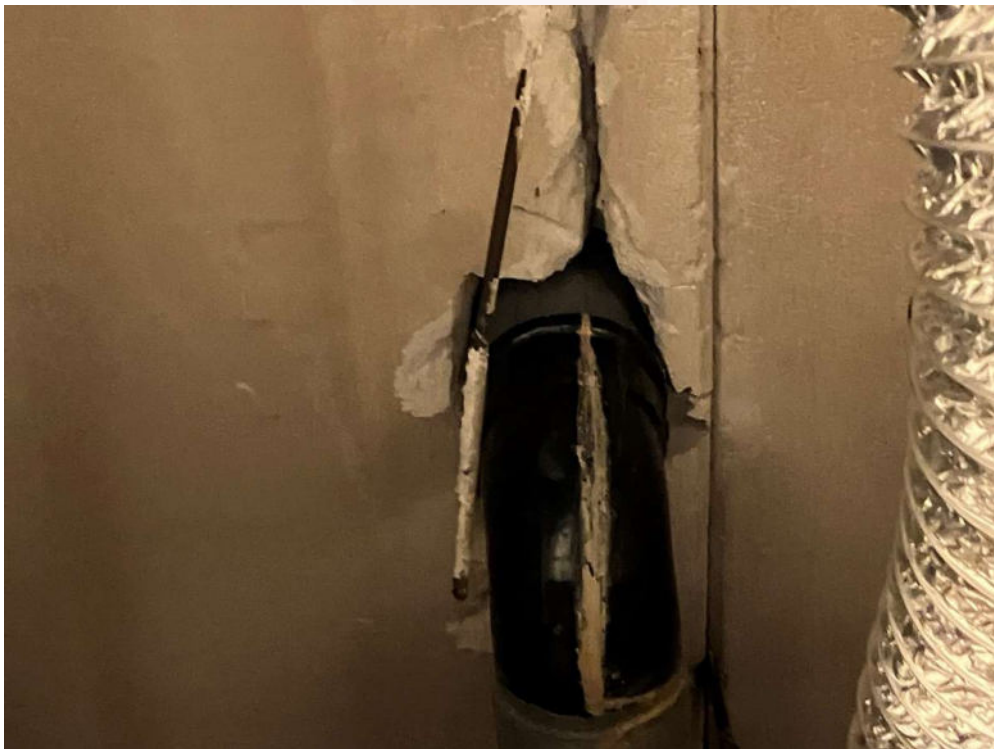
*Photograph 38 – Service penetration in RAAC Concrete with no trimming support and bent reinforcement visible – no change*

Water ingress elsewhere through existing penetrations in the RAAC Concrete would be addressed as part of replacement roof works.

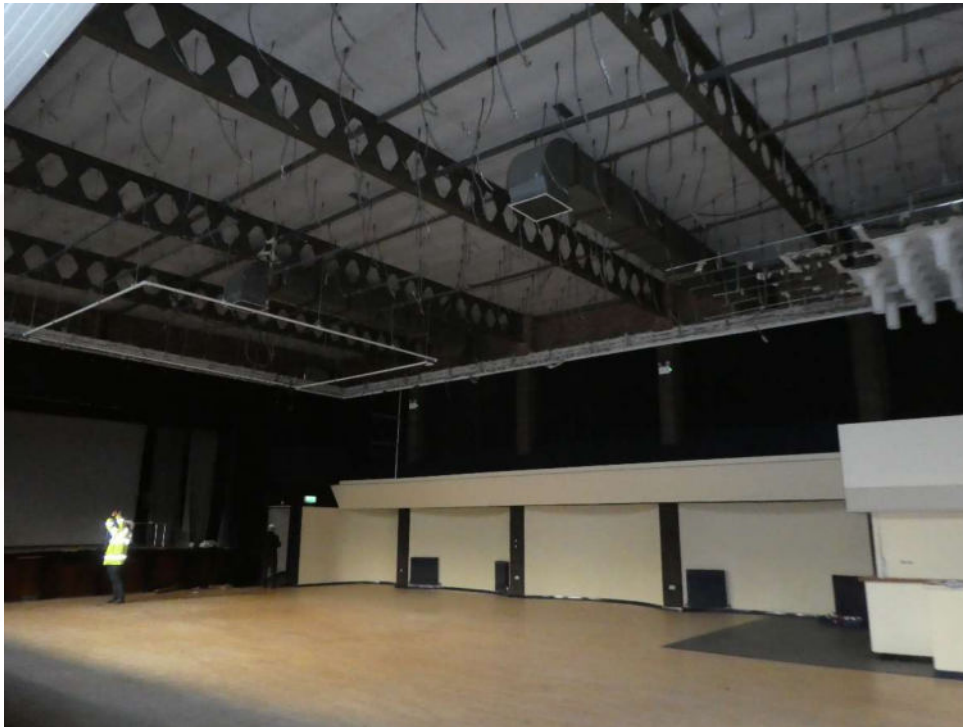
*Photograph 39 – roof arrangement over theatre hall*

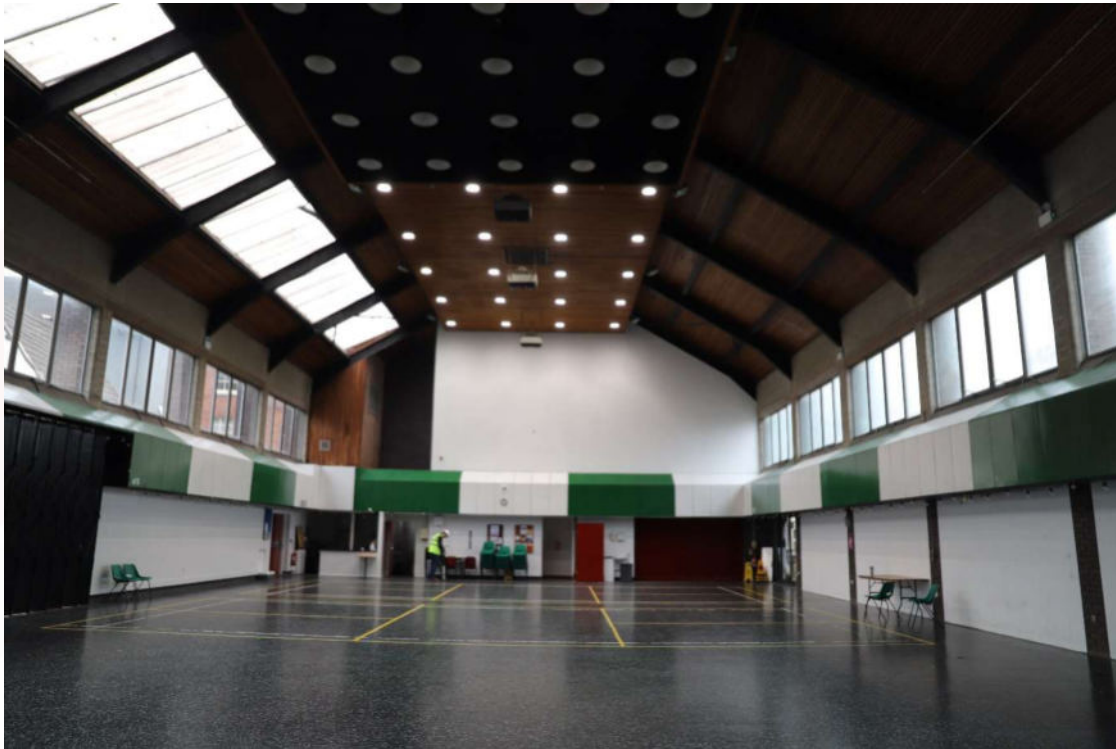
*Photograph 41 – Roof arrangement over Market Hall – no change*

Cracking within the Market Hall can be monitored but it is not critical that this is repaired until a time that re-roofing works are considered here.

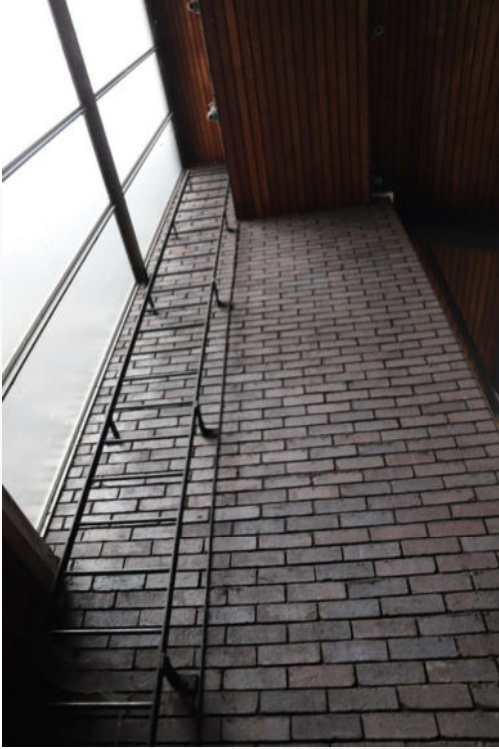
*Photograph 43 – Access ladder to high level service void – no fall arrest system in place – no change*

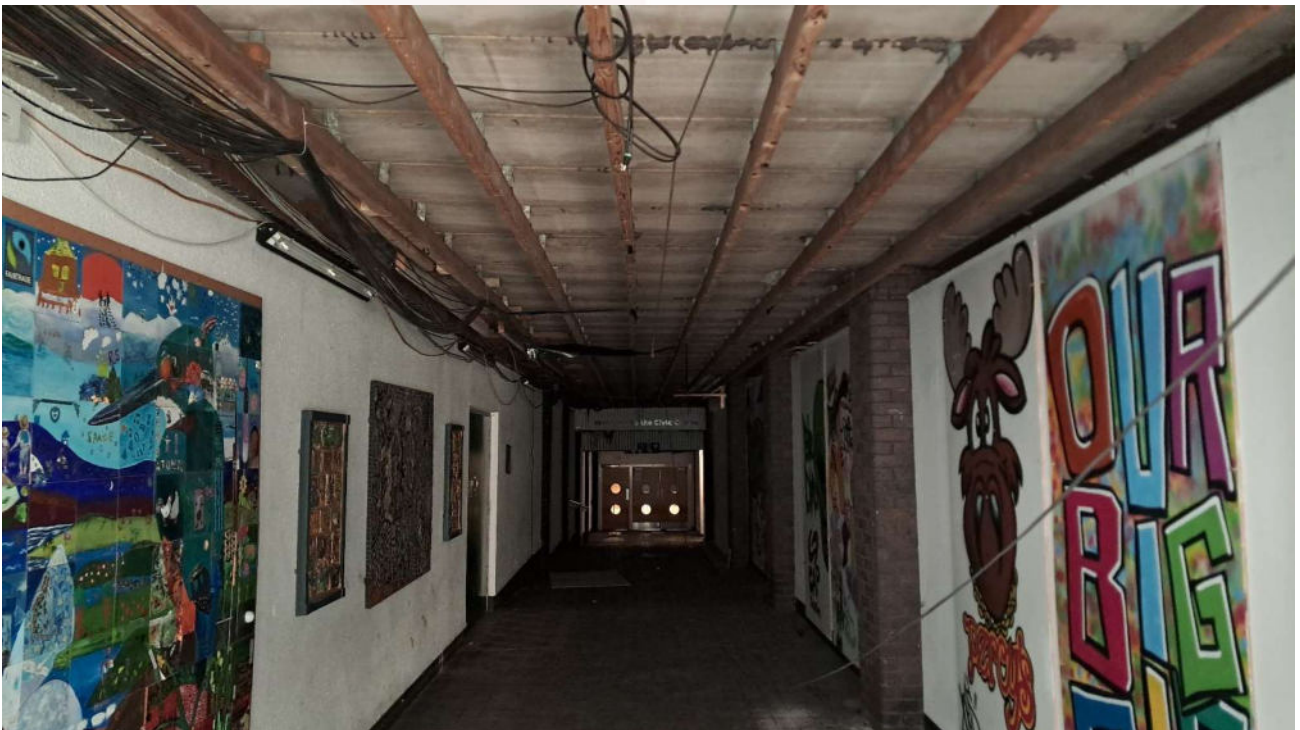
*Photograph 44 – typical roof arrangement in Corridor*

We would also recommend propping of the corridor area as a precaution.

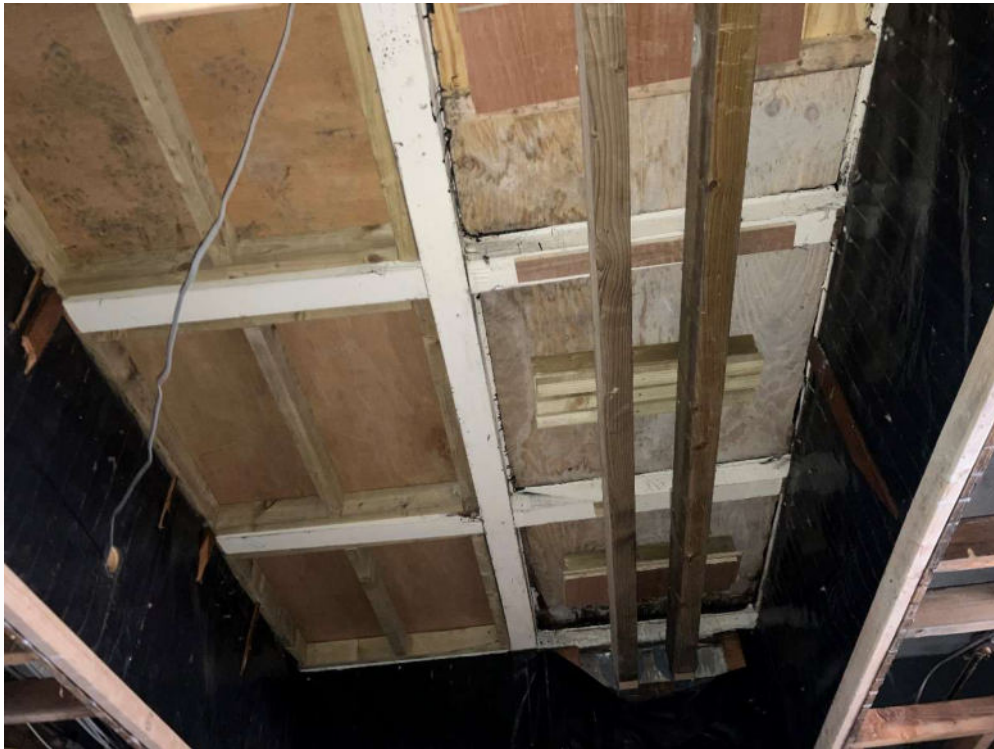
*Photograph 47 – Section of timber roof to corridor by entrance to Civic Centre*

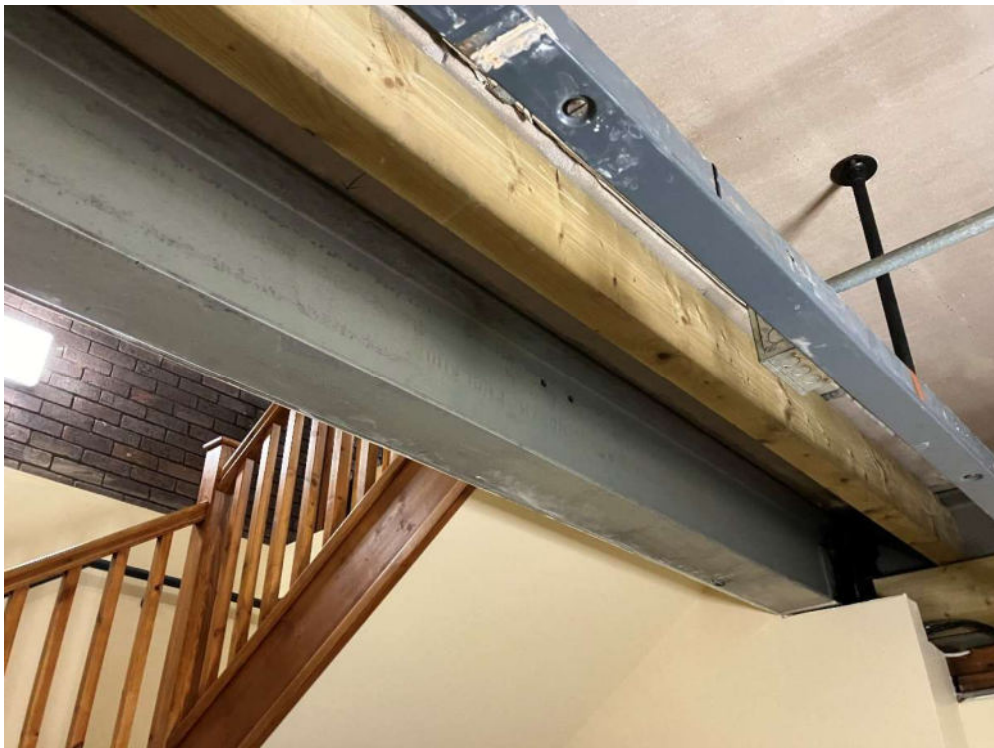
*Photograph 48 – RAAC concrete forming landing to fire escape leading from Lounge Bar to Corridor*

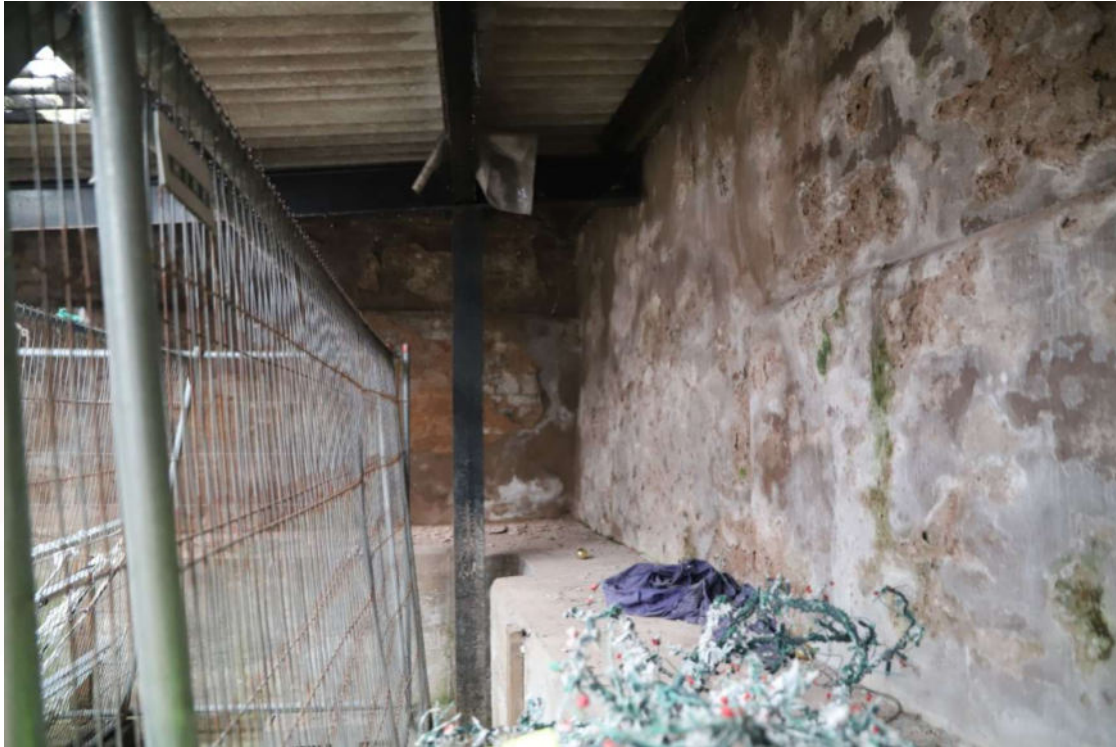
*Photograph 49 – Typical damp to rear party wall in stores – no change*

The stores should also be considered for demolition and replacement with a new fit for purpose structure.

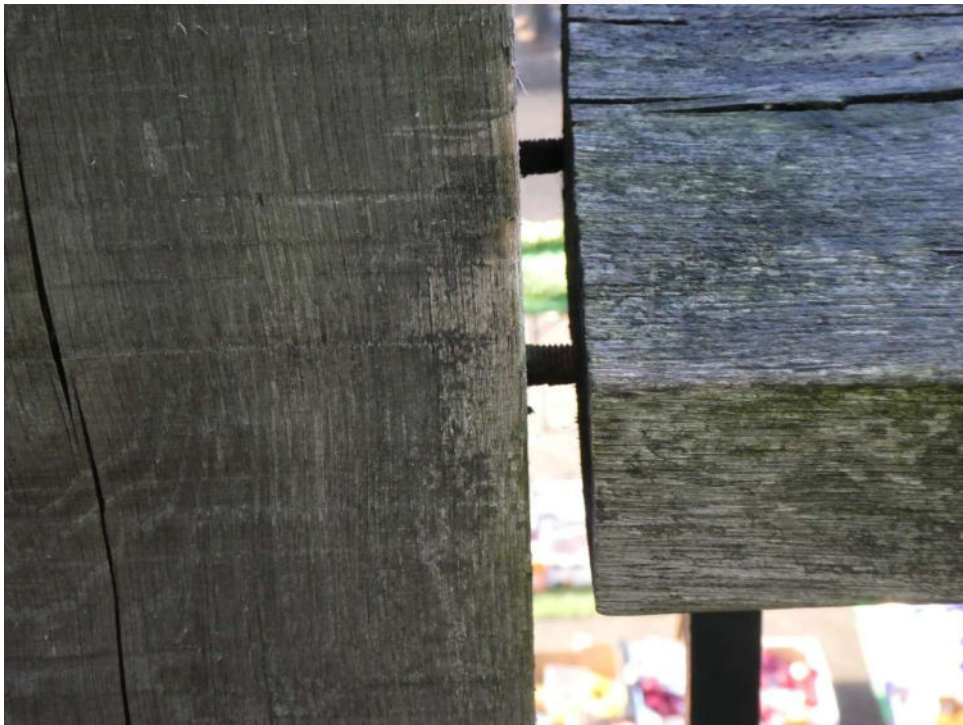
*Photograph 52 – separation at balustrade joints*

The condition of the timber façade to the front of the Civic Centre should be considered for replacement or treatment of the timbers to extend its current lifespan.

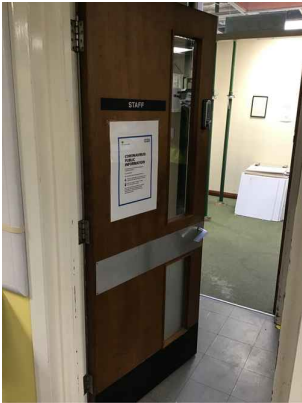
Pin Photos

Other, Missing structure

Fire door not fit for purpose - requires replacing with FD30s in line with strategy.

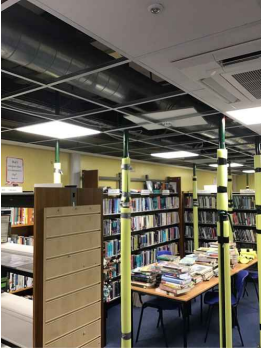
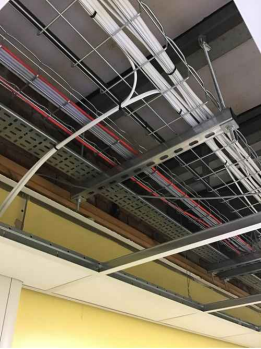
0003:15 - History 1 of 1 (latest)

No compartmentation issues noted - wall appears to be brick masonry cavity wall which is load bearing to library structure.

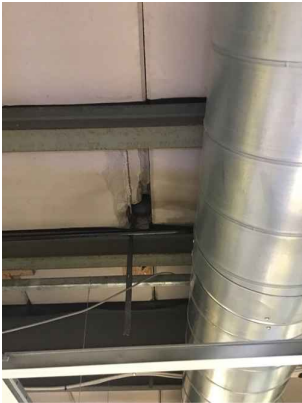
Pin Number: 0004:15

Comments: Damage to RAAC ceiling deck noted - no compartmentation issues related.

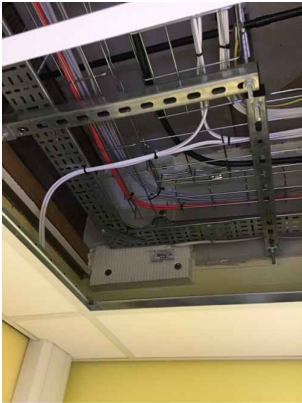
Fire batt installed on head of the wall not clear why this is required -however no issues noted.
