## **Building Condition Survey Report**

(NSDC018) Whitchurch Civic Centre & (6000) Whitchurch Library  
High Street, Whitchurch, Shropshire, SY13 1AX

**Date of Survey: January/February 2026**

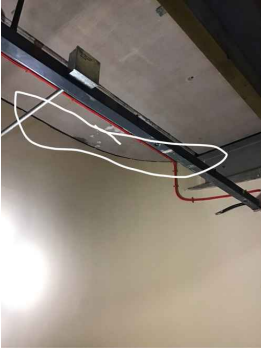
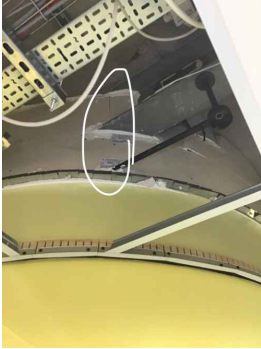
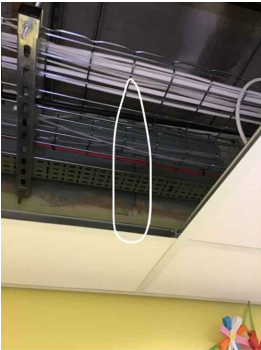
0006:15 - History 1 of 1 (latest)

Board Missing, Head of wall

Compartmentation around stairwell - boarding is not scrim and jointed as required to provide 60 minutes protection. It is not clear what the structure is behind the boarding. To the head of the plasterboard within the stairwell this does not appear to have been sealed.

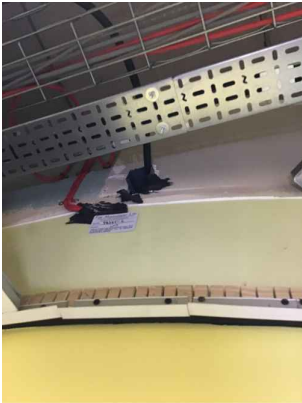
**Pin Number:** 0007:15

**Comments:**  
Cable penetrations seal is poor - cable conduit exposed. HPE to be replaced and made good.

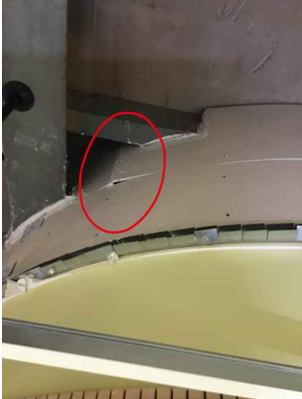
**Pin Number:** 0008:15

**Item Type:** Board Missing, Compartment Wall

**Comments:**  
Plaster Board exposed - does not appear to be FR boarding, no marking to suggest as such. Screws do not appear to be drywall screws nor have these been scrimmed or recessed.

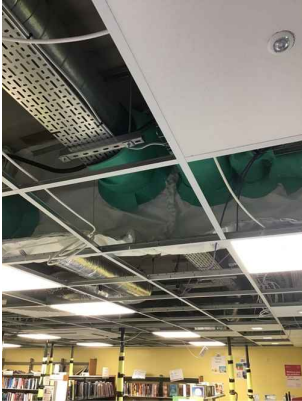
0009:15 - History 2 of 2 (latest)

Fire curtain with ceiling void - located centrally within library area assumed to break distance within void since it is more than 20 lm.

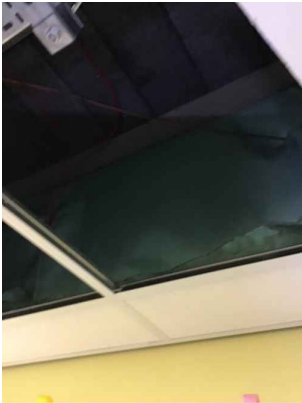
Pin Number: 0010:15

On review of the fire strategy and consideration of the occupancy and operation of the building - this is considered to be adequate. Some minor ease and adjust required of the doors noted where they do not freely close shut

Some breaches and cable penetrations were noted. Curtain should be inspect annually.

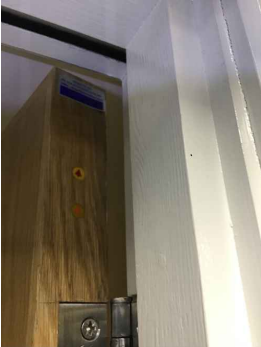
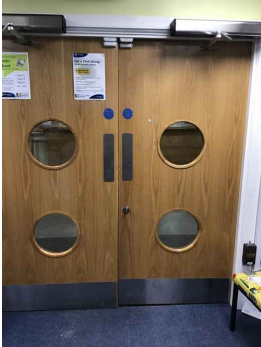
0011:15 - History 1 of 1 (latest)

Some minor ease and adjust required of the doors noted where they do not freely close shut.

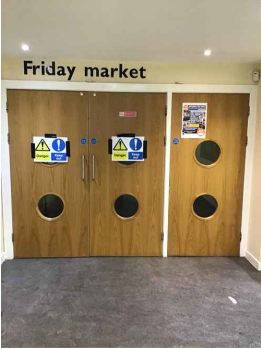
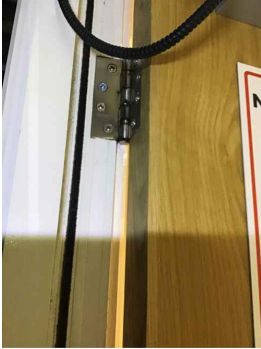
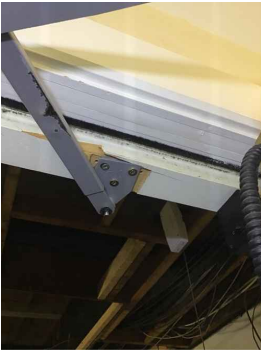
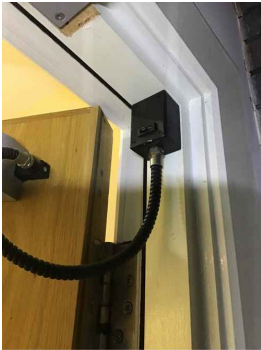
Pin Number: 0012:15

Hinges noted to be packed sitting proud of frame. Excessive oil leakage.

Head of frame damaged.

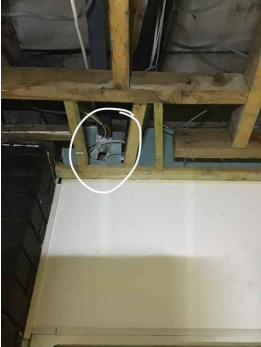
0013:15 - History 1 of 1 (latest)

Item Type: Board Missing, Head of Party Wall, Compartment Wall

Comments: Board above fire door is in poor condition generally with damage noted around cable penetrations requiring re sealing. Edge of boards have not been scrimmed and jointed above the door.

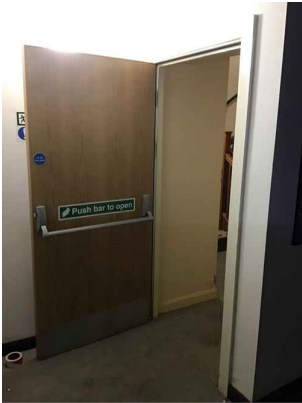
Pin Photos  
Photo 1 of 1

FD60s door appears in good order. There is no closer and function is one way which should be considered within the fire strategy.

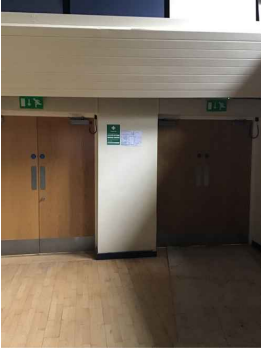
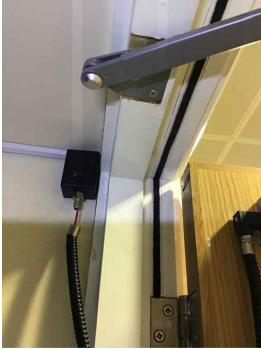
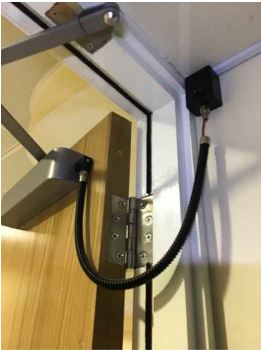
Doors are FD30s. General maintenance required ease and adjust.

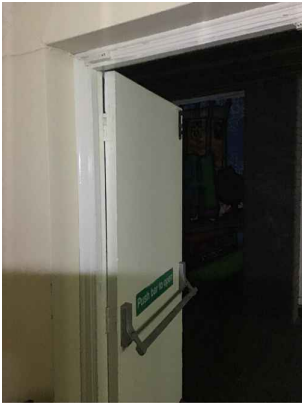
Replace Fire Door - are not fit for purpose - require replacement with double FD30s doorset - to protect the covered corridor.

Consideration prior to the survey was that corridor should be protected to 60mins. Following the survey the risk appears minimal in compromised the route of escape - the principal corridor door from the reception is 60 mins - 30mins protection from hall would be adequate and in line Part B guidance.

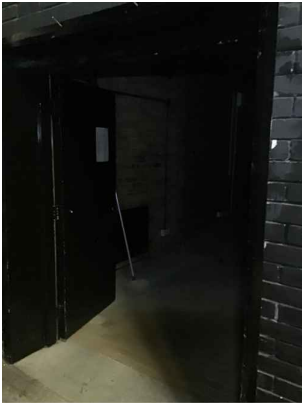
Following the survey we do not believe that this door set is required to be fire rated - the travel distances from the stage and seating area are within excepted travel distance tolerance - see updated compartmentation layout plan.

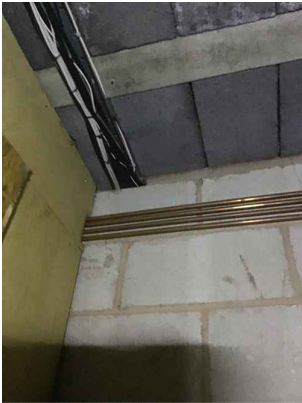
Cable penetrations are not fire stopped consider installing HPE mastic.

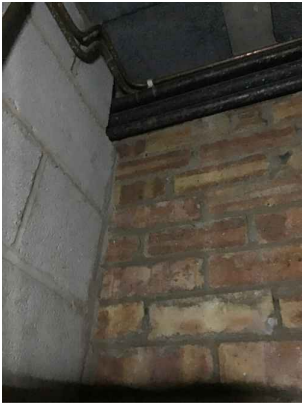
Pipework pentretations not sealed. Install appropriate fire intumescent mastic sealant.

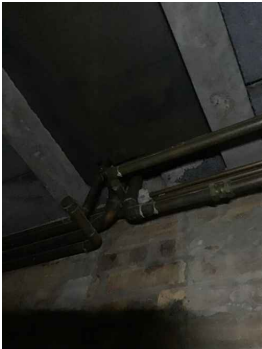
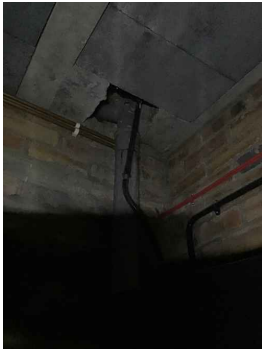
Pipework penetrations into ceiling deck do not appear to be sealed - exposing the compartment into the first floor.

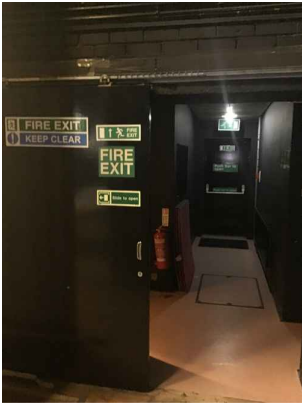
Sliding door from stage - Following the survey we do not believe that this door set is required to be fire rated - the travel distances from the stage and seating area are within accepted travel distance tolerance - see updated compartmentation layout plan.

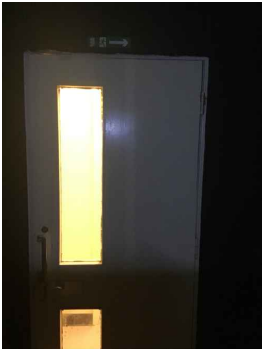
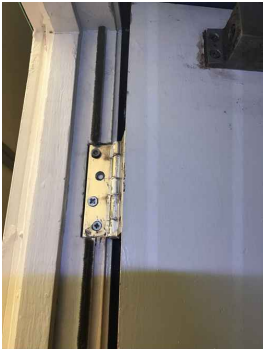
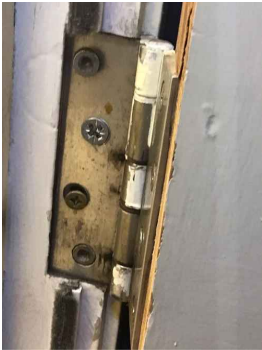
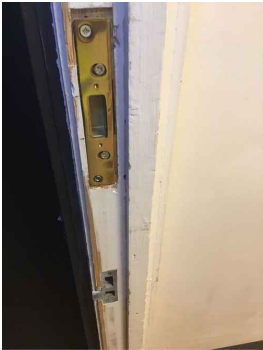
**Pin Number:** 0023:15

Replace Fire door - not fit for purpose. Inadequate door leaf, ironmongery and missing smoke seals.

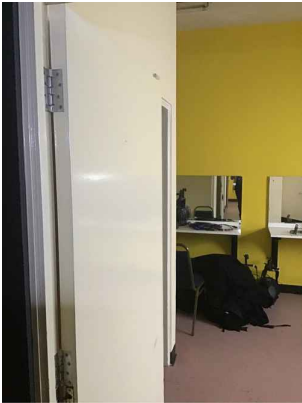
Replace Fire door - not fire rated and not fit for purpose - Door requires replacement.

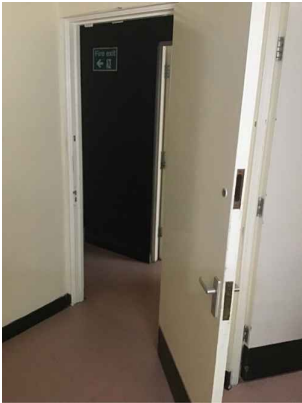
Pin Number: 0025:15

Comments: Replace Fire door - not fit for purpose - requires replacing with FD30s.

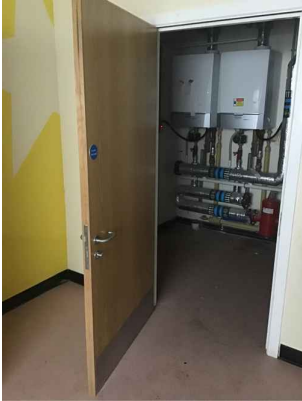
0026:15

Fire door in good condition - some minor ease and adjust required.

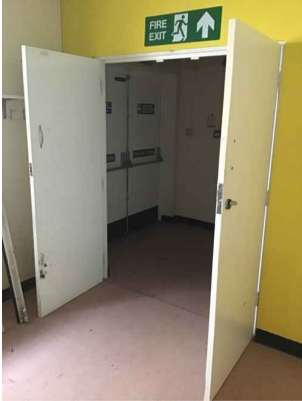
Pin Number: 0029:15

Comments: Replace Fire Doors - not fire rated - to be replaced with FD30s fire rated doorset.

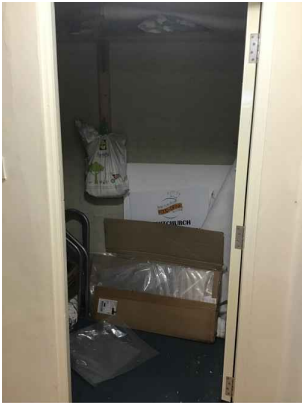
Pin Number: 0031:15

Comments: Store cupboard could remain - ensure store is kept locked with appropriate signage. Should be reviewed within FRA and Fire Strategy.

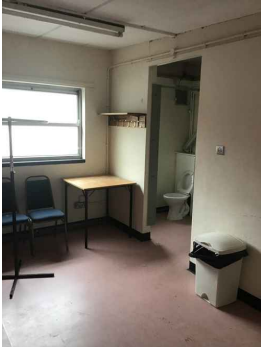
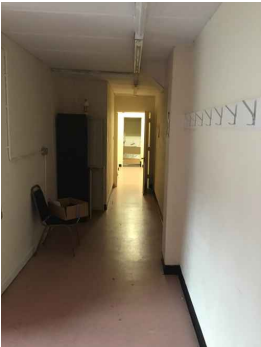
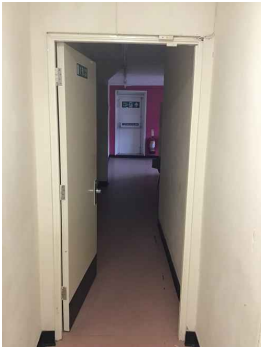
Pin Number: 0032:15

Comments: To be reviewed within FRA - dressing room and stairwell could form same compartmentation - secondary means of escape allowed over roof.

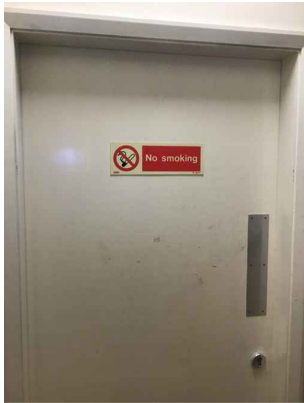
Pin Number: 0033:15

Existing fire door appears in reasonable condition with smoke seal in place. The door is aged with no reference to fire rating. Consider replacing.

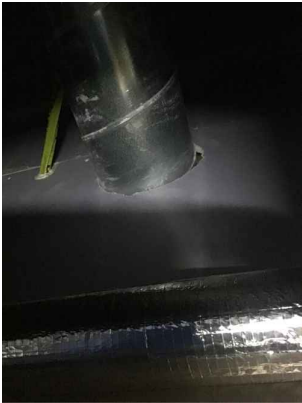
0034:15 - History 1 of 1 (latest)

Duct within ceiling does not appear to be sealed - penetrating the plaster board.

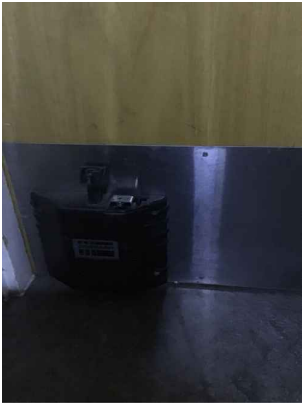
Pin Number: 0035:15

Comments: Door hold release to kitchen appears damage - to be repaired/ replaced.

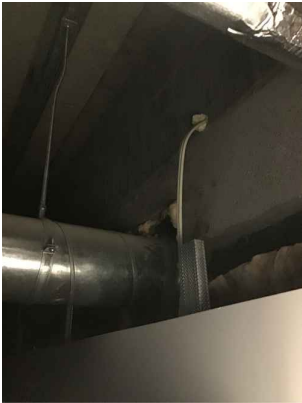
**Pin Number:** 0036:15

PU foam noted around ductwork to be removed and ablative intumescent mastic installed to seal around penetrations. Fire damper appears to in the place of the compartment line. Test records to reviewed and function confirmed.

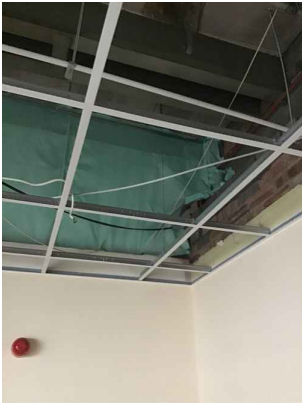
**Pin Number:** 0038:15

Compartmentation has been supplemented with what appears to be a fire rated curtain. No detail on product or rating. Fire rating to be confirmed. We were also unable to view structure behind the curtain. Some breaches and cable penetrations were noted. Curtain should be inspect annually.

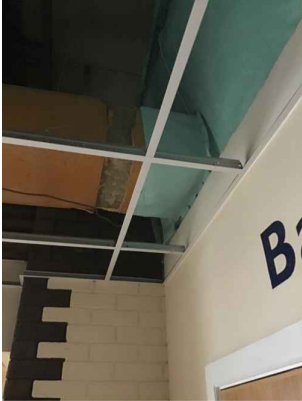
0039:15 - History 1 of 1 (latest)

No evidence of fire damper with duct.

Ductwork servicing HVAC on the first floor - It was not clear whether this HVAC was in operation - it appeared on survey to be redundant. The ductwork is covered in what appears to be a type of PU insulation. There was no information on site to confirm. To be reviewed within the buildings FRA.

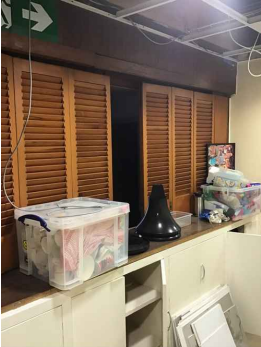
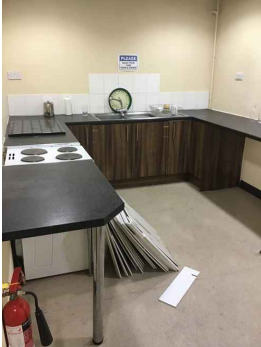
Pin Number: 0040:15

Consideration prior to the survey was that the kitchen should be separated. Following the survey the risk appears minimal with small kitchen used infrequently for functions - not requiring separation. Travel distance from both the bar and function room are in the acceptable travel distances.

2013 Fire strategy - confirms that only the Landing/ stairwell require separation with the installation of second protected means of escape from the lounge.

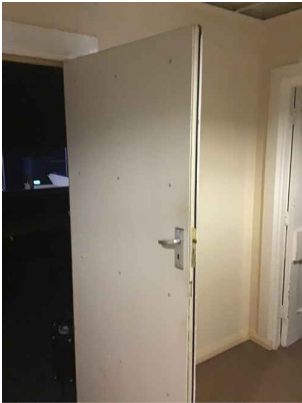
0041:15 - History 1 of 1 (latest)

Replace Fire door - servicing the control room is inadequate. There is no clear indication of rating. The leading edges and intumescent strips are damage beyond repair. It is recommended that the door is replaced.

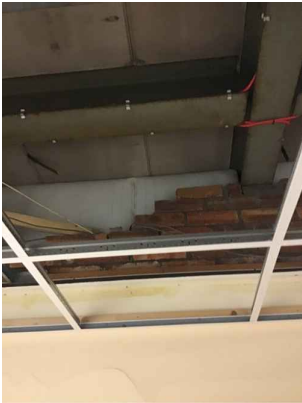
0042:15 - History 1 of 1 (latest)

Compartmentation has been supplemented with what appears to be a fire rated curtain. No detail on product or rating. Fire rating to be confirmed. We were also unable to view structure behind the curtain. Some breaches and cable penetrations were noted. Curtain should be inspect annually.

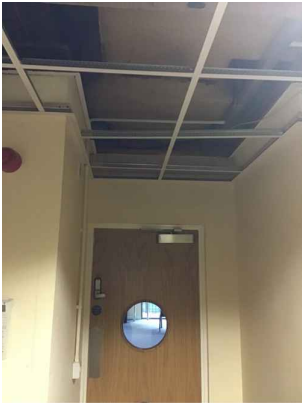
0043:15 - History 1 of 1 (latest)

The control (lighting room) should be compartmentalised with the main hall - given compartmentation would prove difficult to achieve with specialist shutters.

2013 Fire strategy - confirms that only the Landing/ stairwell require separation with the installation of second protected means of escape from the lounge
